# Upgrades Maximize Efficiency of 82-Year-Old Pump

**Publisher:** Pumps & Systems / August, 2012

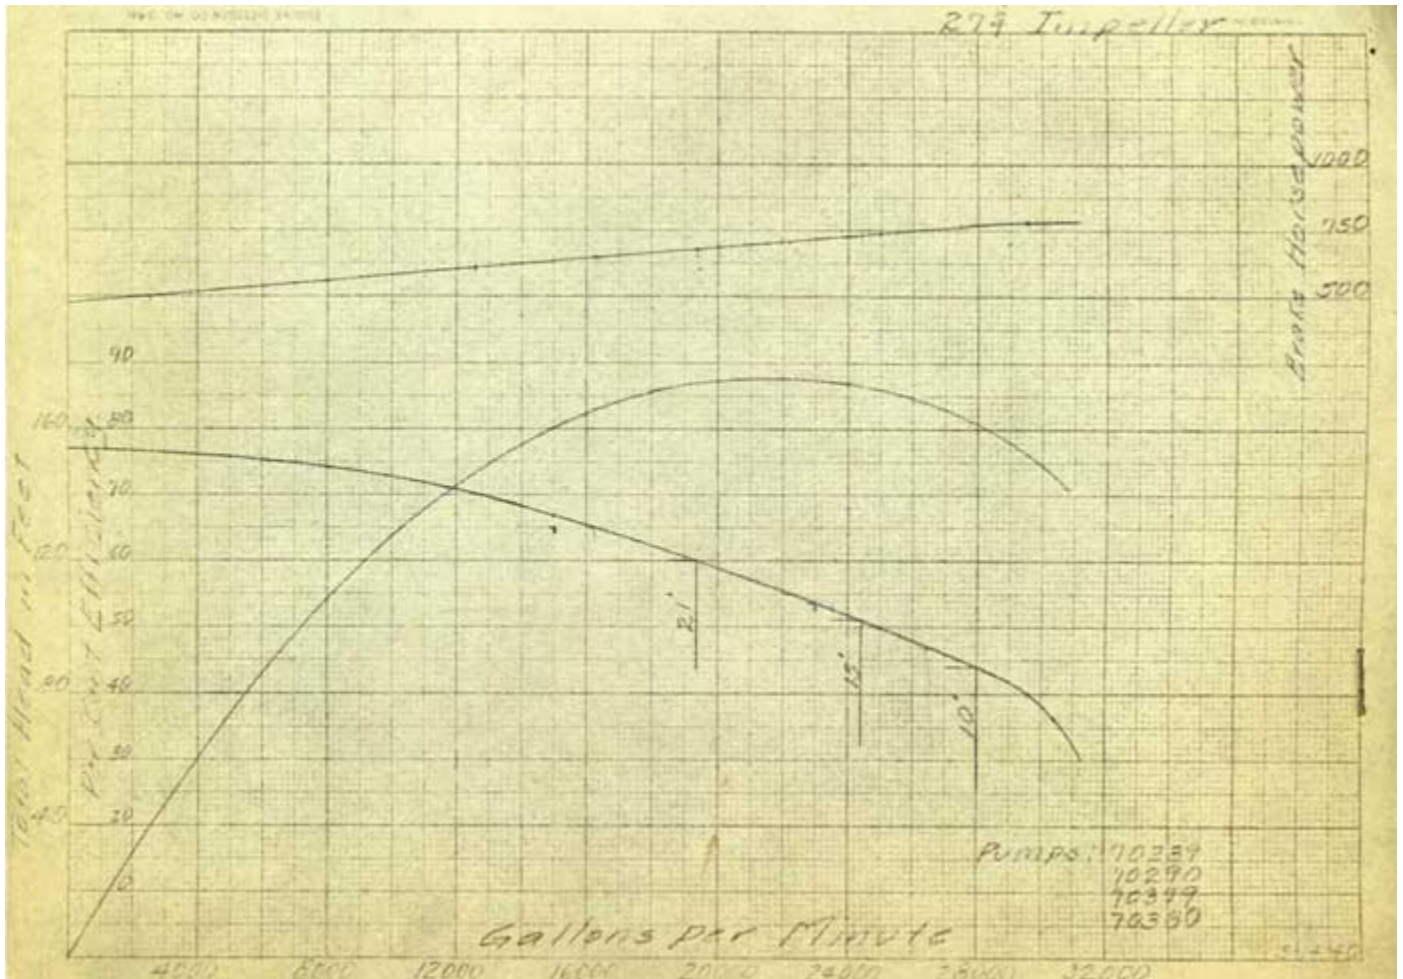
Positioned on the shores of Lake Michigan are two stations that contain cooling water pumps which feed cooling water to BP's Whiting Refinery. The #1 water station contains four IR 24 HV pumps, which are large, single-stage, double-suction, horizontal split case pumps. Four pumps in station #1 (P-11, P-12, P-13, and P-14 in the photo below) are unique in that they were designed with a bottom-suction configuration.

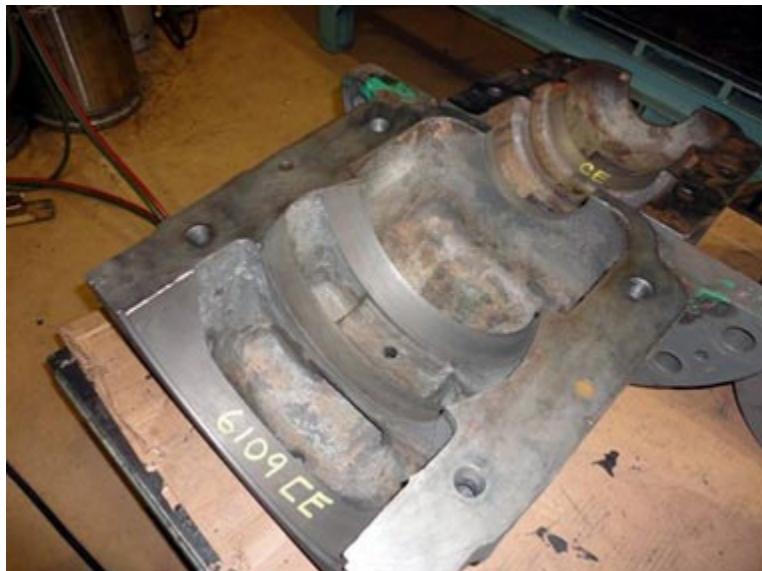
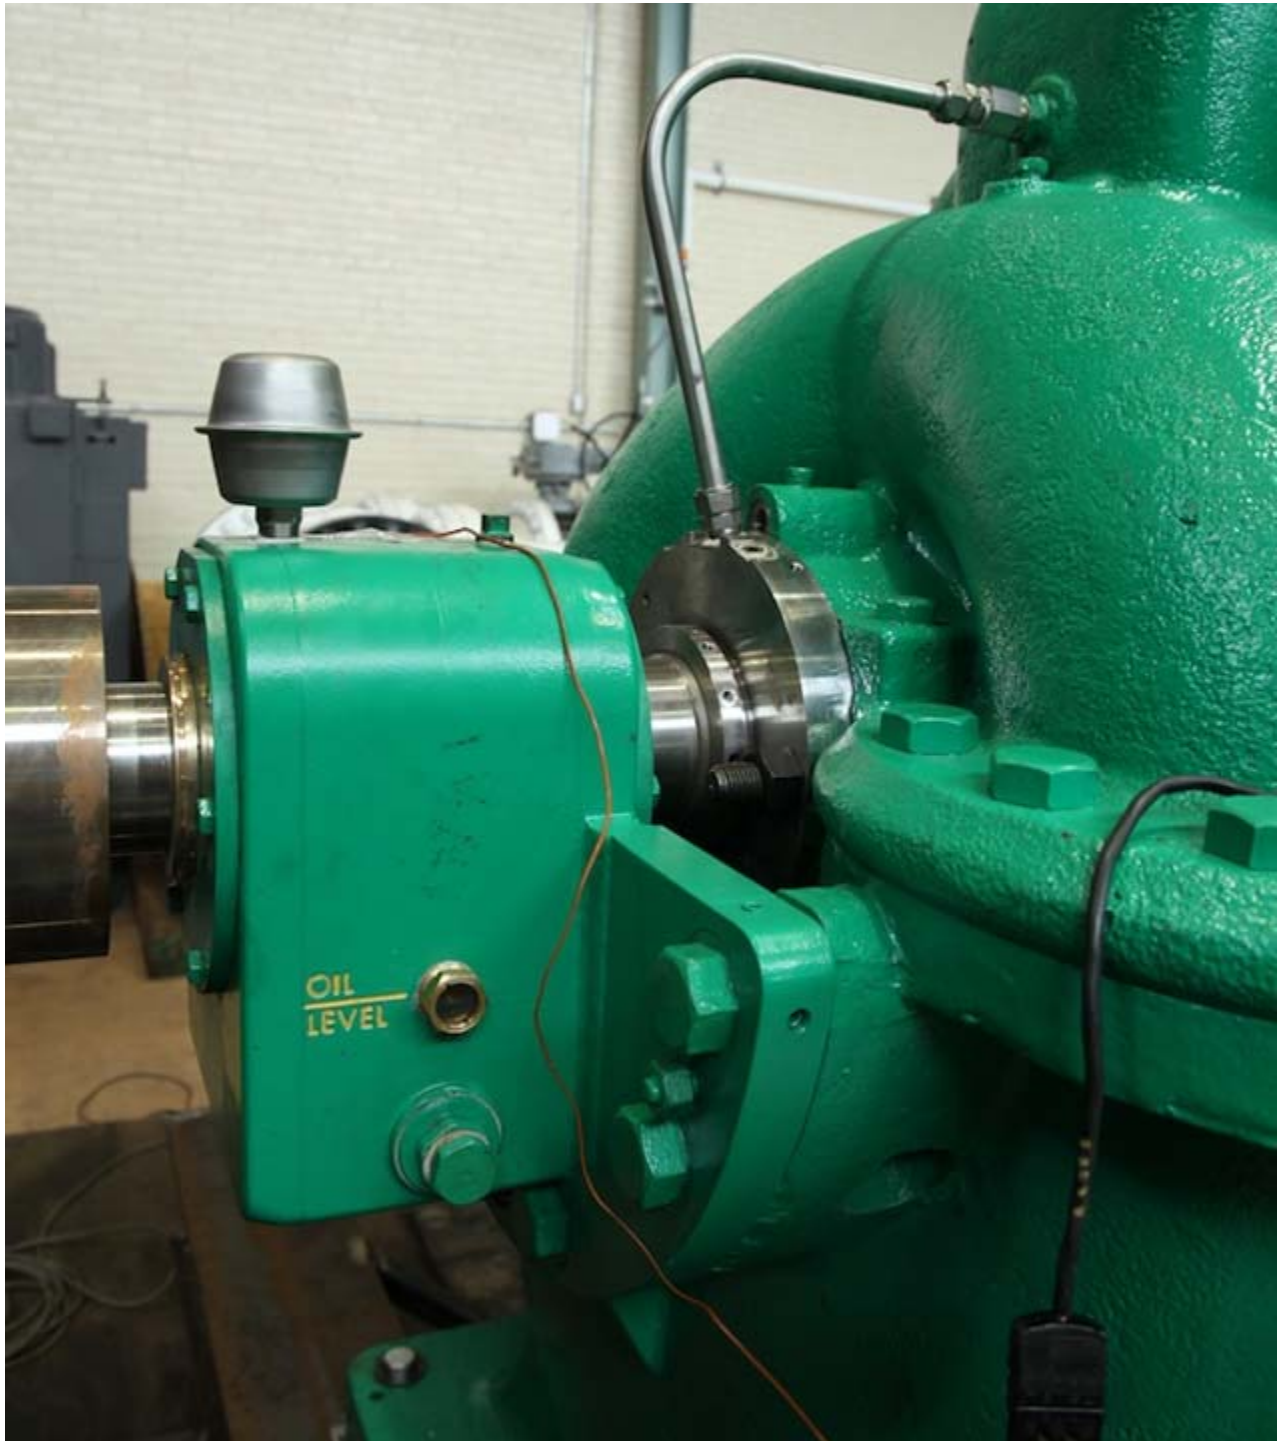
The refinery's rotating equipment engineers first asked Hydro's engineers about redesigning the bearing housings. The original bearing housings were 2.5 foot long with spherical shell journal bearings that were hard to machine and made proper alignment difficult. More importantly, redesigning the bearing housings would help to reduce the weight on the external bearings. Because the bearings were identified to be an obsolete design, Hydro's engineers evaluated new bearing configurations at the request of the refinery. Axial thrust and bearing loads were reviewed to determine the best bearing design. Modifying the bearing design gave the refinery another option to upgrade from packing to mechanical seals, which would provide an added benefit of reducing leakage and decreasing energy consumption. The evaluation of upgrading to mechanical seals prompted a review of shaft deflection, or bend in the shaft. Mechanical seals can accommodate a limited amount of shaft deflection, so the shaft would need to be redesigned to work with the mechanical seals.

Once the engineering review was complete and all the modifications were agreed upon, Hydro went to work. The shaft was modified to a stepped design and the distance between the bearings was shortened to reduce deflection at the seal faces. The sleeve bearings were removed and ball bearings were put in to greatly handle the axial thrust of the rotor, thus stabilizing the shaft and lowering vibration. New mechanical seals were installed along with newly manufactured bearing housings,

which were fabricated at Hydro's service center. Hydro manufactured the new bearing housings from steel plate using their 5-axis CNC machine.

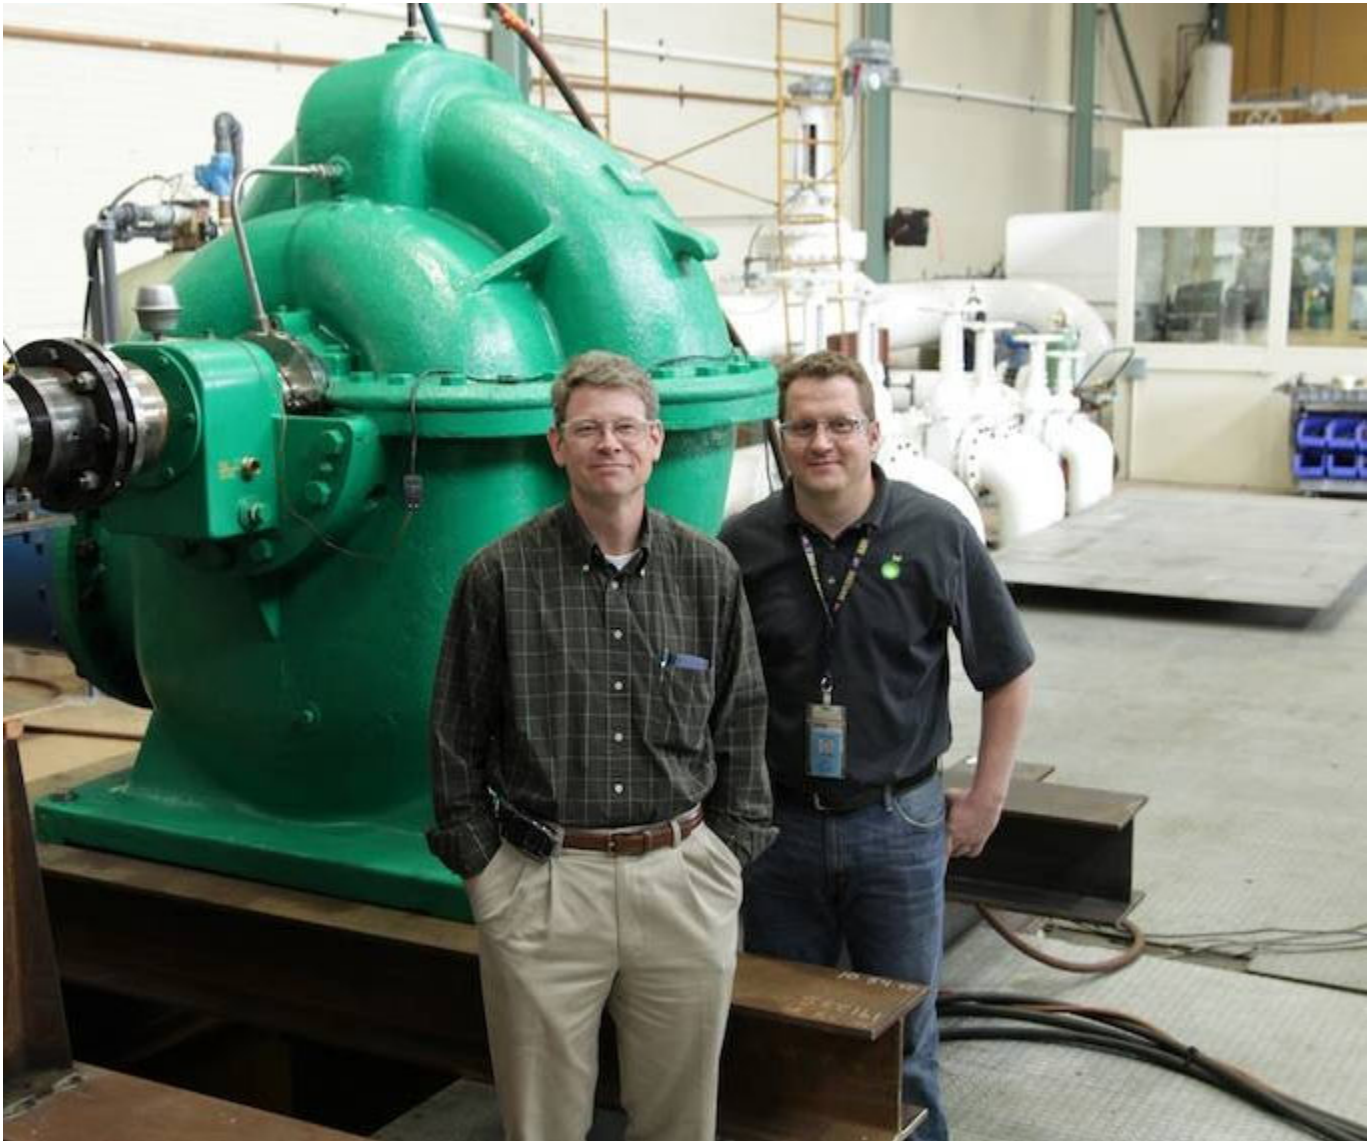
To test the pump, Hydro's Test Lab engineers designed and constructed a customized test configuration. Instead of placing this pump on the horizontal test stand, it was set up over the test lab's vertical pit to accommodate the 30" bottom suction inlet. A sturdy baseplate was erected to support the 800-horsepower motor and the pump, which sat above the vertical pool that contained approximately 65,000 gallons of water. Attached to the pump's suction inlet was a 17-foot column pipe that extended down into the pit and would be used to draw water up into the pump.

When a horizontal pump is tested, it is critical to flood the system before the pump is started. In actual operation in the field, the elevation of the water in the sump below the pumps is controlled by a sluice gate that holds back the water in Lake Michigan from flooding the water station. In this unique set up, all the water was well below the pump level; so Hydro's test lab engineers had to back fill the pump using water from the 38,000 gallon tank on the horizontal test loop. A butterfly valve had been strategically affixed to the bottom of the column pipe and remained closed while Hydro's test lab

engineers opened the tank valve and flooded the pump. Once the pump was completely flooded, Hydro's test lab engineers closed the valve to the tank and opened the butterfly valve to the pit. Using an educator, a vacuum was created to keep the water from draining into the pit. This allowed for optimal pump start up conditions.

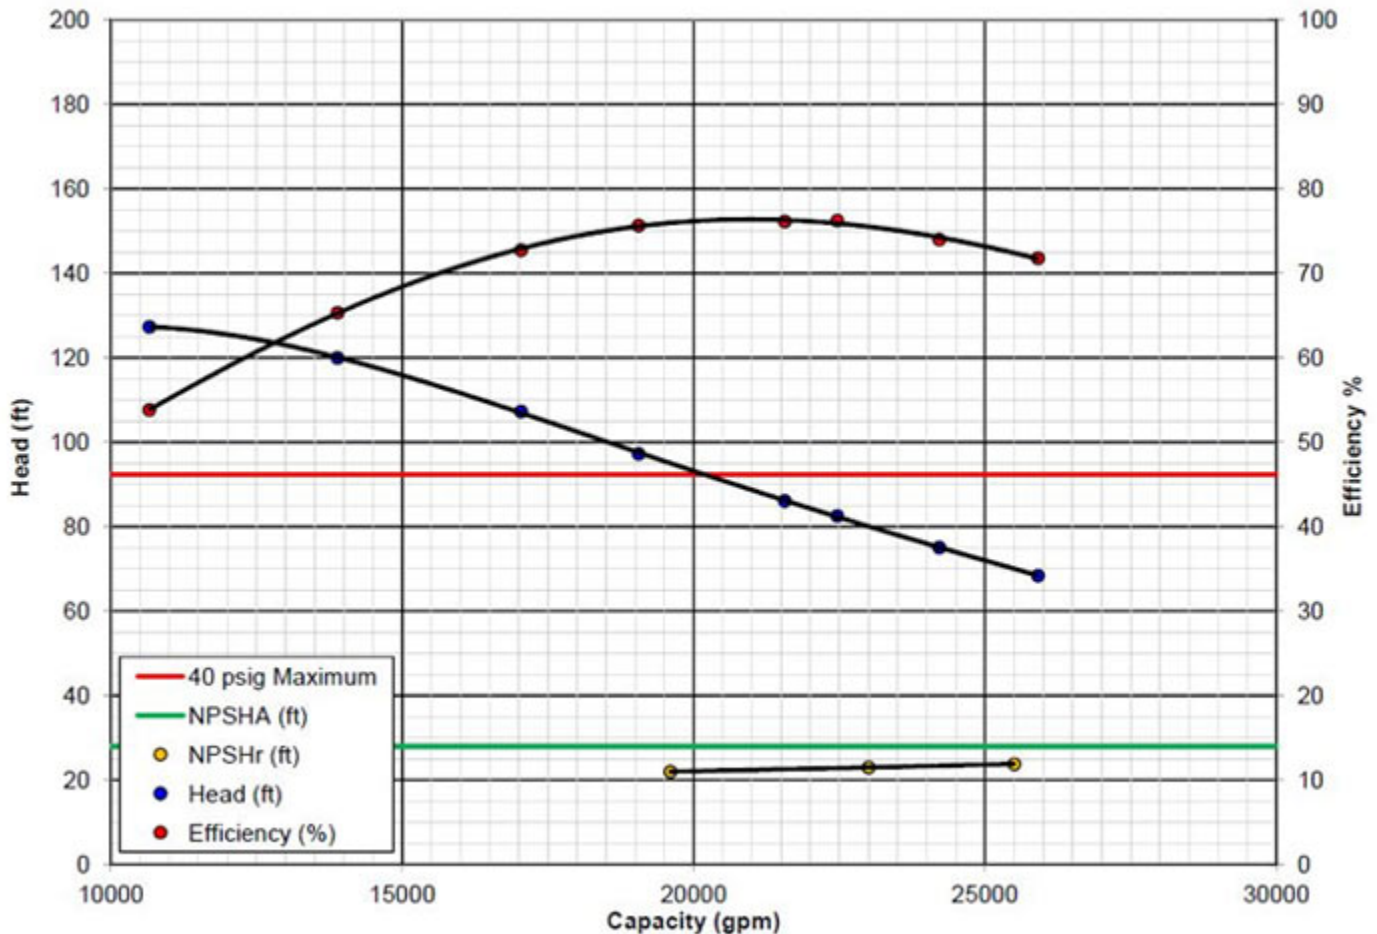
The tests showed that the pump can be operated to the right of BEP and still stay within net positive suction head available (NPSHa). The data indicates that one pump operating at a higher capacity can eliminate the need for three pumps operating at reduced capacity. These findings suggest significant potential energy savings for the refinery and may enable BP Whiting to run just one of these pumps in each water station during the winter months and two pumps in each water station during the summer months. "The performance testing we did went a long way toward allowing us to shut down unnecessary water pumps, and the modifications we made to this pump will allow us to run it more reliably," confirms Bill Rademacher, one of the Rotating Equipment Engineers who helped lead the
