## Using Latest Technology to Refurbish a 50-year-old Pump Element

**Power pump performance improved with redesign of the first-stage, double-suction impeller and twin volute.**

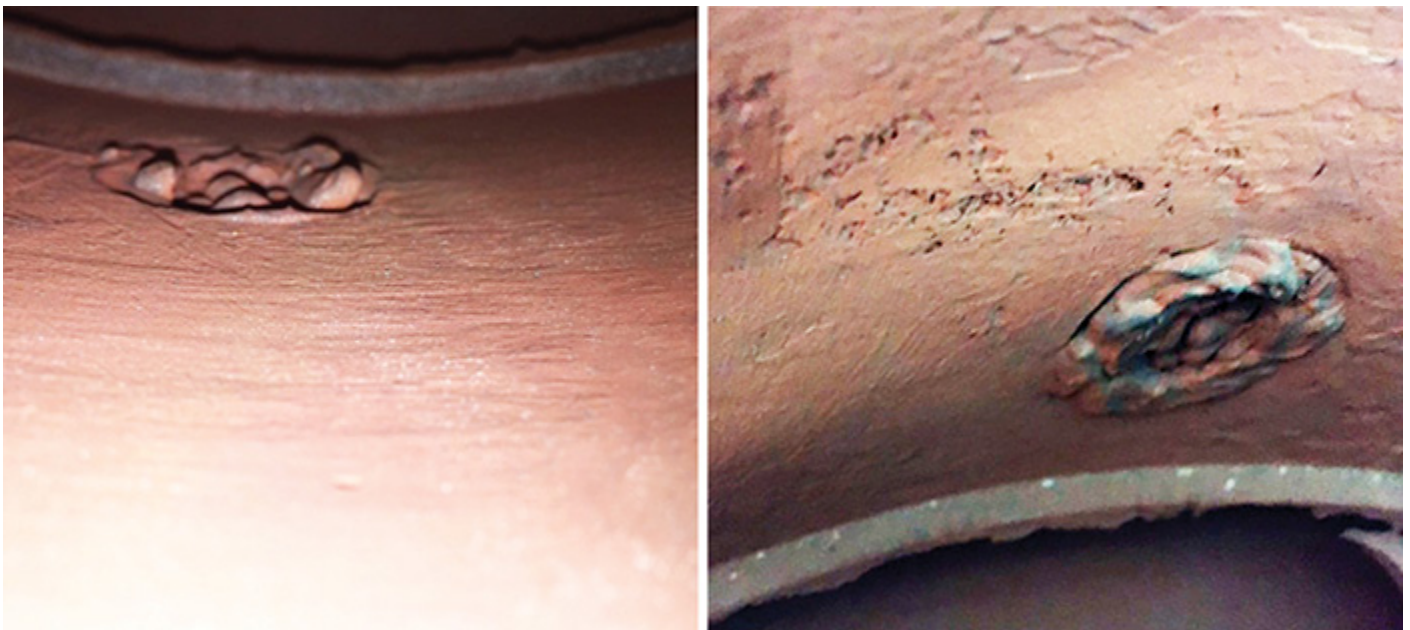
Chaplets are usually comprised of different metallurgy from the metal being poured and can create a weak area if left in place. Image 2 shows areas that were either utilized for chaplets or are core sand clean-out plugs, which were excavated and welded.

The engineers eliminated the need for chaplets during the pouring process by using 3-D technology,

which allows for the manufacturing of the cores in a hybrid design that will lock them in place inside the mold. By using this method, the sophisticated technology averages the wall thickness, minimizes core shift and minimizes welding. The volute areas were examined by the bore scope and properly cleaned.

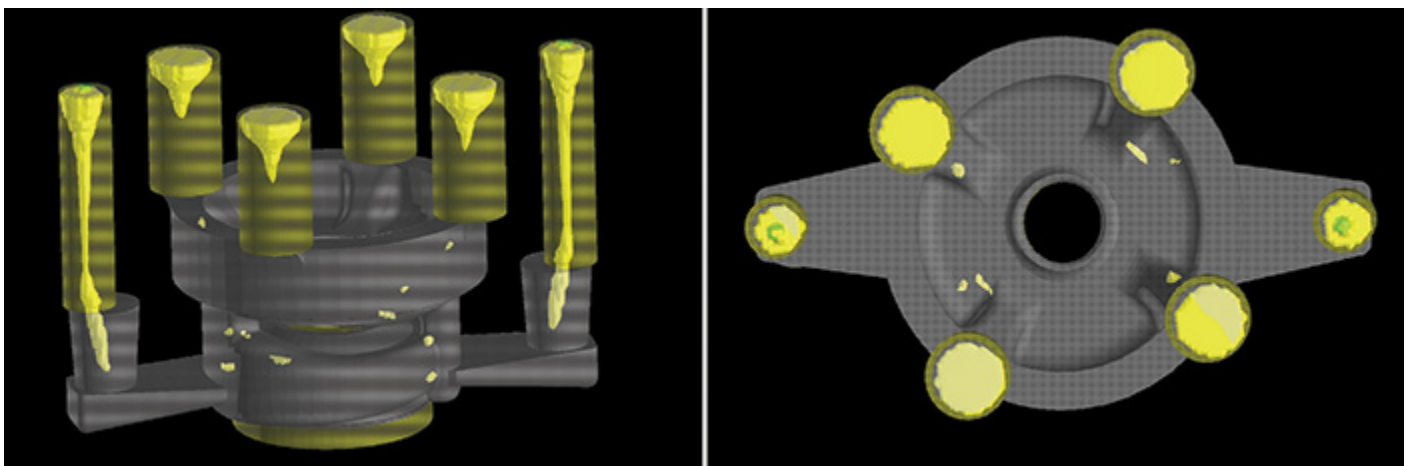
In the volute crossover areas, Hydro noticed a significant amount of flash on both sides. This is created by core lift where two cores are joined together. While the 3-D printing method will not eliminate the need for separate cores, it allowed Hydro to move the core split to an area that is accessible for grinding. The 3-D printed cores were 0.005-0.20-inch accurate dimensionally in the x, y, and z axis. This gave the engineers precision core filament during the mold building process.

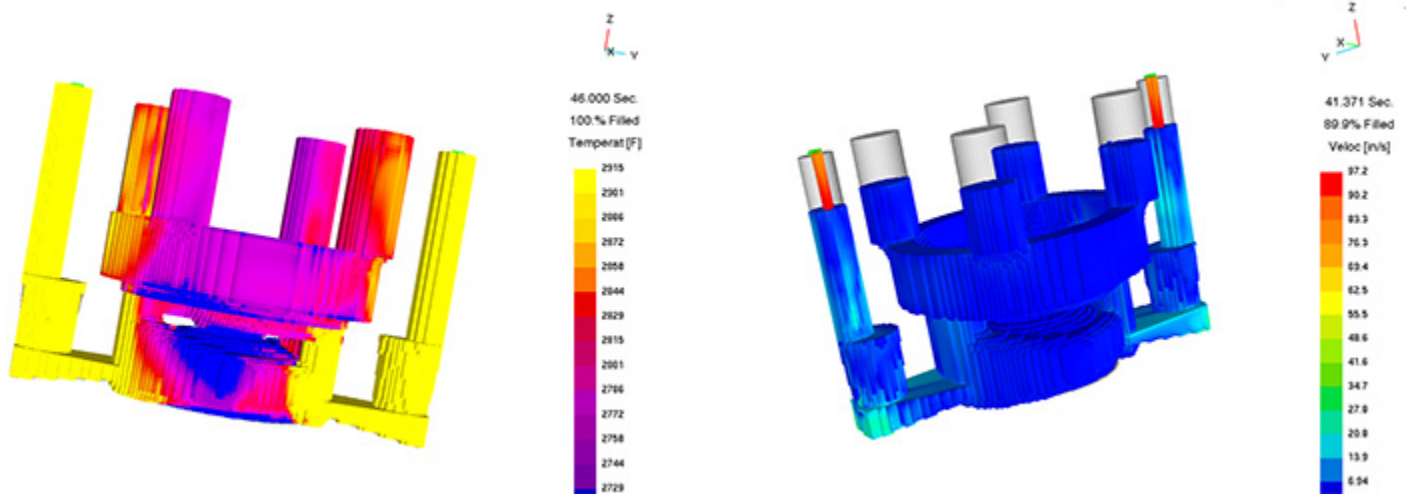
These indications showed the predicted shrinkage in a worst-case scenario. This is minimal and can be addressed during the rough machining stage. Even in extreme conditions, these predicted shrink areas might not exist. This is a theoretical calculation that has proven to be accurate. These areas are then evaluated during the RT process.

This is a similar analysis, but in the optimum condition. All the indications are in the riser tubes, and the main casting body is free of defects. Hydro provided the foundry a pour data form for each individual casting and then meets those specs.

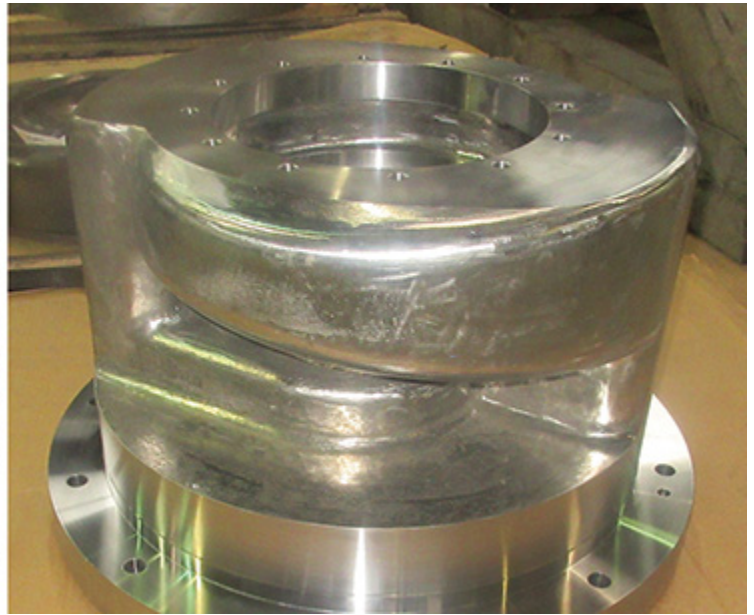
Velocity control is critical in all aspects of pouring. High velocity triggers gas reactions, premature freezing of metal fragments and inconsistent feeding. This is a critical step to ensure that the gating has the proper choke to minimize turbulence during the pouring process. Typically, it is important to keep the velocity below 30 inches per second. Choke points are how foundry workers control the speed of metal. The software package has a program to help design choke points when creating the gating system.

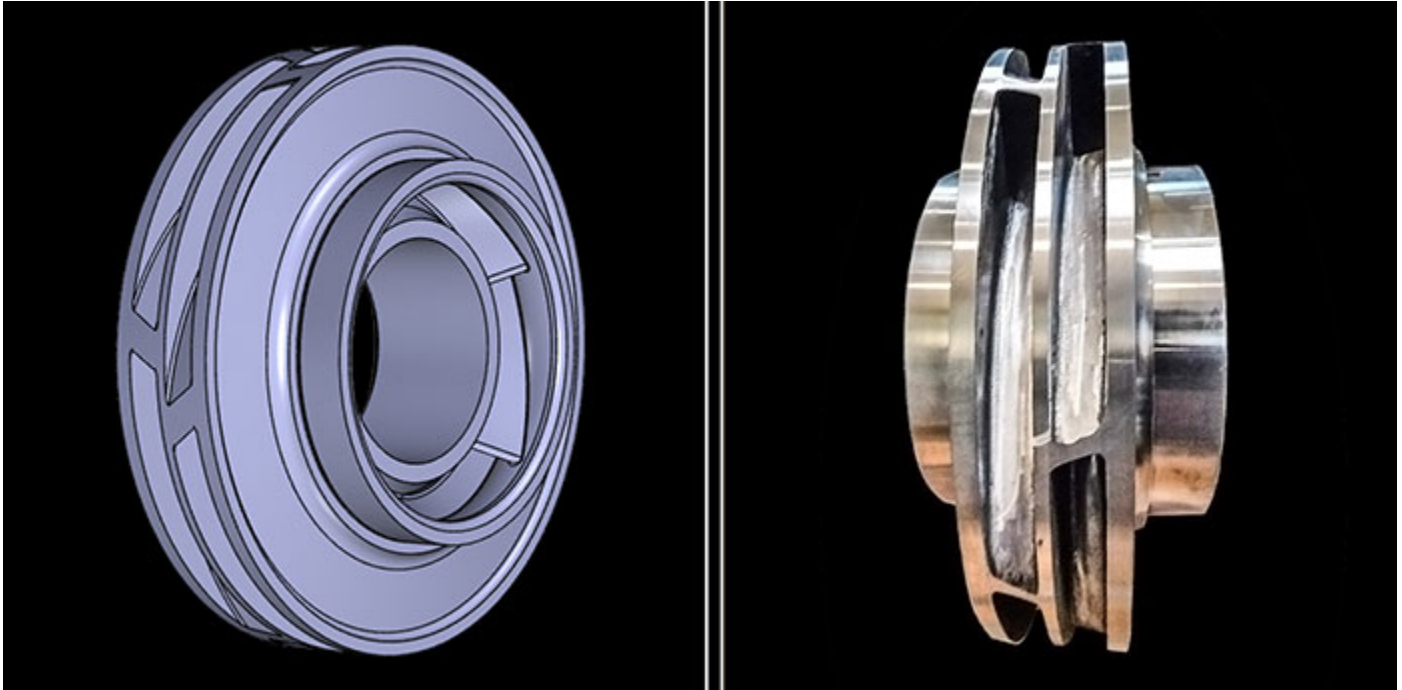
Pressure pulsations at vane frequency are initiated by each of the vanes of the impeller passing close to the volute cutwater lip. These pulsations can affect vibration of the machine. Traditional methods to reduce these pressure pulsations involve increasing the distance between the impeller vanes and lips to allow time, distance and viscosity to smooth out this pressure wave. Unfortunately, this technique does not come without penalty and affects both pump head and efficiency.
