## Using Latest Technology to Refurbish a 50-year-old Pump Element

**Power pump performance improved with redesign of the first-stage, double-suction impeller and twin volute.**

**Written by:** Dave Allard & Dr. Gary Dyson

**Published by:** Pumps & Systems

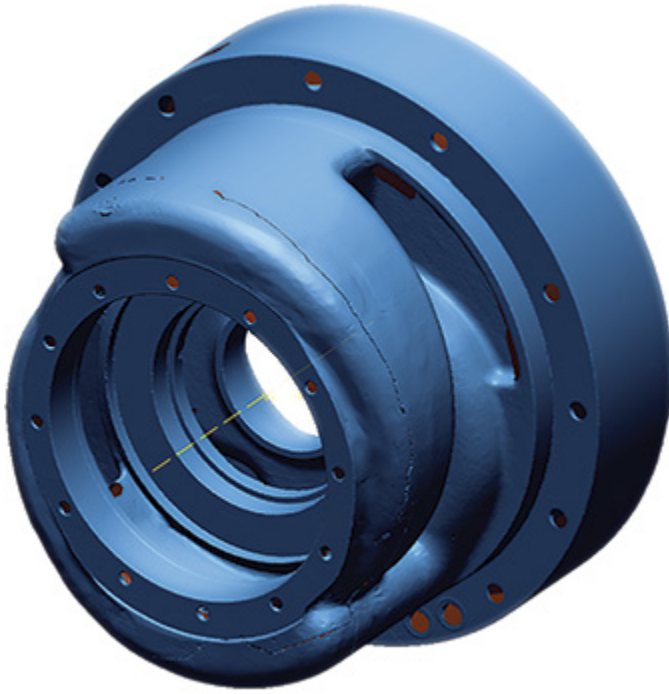
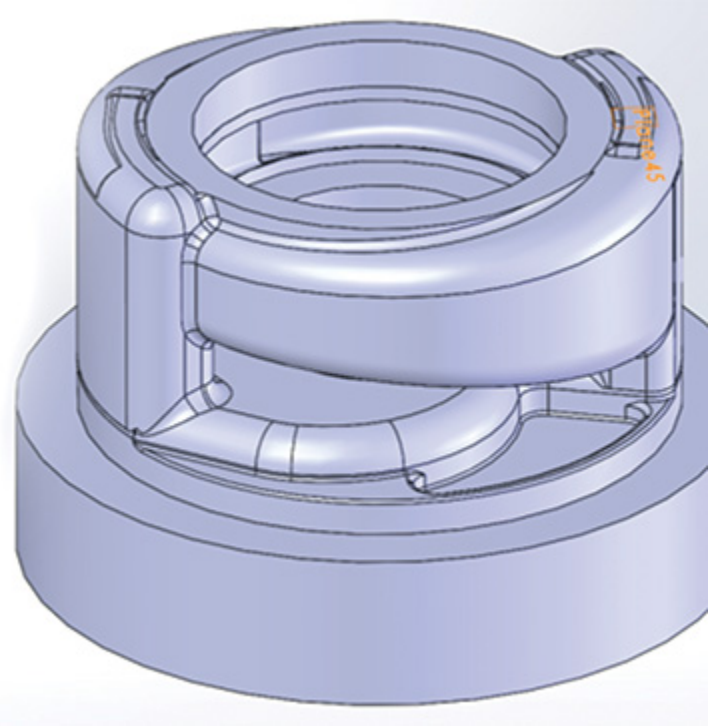
In the volute crossover areas, Hydro noticed a significant amount of flash on both sides. This is created by core lift where two cores are jointed together. While the 3-D printing method will not eliminate the need for separate cores, it allowed Hydro to move the core split to an area that is accessible for grinding. The 3-D printed cores were 0.005-0.20-inch accurate dimensionally in the x, y, and z axis. This gave the engineers precision core filament during the mold building process.

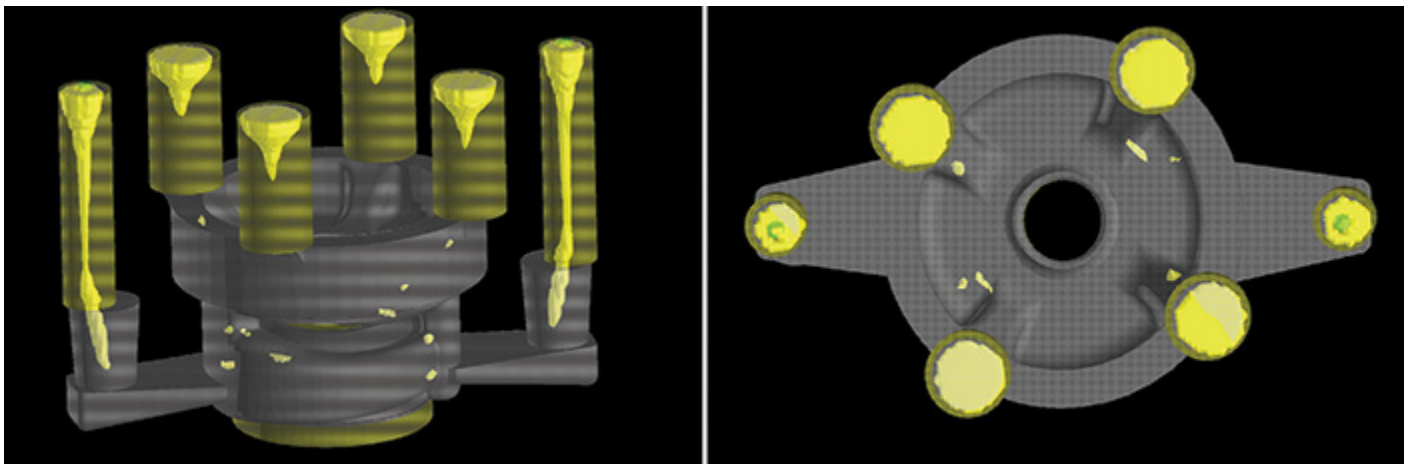
### CFD Solidification Analysis

Initial analysis of the raw material identified the areas of concern to help direct the design of the riser pattern and also highlight the preferred area of the in-gates. Risers are cylindrical tubes insulated by exothermic sleeves to generate heat once they are filled with liquid metal.

Two major feed areas were addressed by adding risers and chills to help direct the solidification of the metal. Risers were placed to direct solidification impurities from the base metal.

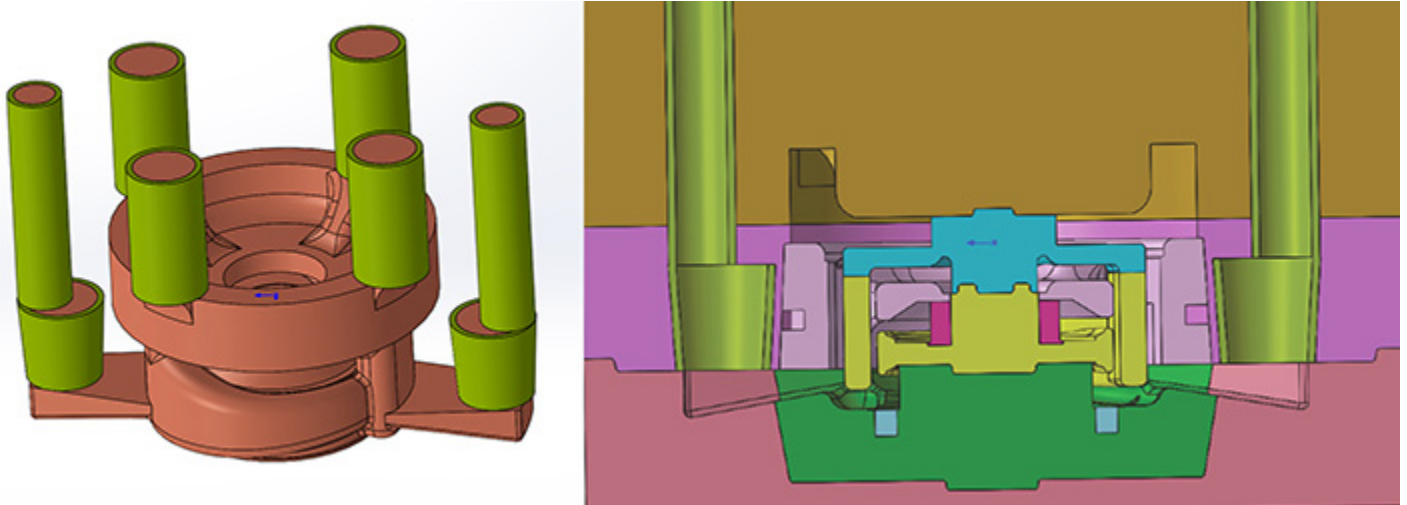
### Velocity Analysis

Velocity control is critical in all aspects of pouring. High velocity triggers gas reactions, premature freezing of metal fragments and inconsistent feeding. This is a critical step to ensure that the gating has the proper choke to minimize turbulence during the pouring process. Typically, it is important to keep the velocity below 30 inches per second. Choke points are how foundry workers control the speed of metal. The software package has a program to help design choke points when creating the gating system.
