## Using Latest Technology to Refurbish a 50-year-old Pump Element

**Power pump performance improved with redesign of the first-stage, double-suction impeller and twin volute.**

**Written by:** Dave Allard & Dr. Gary Dyson

**Published by:** Pumps & Systems

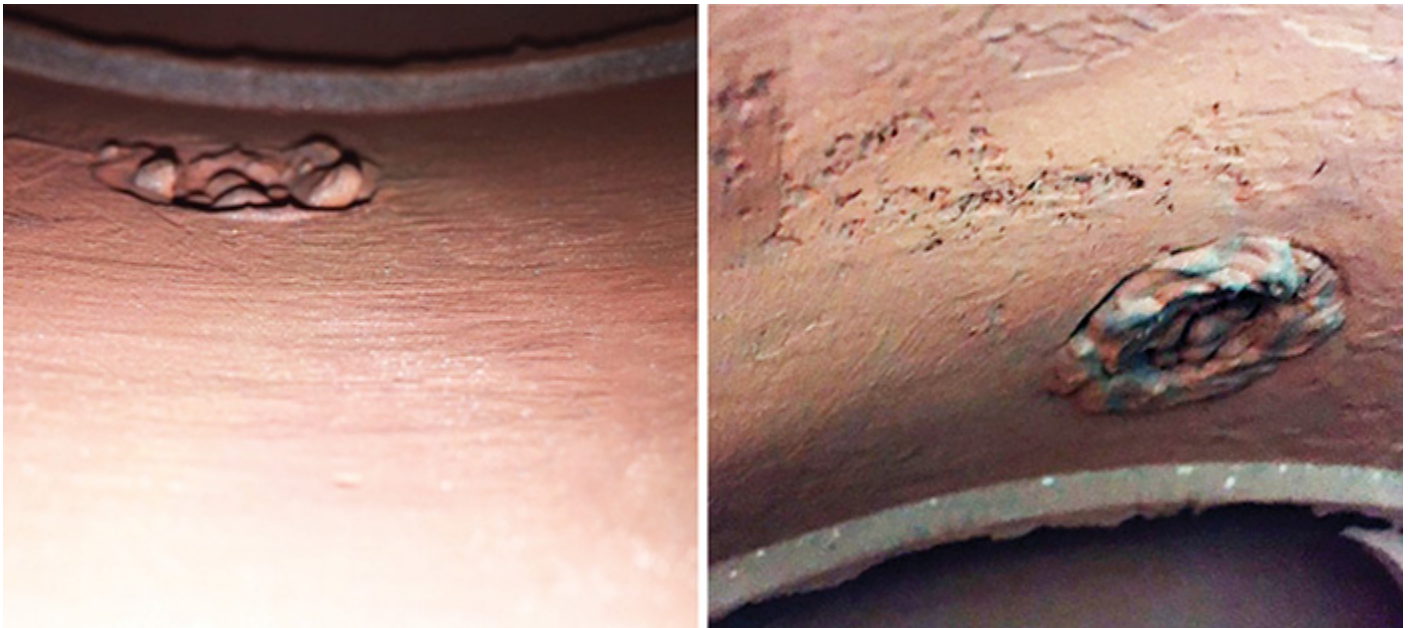
Chaplets are usually comprised of different metallurgy from the metal being poured and can create a weak area if left in place. Image 2 shows areas that were either utilized for chaplets or are core sand clean-out plugs, which were excavated and welded.

The engineers eliminated the need for chaplets during the pouring process by using 3-D technology,

which allows for the manufacturing of the cores in a hybrid design that will lock them in place inside the mold. By using this method, the sophisticated technology averages the wall thickness, minimizes core shift and minimizes welding. The volute areas were examined by the bore scope and properly cleaned.
