# An Engineered Battle Against Cavitation

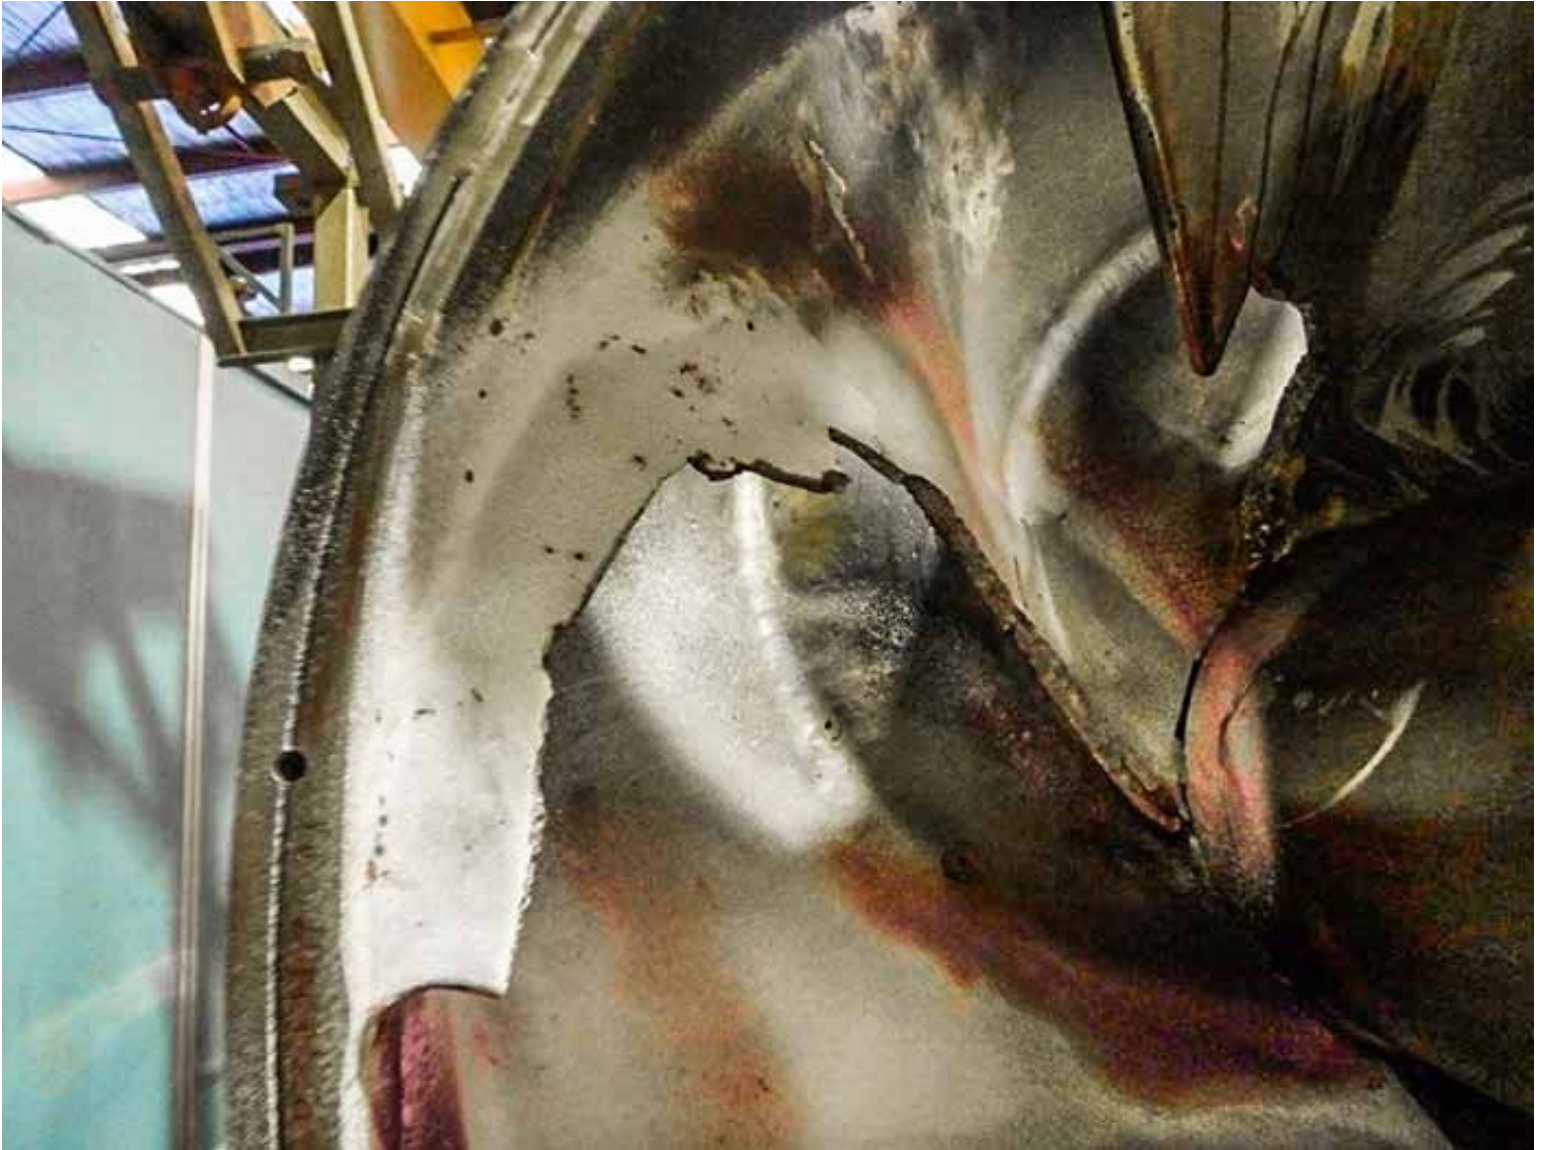
The results of the forensic analysis showed that the impeller blades were suffering cavitation to the low-pressure side of the vanes. Additionally, the cavitation and cracked vanes toward the eye also indicated that the sizing of the inlet and its associated blade angles may be active factors in the repeated failures.
