Engineering Pumps for
Better Performance and Longer Life

Refurbishing a Contaminated Nuclear Casing

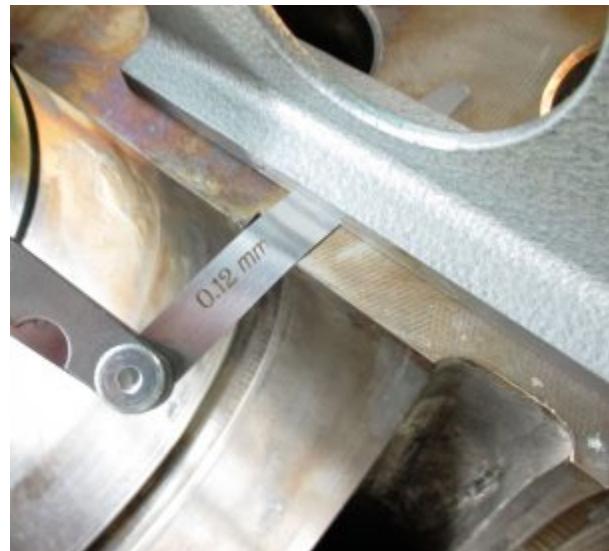
Hydro's team [inspected the pump, the casing, and the internal element and explored all possible options](#) (Figure 1). Hydro was able to find an inventive solution by machining the casing in the contaminated state and developing creative methods to guarantee a proper fit-up when the casing repair was completed. Despite the OEM suggesting a new pump be purchased, the service provider was able to find an innovative and cost-saving way for the plant to repair the casing and reduce downtime.

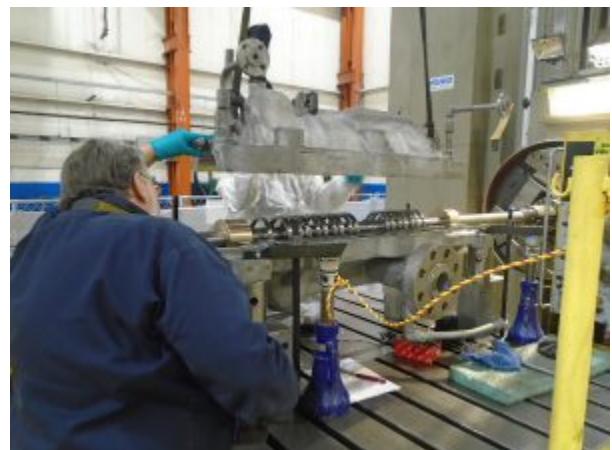
The precision mock-up rings were used to measure concentricity and to ensure that the rotor would fit properly in the casing when assembled (Figure 3). The precision mock-up rings were manufactured by Hydro.

During their initial inspection at the nuclear plant, Hydro measured the relevant components of the rotor so they could create mock-up wear rings. These rings are the stationary components that support the rotor in the casing. If the mock-up rings matched exactly, then the rings could be manufactured to ensure the repaired casing would fit properly.

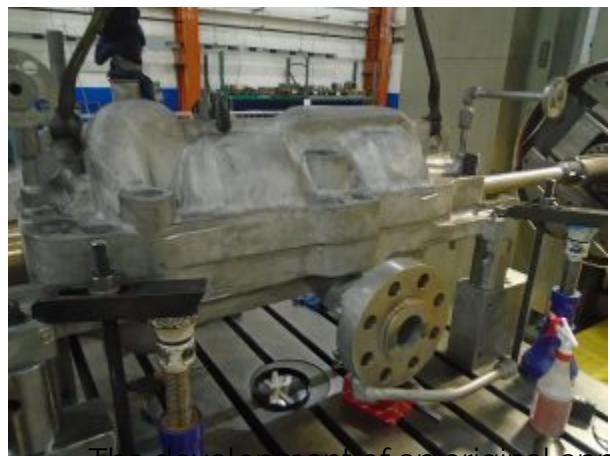
Hydro performed a final cleaning and passivation check to ensure that no iron contaminants were found in the newly repaired casing. With negative results on the passivation check, Hydro was able to ship the casing back to Europe (Figure 4). The customer was impressed with the innovative approach and with the management of the many details in this unique project scope. The creative approach saved the nuclear plant time and money, while also reducing their risk.
