Refurbishing a Contaminated Nuclear Casing

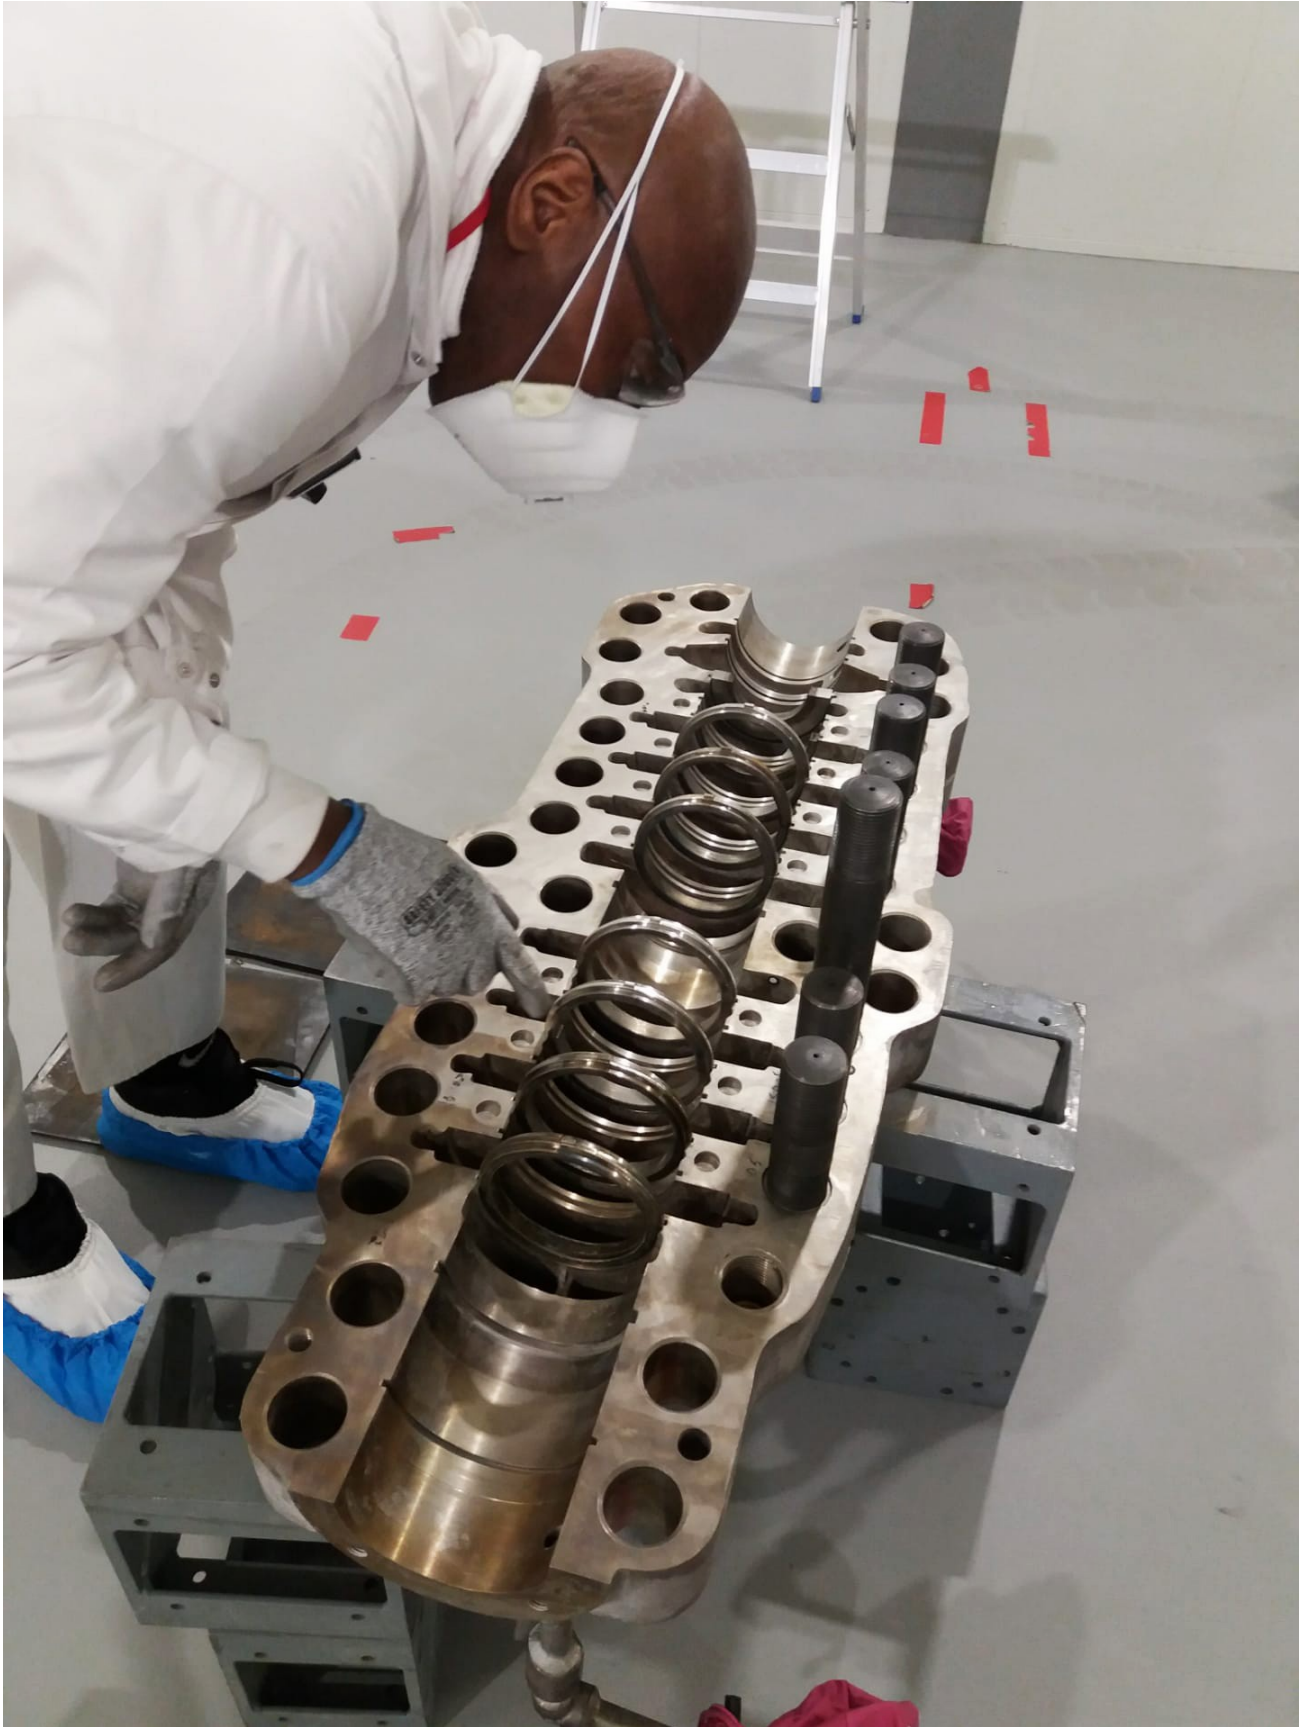
Hydro's team [inspected the pump, the casing, and the internal element and explored all possible options](#) (Figure 1). Hydro was able to find an inventive solution by machining the casing in the contaminated state and developing creative methods to guarantee a proper fit-up when the casing repair was completed. Despite the OEM suggesting a new pump be purchased, the service provider was able to find an innovative and cost-saving way for the plant to repair the casing and reduce downtime.

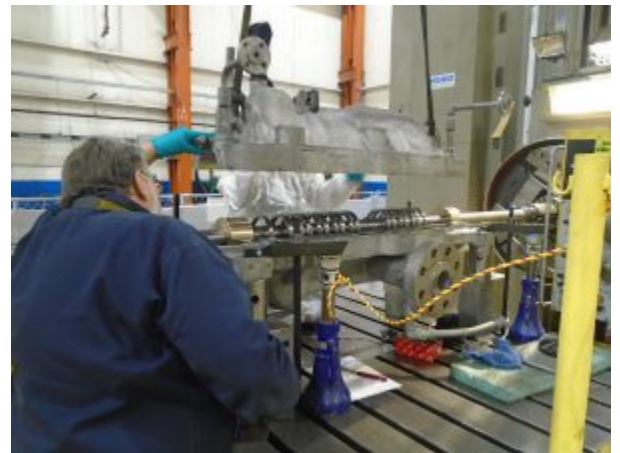
The precision mock-up rings were used to measure concentricity and to ensure that the rotor would fit properly in the casing when assembled (Figure 3). The precision mock-up rings were manufactured by Hydro.

During their initial inspection at the nuclear plant, Hydro measured the relevant components of the rotor so they could create mock-up wear rings. These rings are the stationary components that support the rotor in the casing. If the mock-up rings matched exactly, then the rings could be manufactured to ensure the repaired casing would fit properly.

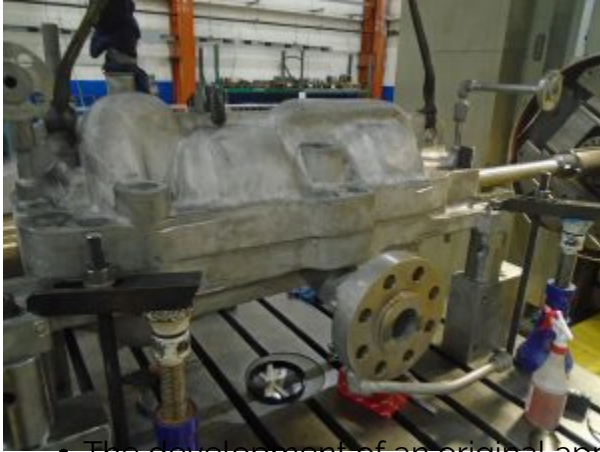
Hydro performed a final cleaning and passivation check to ensure that no iron contaminants were found in the newly repaired casing. With negative results on the passivation check, Hydro was able to ship the casing back to Europe (Figure 4). The customer was impressed with the innovative approach and with the management of the many details in this unique project scope. The creative approach saved the nuclear plant time and money, while also reducing their risk.
