Refurbishing a Contaminated Nuclear Casing

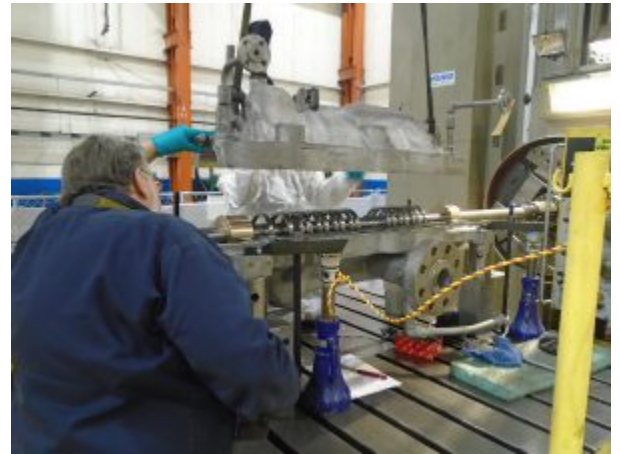
The precision mock-up rings were used to measure concentricity and to ensure that the rotor would fit properly in the casing when assembled (Figure 3). The precision mock-up rings were manufactured by Hydro.

During their initial inspection at the nuclear plant, Hydro measured the relevant components of the rotor so they could create mock-up wear rings. These rings are the stationary components that support the rotor in the casing. If the mock-up rings matched exactly, then the rings could be manufactured to ensure the repaired casing would fit properly.

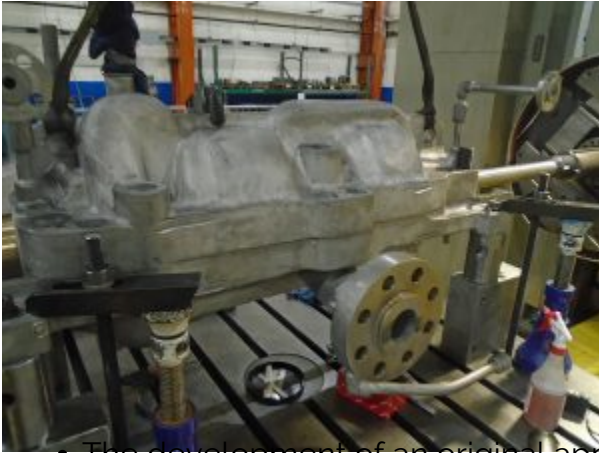
Hydro performed a final cleaning and passivation check to ensure that no iron contaminants were found in the newly repaired casing. With negative results on the passivation check, Hydro was able to ship the casing back to Europe (Figure 4). The customer was impressed with the innovative approach and with the management of the many details in this unique project scope. The creative approach saved the nuclear plant time and money, while also reducing their risk.
