Pump Testing Overcomes Challenging Suction Configuration

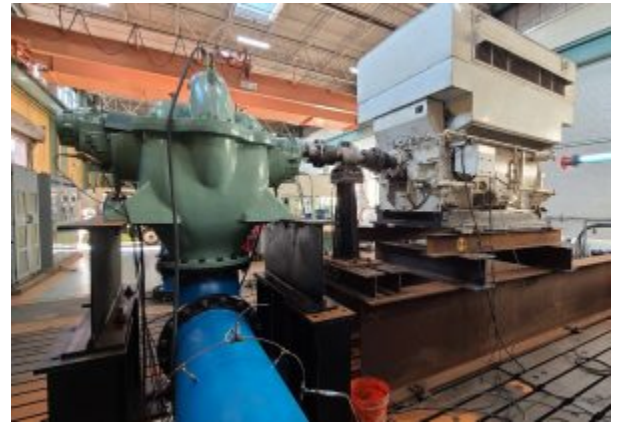
The bottom suction design of the pump provided some challenges in the design of the test layout and in conducting the NPSH test. The bottom suction design of the pump did not allow for the typical piping layout design. Instead, the mounting feet of the pump needed to be elevated and supported at least 5 feet from the floor to correctly connect to the suction manifold. Changing the pump mounting elevation meant that the motor also needed to be elevated and supported at the same height.

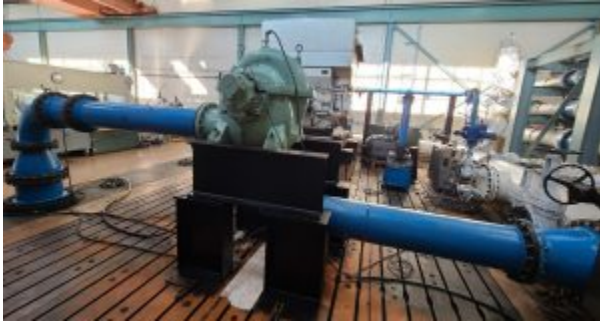
Another challenge encountered during the NPSH test was that the setup of the test loop required an elbow connected to the suction flange of the pump. This elbow affects the pressure distribution in the suction piping and can affect the fluid upstream of the elbow where suction pressure is measured. Even with these difficulties, the test lab was able to achieve accurate results due to the testing experience of the team analyzing the data.

After the testing services, it was determined that the total differential head overperformed the Original Equipment Manufacturer (OEM) curve by 12%. In addition, the pump consumed approximately 13% more power than expected. This test provided the customer with accurate information on how their pump was operating and ultimately led them to consider trimming the impeller to better achieve the desired duty point.
