Pump Testing Overcomes Challenging Suction Configuration

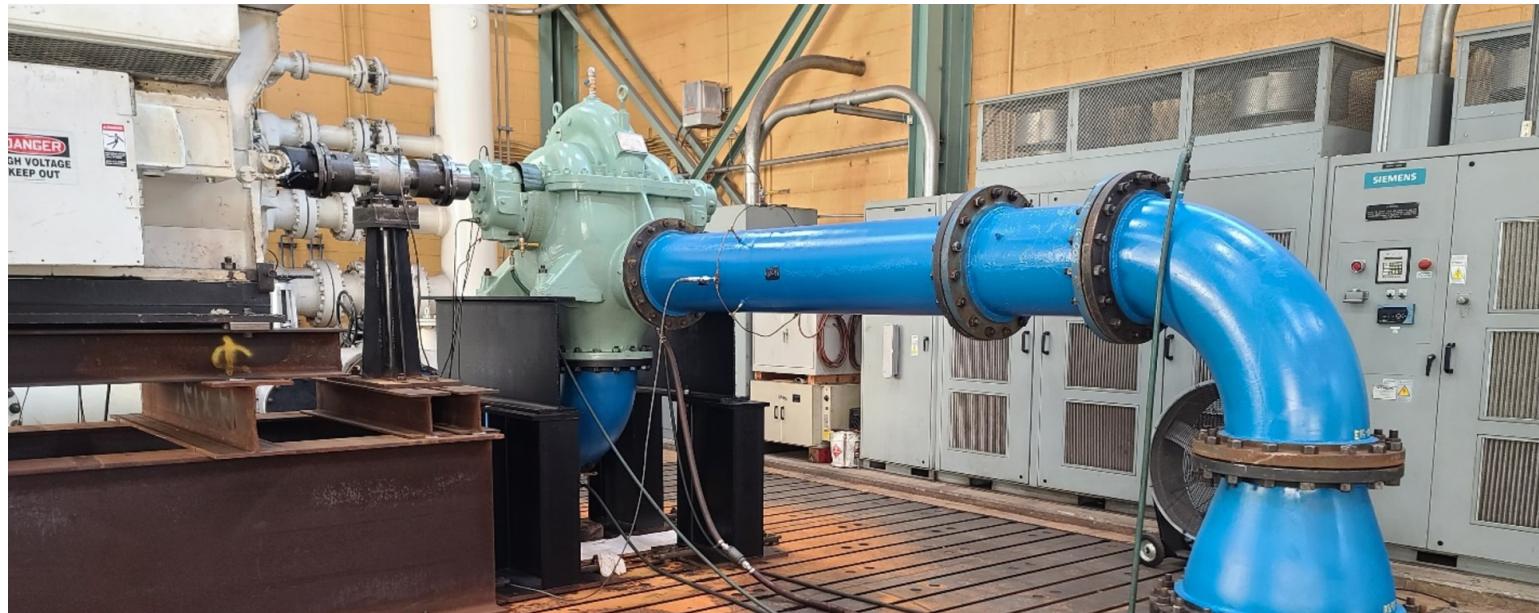
A municipal water treatment plant recently had one of their service water pumps refurbished. The refurbished pump is a single-stage, bottom suction BB1 (between bearing) pump with a double suction impeller. In order to validate the performance of the pump, the plant requested testing services from the Hydro Performance Test Lab. The testing services included a Hydraulic Institute certified performance test, a Net Positive Suction Head (NPSH) test, and a bearing housing vibration test.

The bottom suction design of the pump provided some challenges in the design of the test layout and in conducting the NPSH test. The bottom suction design of the pump did not allow for the typical piping layout design. Instead, the mounting feet of the pump needed to be elevated and supported at least 5 feet from the floor to correctly connect to the suction manifold. Changing the pump mounting elevation meant that the motor also needed to be elevated and supported at the same height.
