Fully Equipped & On the Move

Hydro was called on to reverse engineer a large circulating water pump in the Caribbean to supply parts for refurbishment. The lead times for receiving parts from the original equipment manufacturer (OEM) were excessive. More concerning, the suction bell provided by the OEM had failed during service. All internal ribs were lost, and the bearing holder was found loose within the assembly.

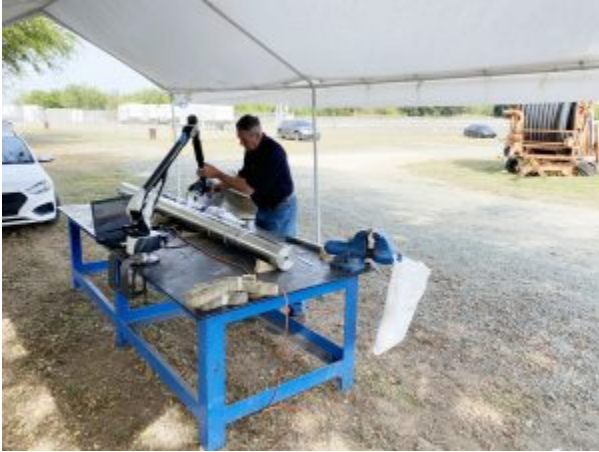
When Hydro reviewed the design of the suction bell, it was clear that low manufacturing cost was prioritized over reliability. Instead of providing a cast component, the suction bell was fabricated and had an excessively thin wall thickness.

Hydro reverse engineered the suction bell and created a model for a cast component, establishing the rib design and bearing holder location based on design experience. Exterior ribs were added to strengthen the bell and the wall thickness at the suction bell skirt was increased from 3/8" to 2". The part was scanned on-site within 1 day, with the engineering analysis, modified casting design, and quote for manufacture being
