Resonant Mode Detected and Resolved in Critical Condensate Pump

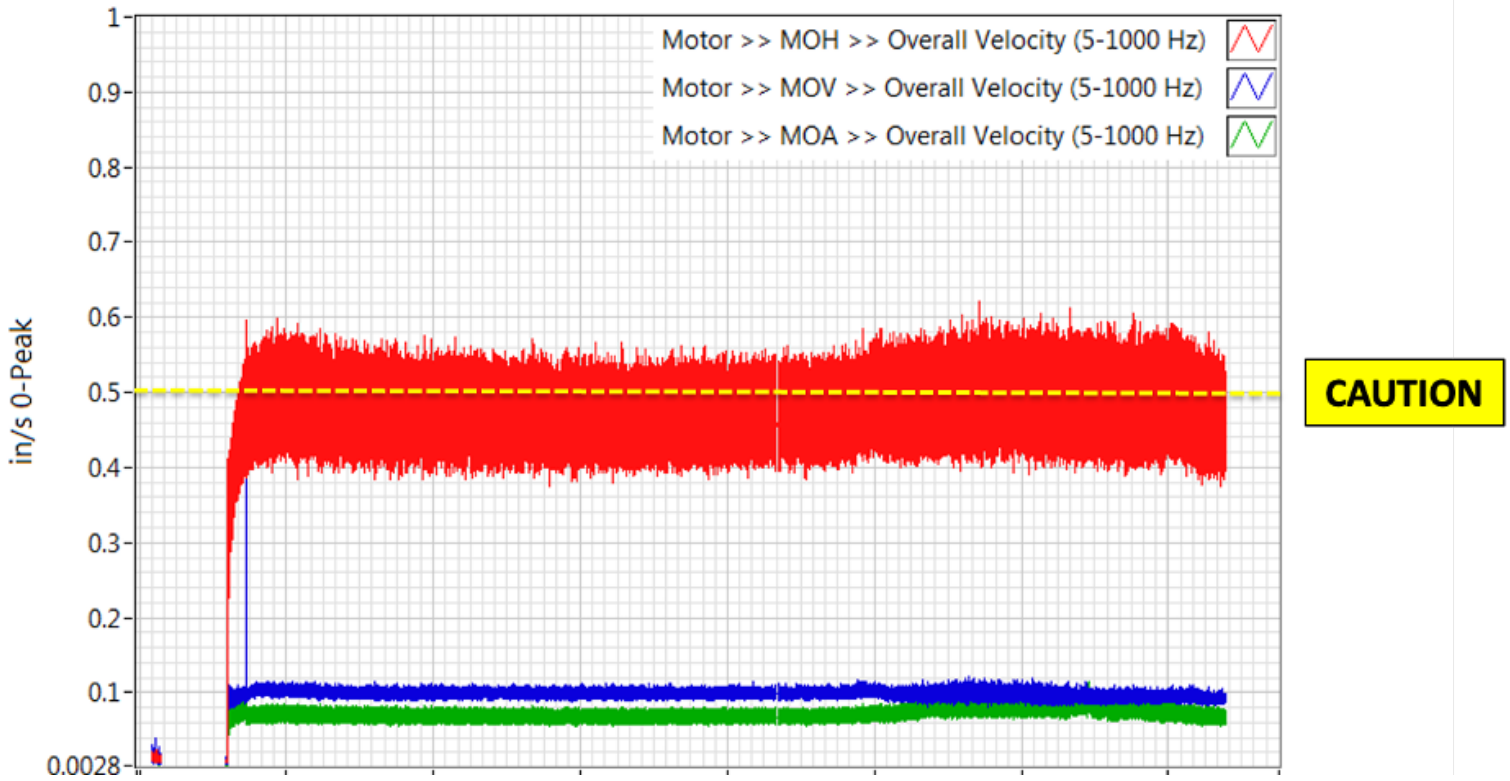
Overall Vibration Trends

Initial on-site vibration measurements following reinstallation showed vibration amplitudes of 0.47 IPS o-P at the outboard motor measurement in the horizontal direction (90 degrees from flow). These amplitudes were found to exceed 0.6 IPS o-P after an extended period of operation.

The vibration being measured was highly directional, which indicated to Hydro Reliability Services (HRS) that this was possibly related to a resonant excitation. It was dominant at 1x running speed.

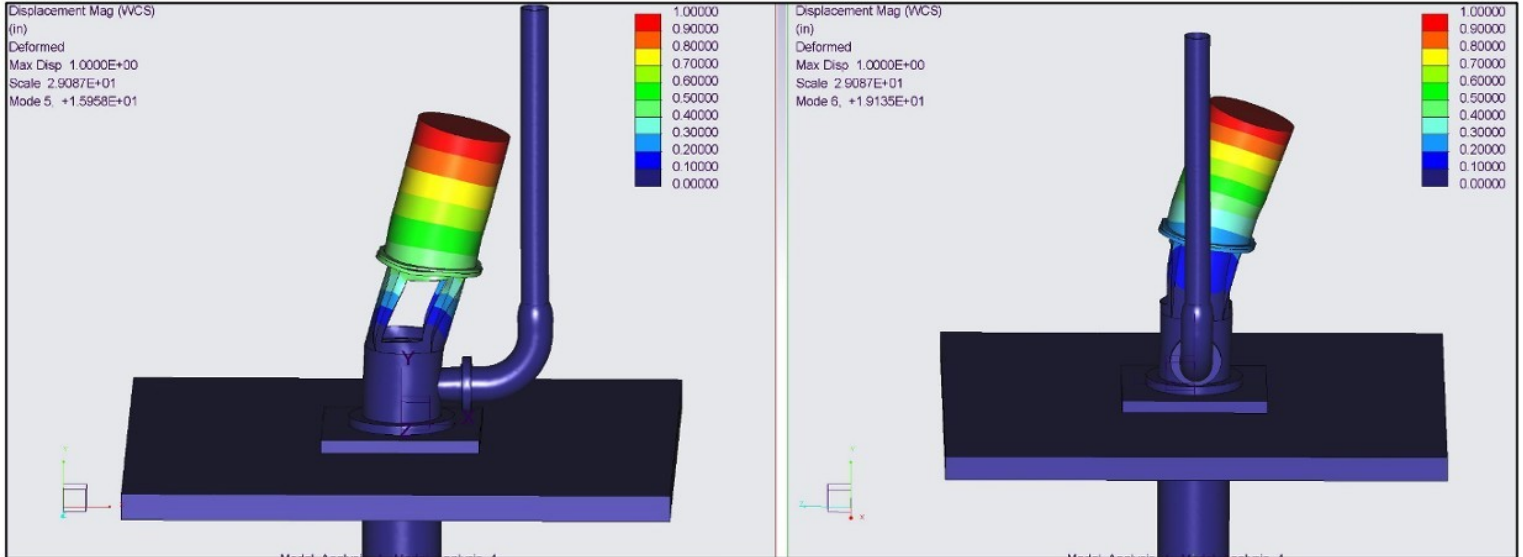
Structural Mode Shapes

The 1st and 2nd motor rocking modes at 16.0 Hz and 19.1 Hz parallel and perpendicular to the discharge, respectively, matched very closely to the natural frequencies collected during the modal analysis. Using the FEA model, HRS determined that adding a 2,500 lb weight to the top of the Unit C Condensate motor would shift the motor natural frequencies down to 14.5 Hz and 16.8 Hz. This would provide a minimum separation margin of -15% from the 1x rpm forcing function, allowing pump 3C to run with lower vibration levels similar to those observed in Pumps 3A and 3B.

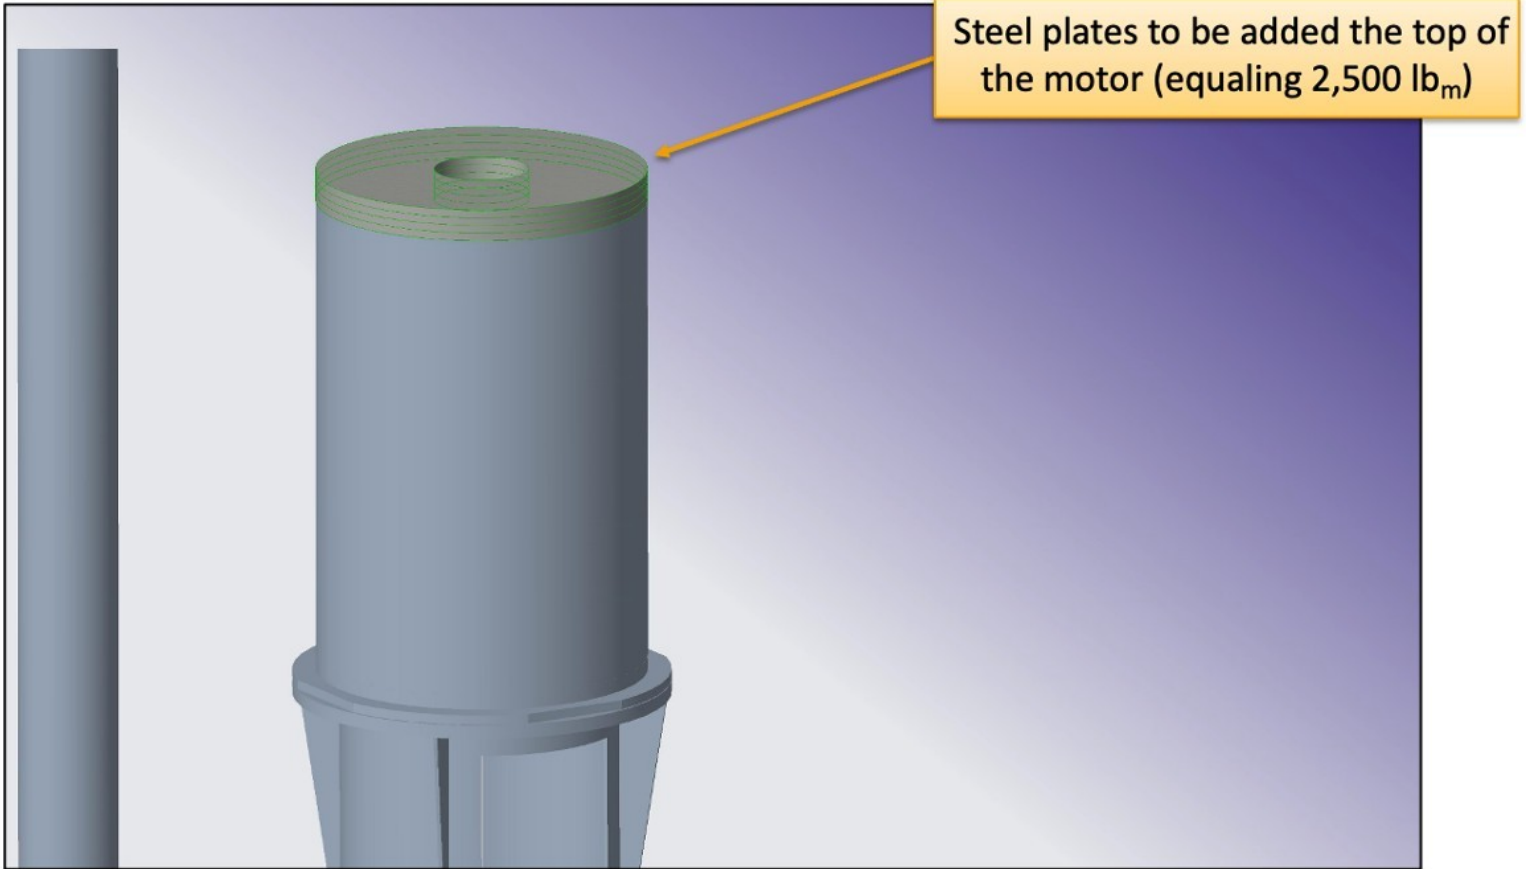
The proposed change was implemented in the field and the plant saw an immediate reduction in vibration from 0.47 IPS 0-P to 0.1 IPS 0-P. Using in-field testing and advanced analytics supported by modeling software allowed the site to not only troubleshoot the problem, but execute a solution that solved it on the first try.
