Resonant Mode Detected and Resolved in Critical Condensate Pump

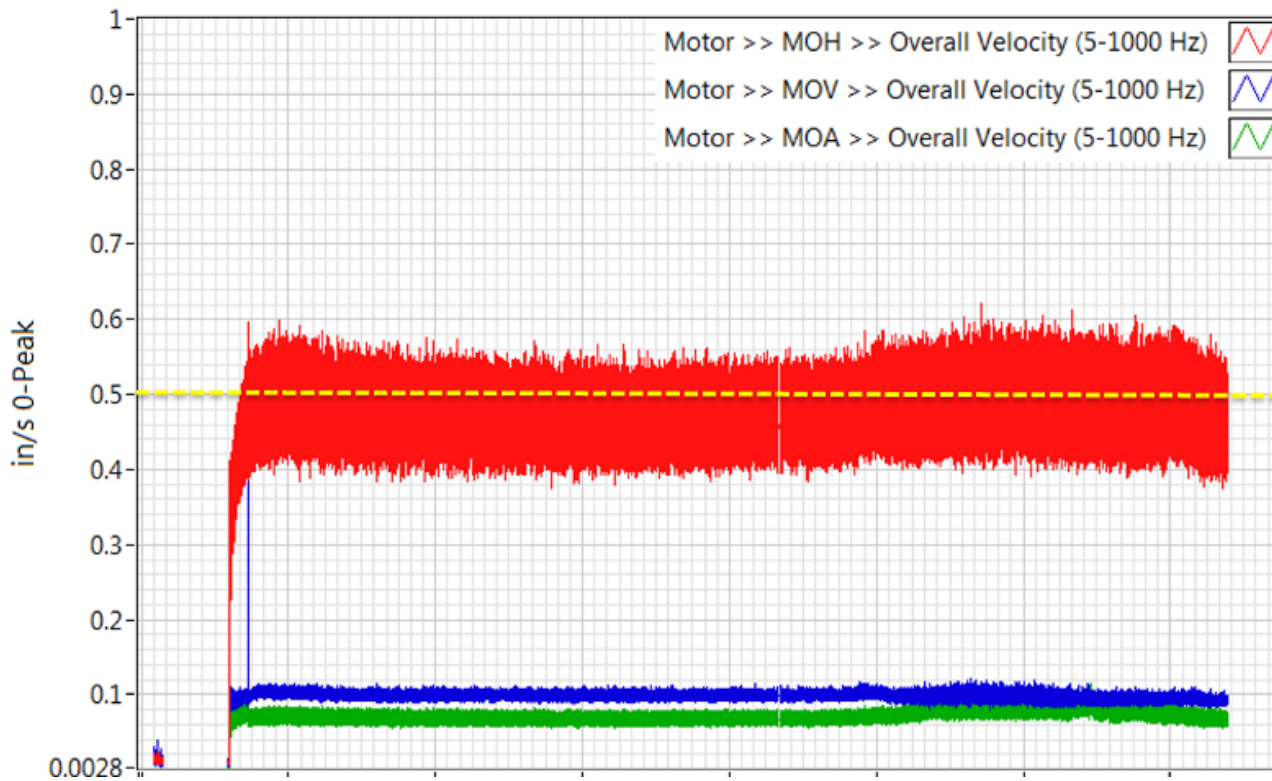
Overall Vibration Trends

Initial on-site vibration measurements following reinstallation showed vibration amplitudes of 0.47 IPS o-P at the outboard motor measurement in the horizontal direction (90 degrees from flow). These amplitudes were found to exceed 0.6 IPS o-P after an extended period of operation.

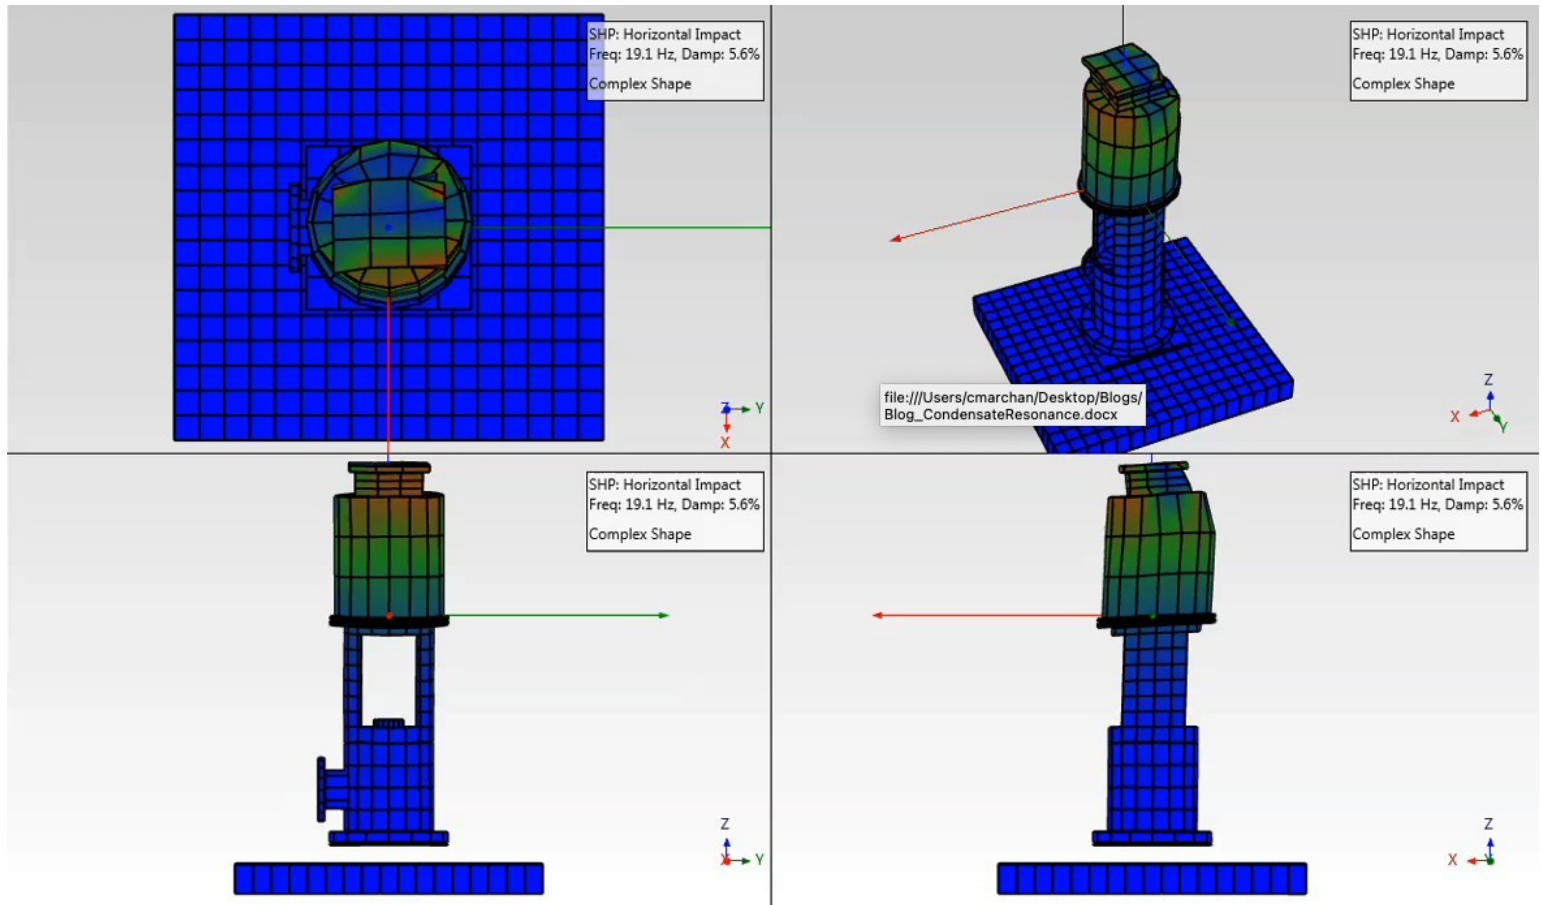
Resonance Comparison (1x RPM)

Impact testing was performed to better understand the structural resonances of the unit. This testing showed that the 3C pump had a structural resonance located at 19.1Hz, which has only a 3.1% margin of separation from the running speed. This resonant condition was suspected as being the primary cause of the elevated vibration amplitudes.

Impact testing of the other installed Condensate pumps revealed a slightly higher separation margin, validating field observations that these pumps were not exhibiting vibration similar to the 3C unit.

Installation	Impact Direction	Resonant Frequency (Hz)	Margin of Separation from 1x (19.7 Hz)
Condensate A	Horizontal	17.5	11.2%
	Vertical	14.6	26%
	Axial	16.5	16.3%
Condensate B	Horizontal	18.5	6.1%
	Vertical	15.7	20.4%
	Axial	18.5	6.1%
Condensate C	Horizontal	19.1	3.1%
	Vertical	16.8	15.3%
	Axial	19.3	2.1%

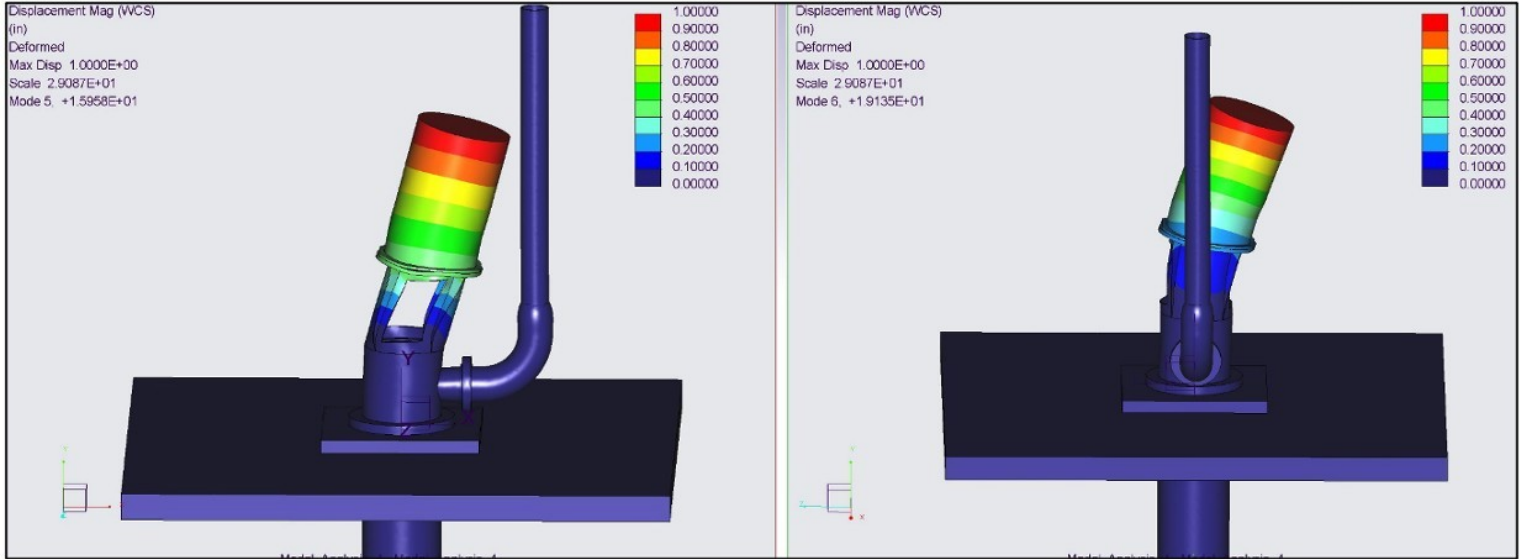
Structural Mode Shapes

A Finite Element Analysis (FEA) was performed on the 3C Condensate pump to develop an effective and economical solution to mitigate the vibration. A 3D model assembly was created from drawings and models using PTC Creo 5.0 software. Hydro calculated the added mass effects from the water contained within and around the pump; the modal analysis data was also used to assist in model calibration.

The 1st and 2nd motor rocking modes at 16.0 Hz and 19.1 Hz parallel and perpendicular to the discharge, respectively, matched very closely to the natural frequencies collected during the modal analysis. Using the FEA model, HRS determined that adding a 2,500 lb weight to the top of the Unit C Condensate motor would shift the motor natural frequencies down to 14.5 Hz and 16.8 Hz. This would provide a minimum separation margin of -15% from the 1x rpm forcing function, allowing pump 3C to run with lower vibration levels similar to those observed in Pumps 3A and 3B.

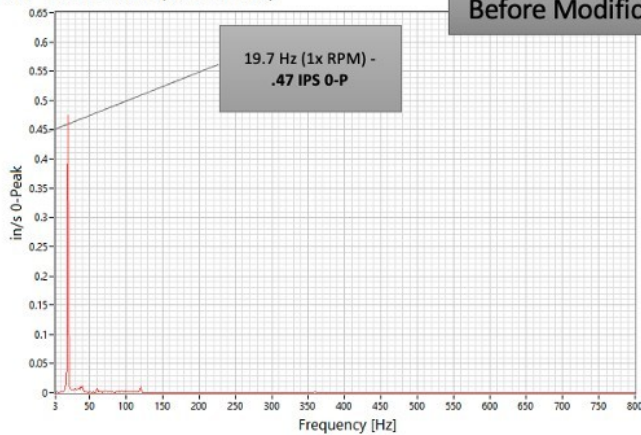
Unit 3C - MOH Position (90° from flow)

Before Modification

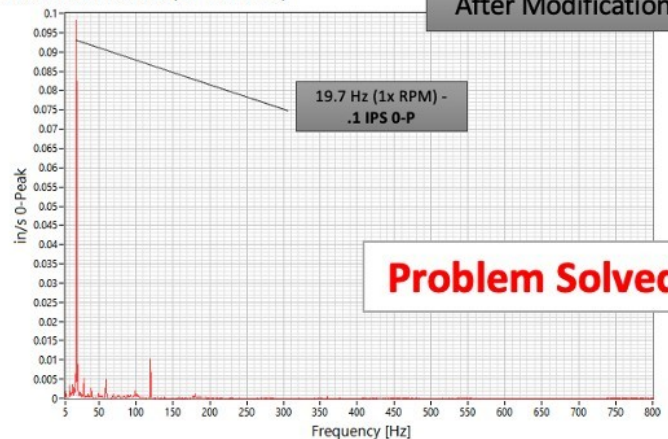
Unit 3C - MOH Position (90° from flow)

After Modification

The proposed change was implemented in the field and the plant saw an immediate reduction in vibration from 0.47 IPS o-P to 0.1 IPS o-P. Using in-field testing and advanced analytics supported by modeling software allowed the site to not only troubleshoot the problem, but execute a solution that solved it on the first try.
