Resonant Mode Detected and Resolved in Critical Condensate Pump

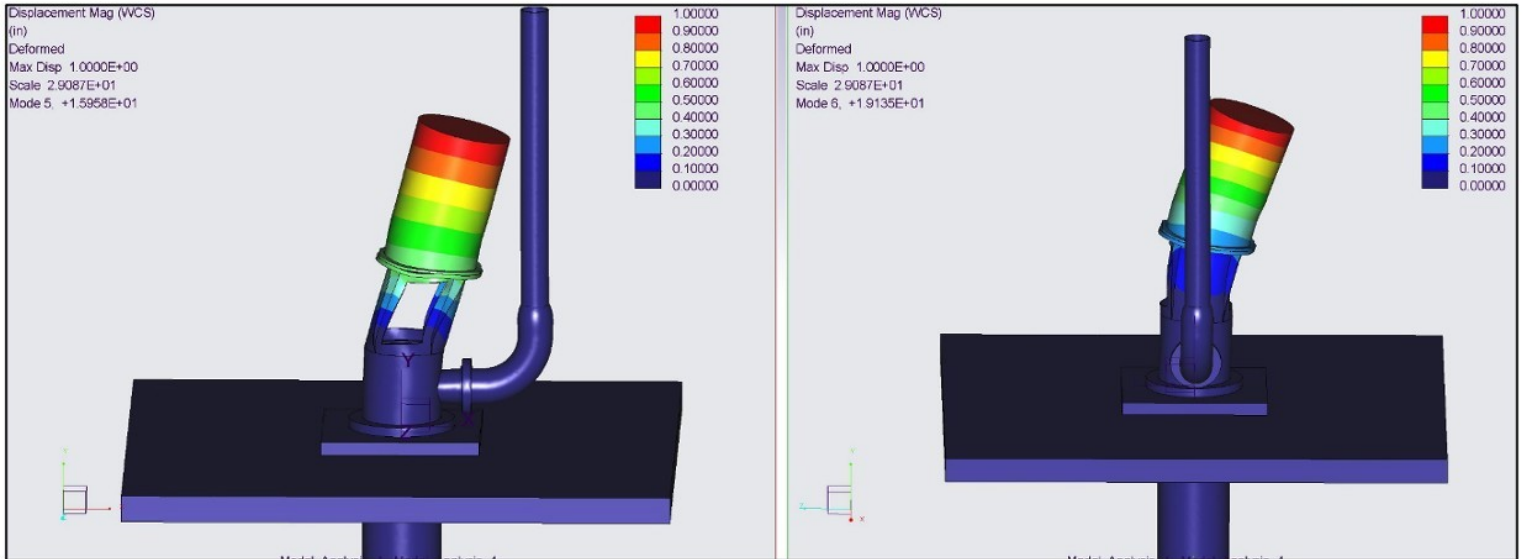
Structural Mode Shapes

The 1st and 2nd motor rocking modes at 16.0 Hz and 19.1 Hz parallel and perpendicular to the discharge, respectively, matched very closely to the natural frequencies collected during the modal analysis. Using the FEA model, HRS determined that adding a 2,500 lb weight to the top of the Unit C Condensate motor would shift the motor natural frequencies down to 14.5 Hz and 16.8 Hz. This would provide a minimum separation margin of -15% from the 1x rpm forcing function, allowing pump 3C to run with lower vibration levels similar to those observed in Pumps 3A and 3B.

A Finite Element Analysis (FEA) was performed on the 3C Condensate pump to develop an effective and economical solution to mitigate the vibration. A 3D model assembly was created from drawings and models using PTC Creo 5.0 software. Hydro calculated the added mass effects from the water contained within and around the pump; the modal analysis data was also used to assist in model calibration.

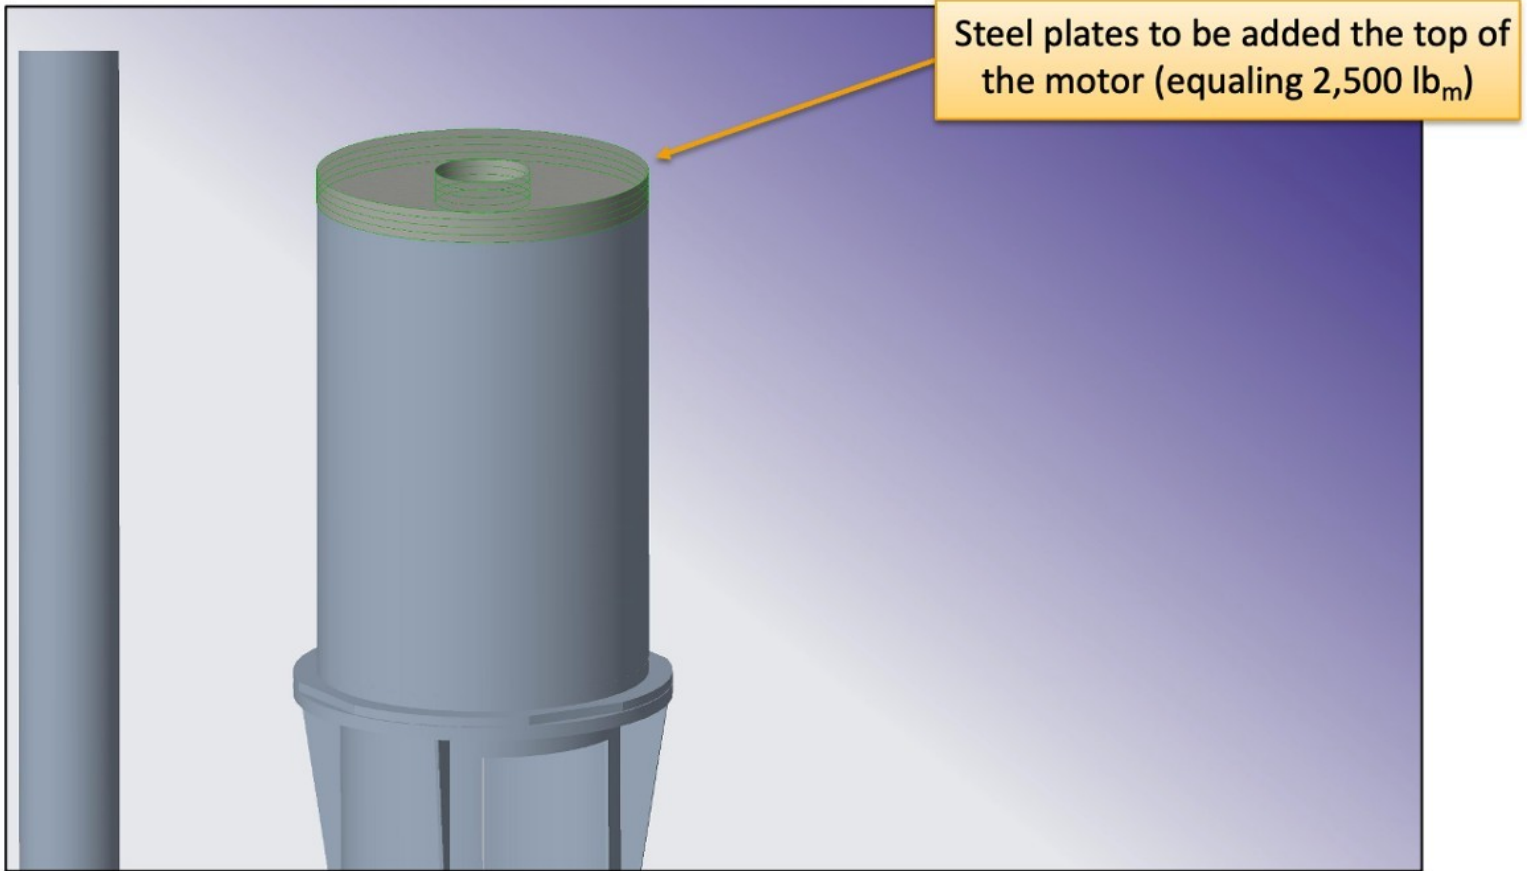
The proposed change was implemented in the field and the plant saw an immediate reduction in vibration from 0.47 IPS o-P to 0.1 IPS o-P. Using in-field testing and advanced analytics supported by modeling software allowed the site to not only troubleshoot the problem, but execute a solution that solved it on the first try.
