Building a Better Boiler Feed Pump

Say goodbye to concerns about pump seizure: By properly applying composite materials to a troublesome boiler feed water pump, this large process facility in Alberta can now run one pump during full-rate operation with very low vibration and higher efficiency.

The value of proper application and installation of modern composites is demonstrated by the results from a 9-stage boiler feed water pump from a large process facility in Central Alberta.

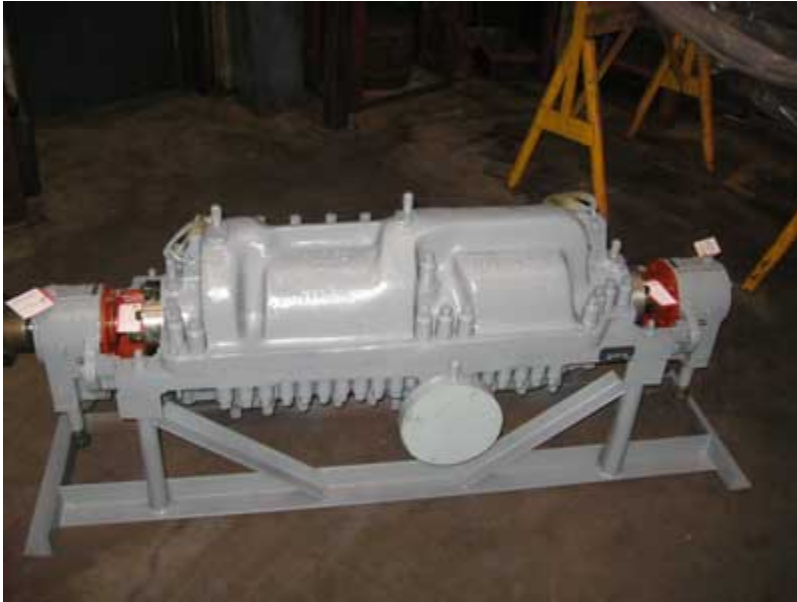
Figure 1. The 9-stage boiler feed water pump

The pump involved is a common design for a process plant boiler feed water pump: 9-stage, horizontally-split, between-bearings design (see Figure 1).

This design includes a double-suction first-stage impeller with wear rings, an eye-side wear ring and inter-stage bushing at each of the other eight stages, two throat bushings, and a pressure reducing bushing between the 5th and 9th stages. The impellers are 9.125-in (232-mm) diameter, with 5-in (127-mm) diameter wear rings.

To optimize the performance of this pump during the available repair time, the repair facility selected a composite material for all of the stationary wear components. The existing 12 percent chrome metal rotating components were used in combination with the composite material. Running clearance between rotating and stationary components was reduced to 0.008-in (0.203-mm), 50 percent of the original design values.

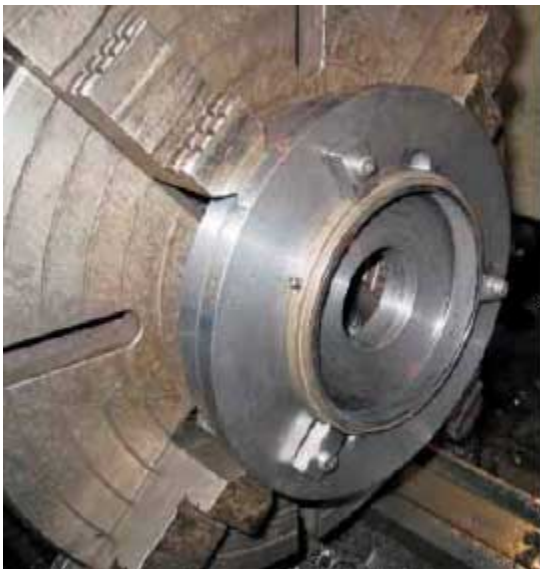
Figure 3. Composite insert in metal case ring holder

Additional design detail was needed for the split inter-stage bushings, as shown in Figure 3. Using the existing components as "holders" for the composite reduced the required machining time - eliminating the need for milling slots and other details on the outside diameter of the components.

To prevent axial movement of the composite, the metal holders incorporated a small shoulder on the low pressure side. There were no pins or screws used for anti-rotation purposes; the composite relying upon a heavy interference fit for anti-rotation. With a very low coefficient of friction and other properties that reduce risk of seizure, this method of installation has proven effective with this composite during the past ten years of field experience.

Instead of fabricating new components with complex geometry for the stationary composite components, the existing components were used as holders for composite "inserts." The existing metal bores were increased, and thin-radial-wall composite inserts were manufactured and pressed into the metal holders.

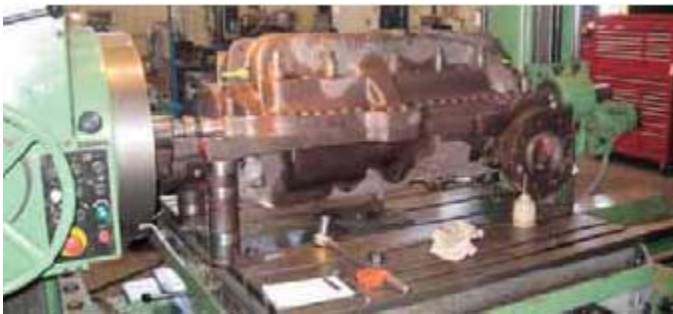
Figure 4. Line boring the pump case

Before the rotor is installed, the pump should be fully inspected. The split-line should be checked to ensure it is true, the line bore and seal chamber bore should be checked for concentricity (see Figure 4), and the rotating element should have limited run-out (typically 0.002-in max).

Individual components should be checked for condition and concentricity. For example, if using the existing case ring as a holder for a composite insert, the metal ring should fit properly within the pump case. Loose or distorted components should be repaired or replaced as needed.
