# Refurbishing a Contaminated Nuclear Casing

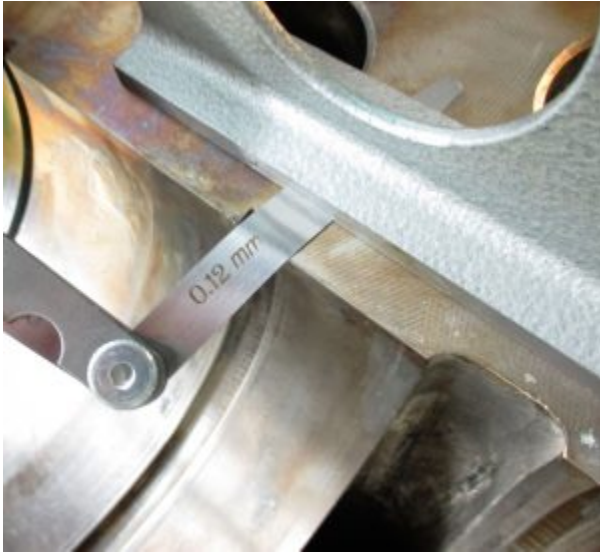
Hydro's team [inspected the pump, the casing, and the internal element and explored all possible options](#) (Figure 1). Hydro was able to find an inventive solution by machining the casing in the contaminated state and developing creative methods to guarantee a proper fit-up when the casing repair was completed. Despite the OEM suggesting a new pump be purchased, the service provider was able to find an innovative and cost-saving way for the plant to repair the casing and reduce downtime.

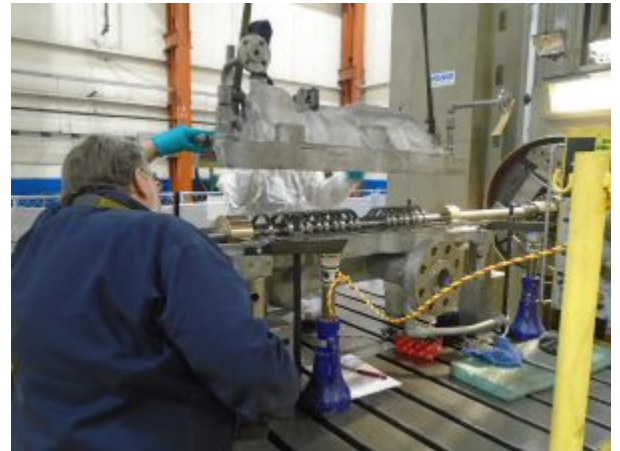
The precision mock-up rings were used to measure concentricity and to ensure that the rotor would fit properly in the casing when assembled (Figure 3). The precision mock-up rings were manufactured by Hydro.

During their initial inspection at the nuclear plant, Hydro measured the relevant components of the rotor so they could create mock-up wear rings. These rings are the stationary components that support the rotor in the casing. If the mock-up rings matched exactly, then the rings could be manufactured to ensure the repaired casing would fit properly.

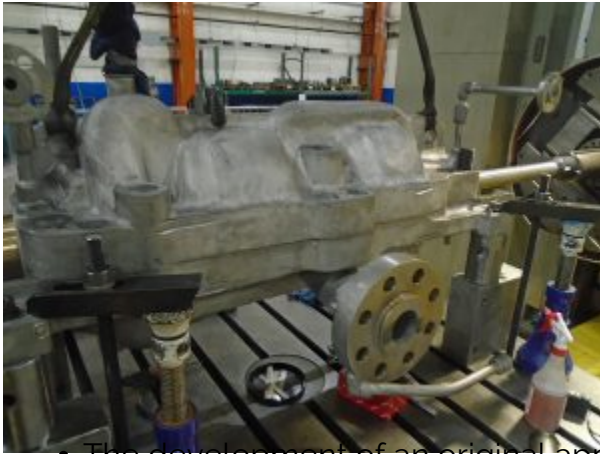
Hydro performed a final cleaning and passivation check to ensure that no iron contaminants were found in the newly repaired casing. With negative results on the passivation check, Hydro was able to ship the casing back to Europe (Figure 4). The customer was impressed with the innovative approach and with the management of the many details in this unique project scope. The creative approach saved the nuclear plant time and money, while also reducing their risk.
