## Resonant Mode Detected and Resolved in Critical Condensate Pump

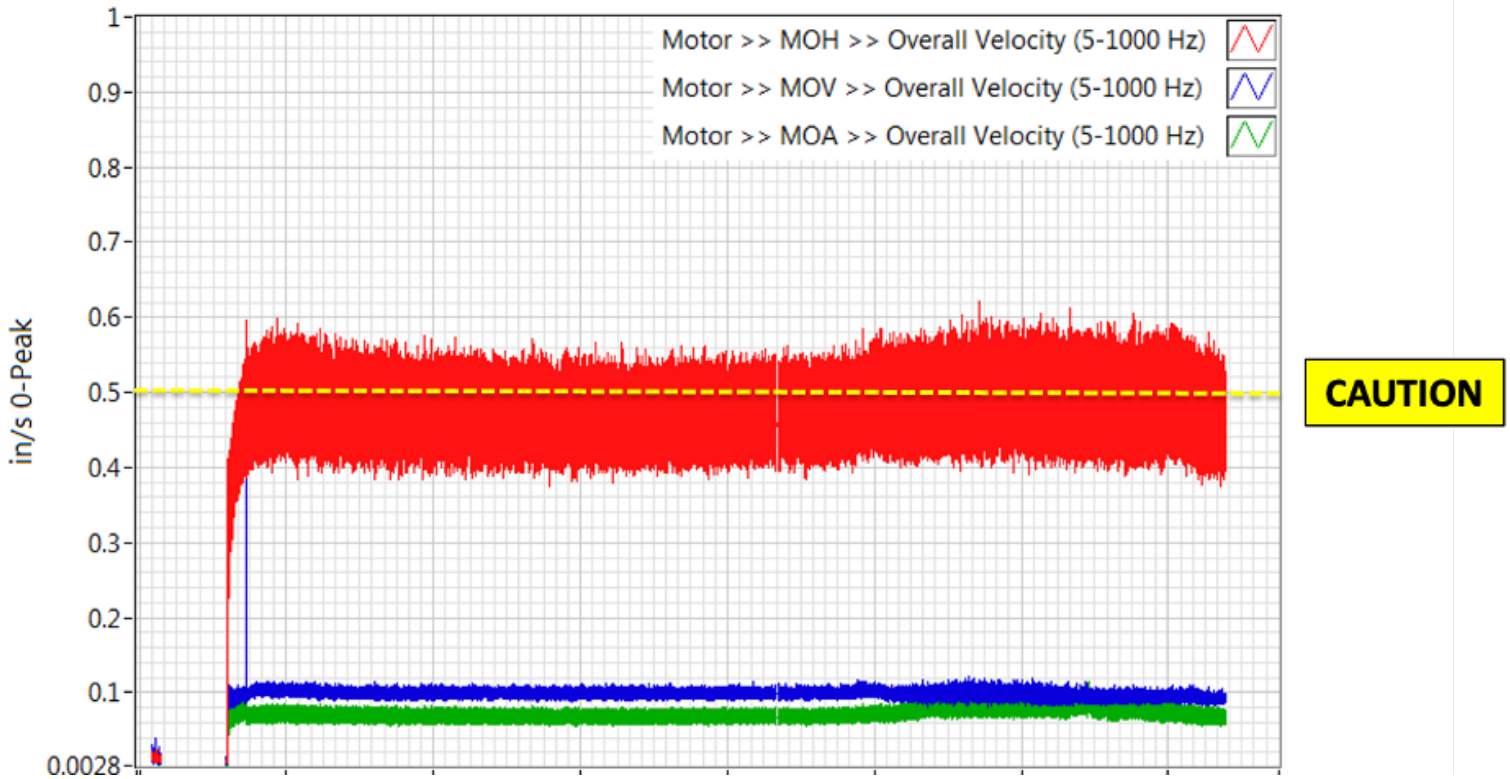
### Overall Vibration Trends

Initial on-site vibration measurements following reinstallation showed vibration amplitudes of 0.47 IPS o-P at the outboard motor measurement in the horizontal direction (90 degrees from flow). These amplitudes were found to exceed 0.6 IPS o-P after an extended period of operation.

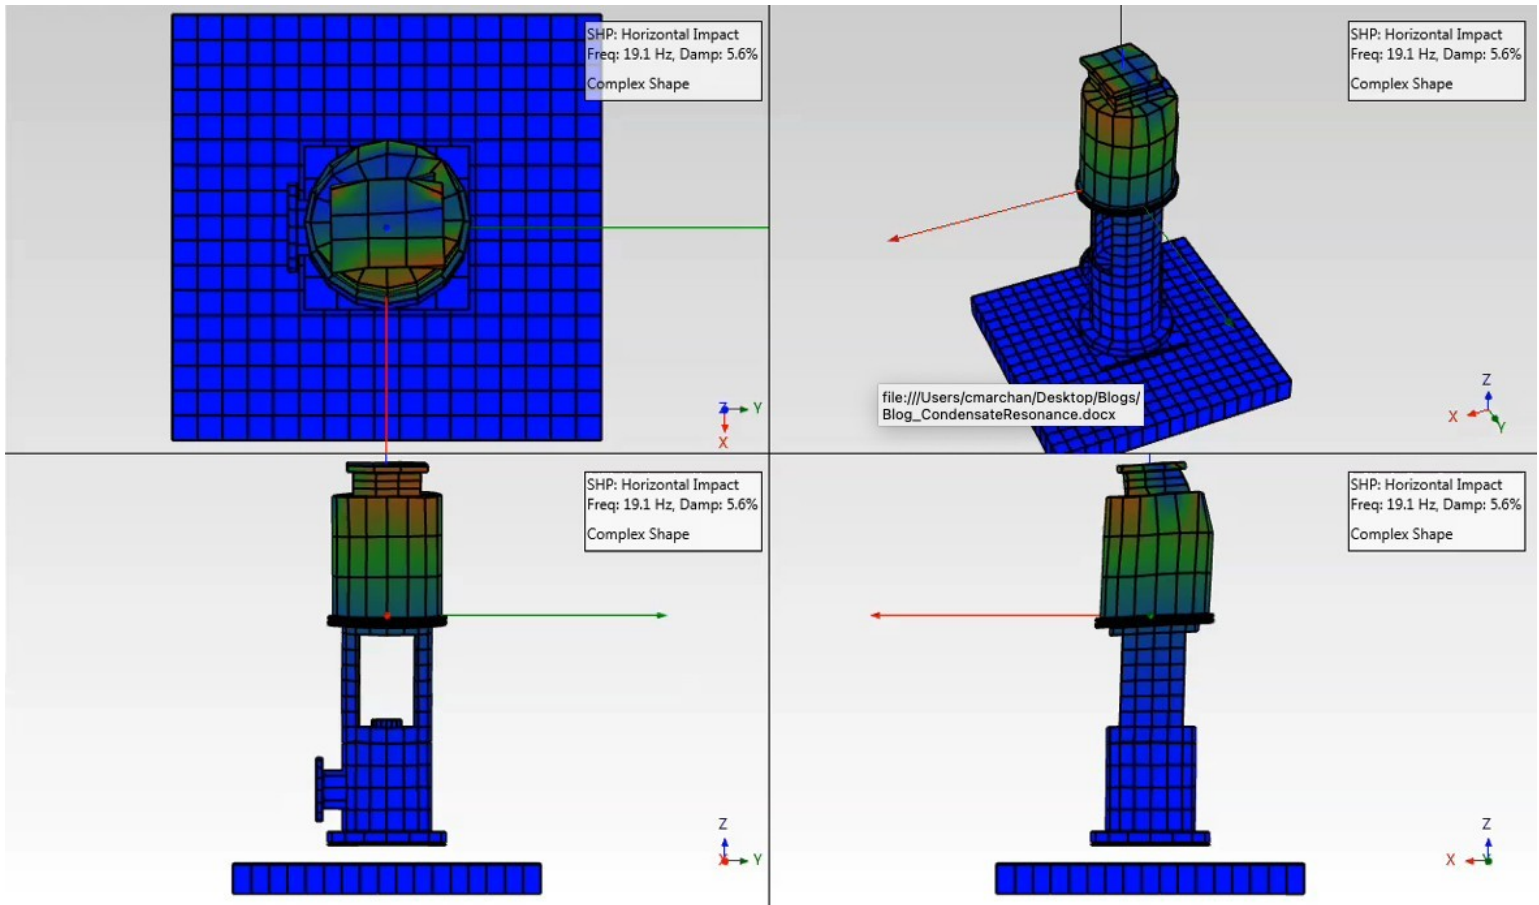
### Resonance Comparison (1x RPM)

Impact testing was performed to better understand the structural resonances of the unit. This testing showed that the 3C pump had a structural resonance located at 19.1Hz, which has only a 3.1% margin of separation from the running speed. This resonant condition was suspected as being the primary cause of the elevated vibration amplitudes.

Impact testing of the other installed Condensate pumps revealed a slightly higher separation margin, validating field observations that these pumps were not exhibiting vibration similar to the 3C unit.

Installation	Impact Direction	Resonant Frequency (Hz)	Margin of Separation from 1x (19.7 Hz)
Condensate A	Horizontal	17.5	11.2%
	Vertical	14.6	26%
	Axial	16.5	16.3%
Condensate B	Horizontal	18.5	6.1%
	Vertical	15.7	20.4%
	Axial	18.5	6.1%
Condensate C	Horizontal	19.1	3.1%
	Vertical	16.8	15.3%
	Axial	19.3	2.1%

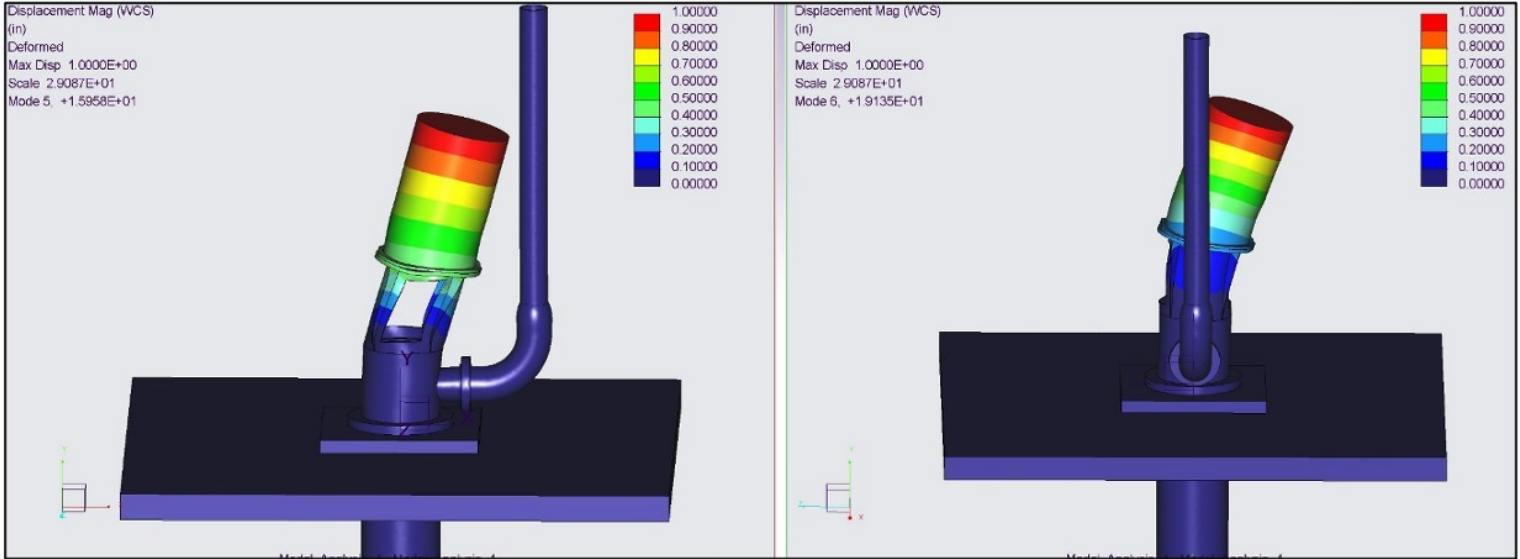
**Structural Mode Shapes**

The 1<sup>st</sup> and 2<sup>nd</sup> motor rocking modes at 16.0 Hz and 19.1 Hz parallel and perpendicular to the discharge, respectively, matched very closely to the natural frequencies collected during the modal analysis. Using the FEA model, HRS determined that adding a 2,500 lb weight to the top of the Unit C Condensate motor would shift the motor natural frequencies down to 14.5 Hz and 16.8 Hz. This would provide a minimum separation margin of -15% from the 1x rpm forcing function, allowing pump 3C to run with lower vibration levels similar to those observed in Pumps 3A and 3B.

A Finite Element Analysis (FEA) was performed on the 3C Condensate pump to develop an effective and economical solution to mitigate the vibration. A 3D model assembly was created from drawings and models using PTC Creo 5.0 software. Hydro calculated the added mass effects from the water contained within and around the pump; the modal analysis data was also used to assist in model calibration.
