Using Latest Technology to Refurbish a 50-year-old Pump Element

Power pump performance improved with redesign of the first-stage, double-suction impeller and twin volute.

Written by: Dave Allard & Dr. Gary Dyson

Published by: Pumps & Systems

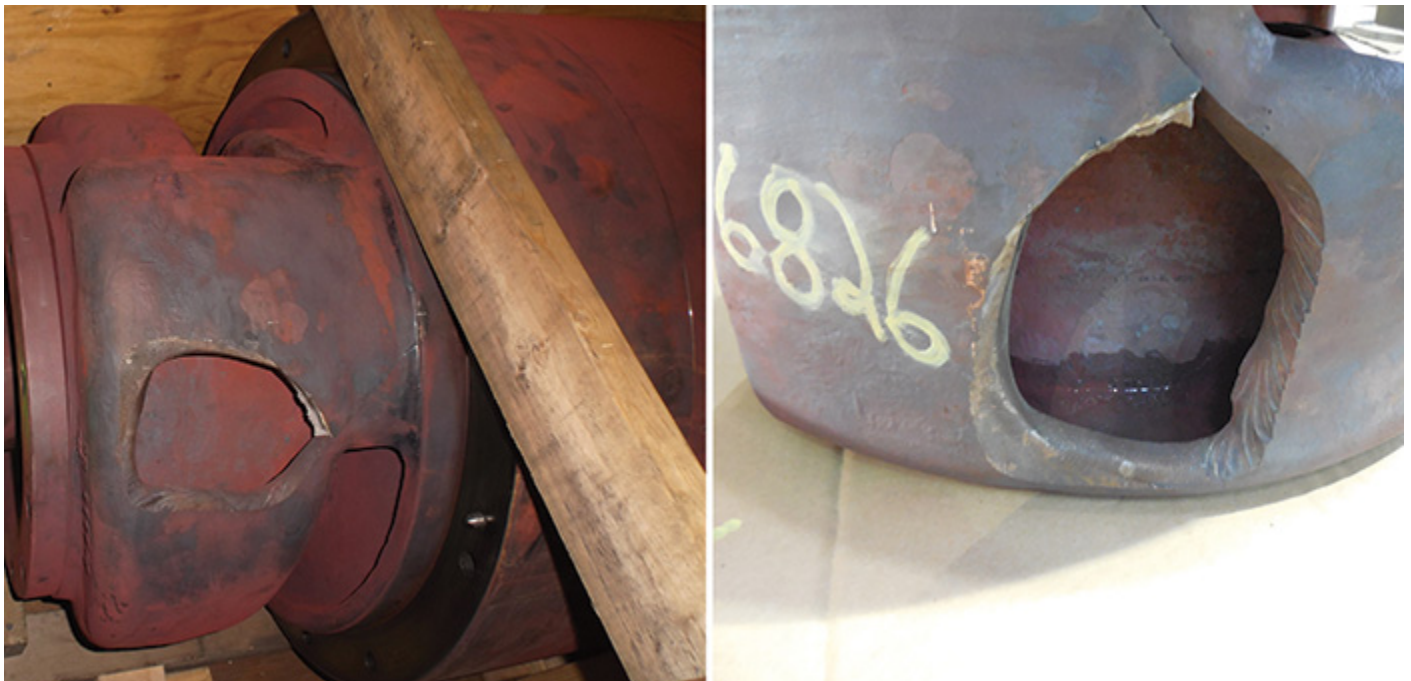
The first-stage twin volute is a complicated casting, which failed during operation as a result of poor design.

Hydro re-engineered the casting by using sophisticated engineering and 3-D modeling, along with simulation software and 3-D sand printing.

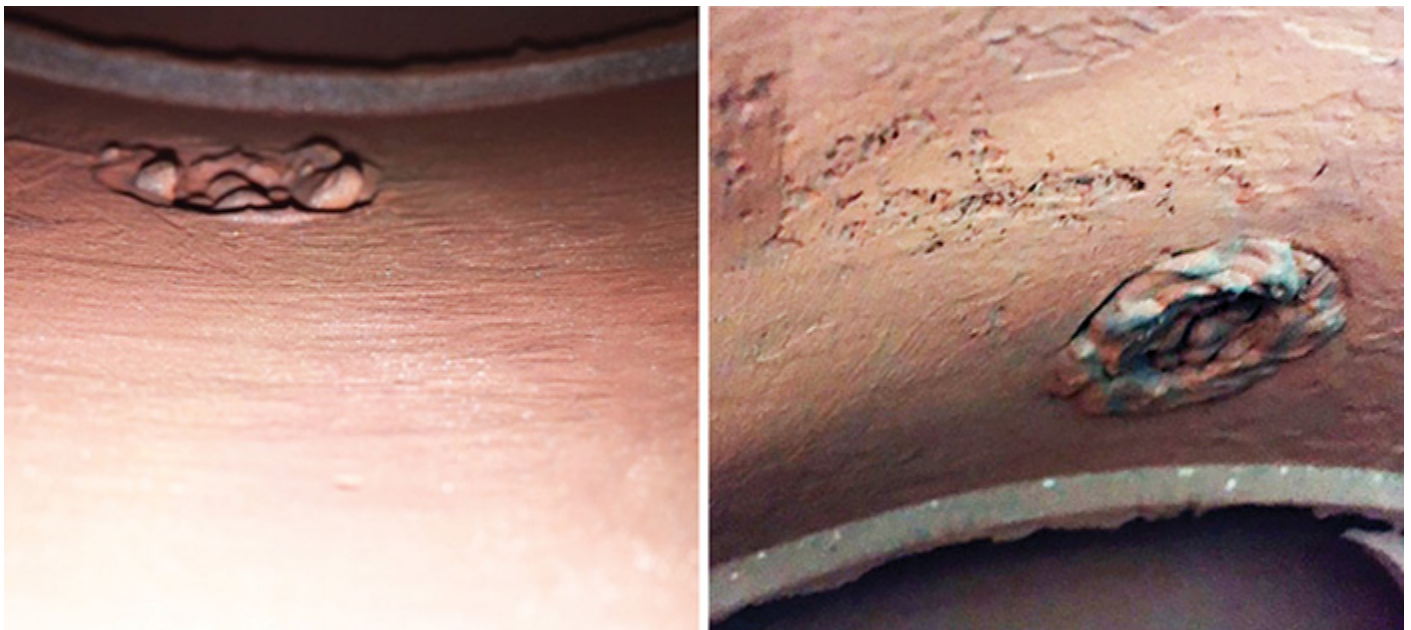
Chaplets are usually comprised of different metallurgy from the metal being poured and can create a weak area if left in place. Image 2 shows areas that were either utilized for chaplets or are core sand clean-out plugs, which were excavated and welded.

The engineers eliminated the need for chaplets during the pouring process by using 3-D technology,

which allows for the manufacturing of the cores in a hybrid design that will lock them in place inside the mold. By using this method, the sophisticated technology averages the wall thickness, minimizes core shift and minimizes welding. The volute areas were examined by the bore scope and properly cleaned.

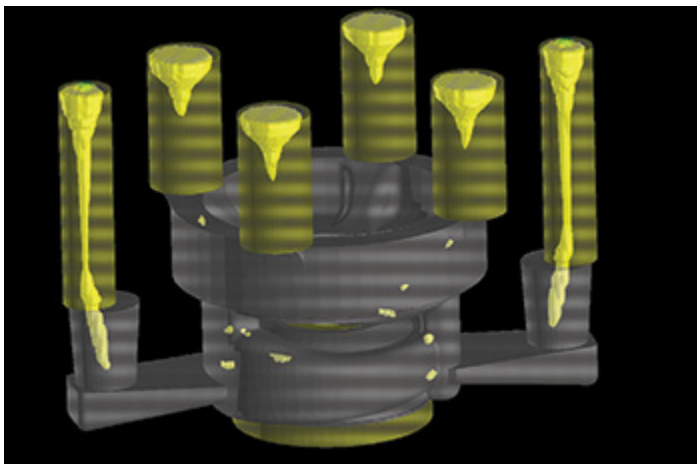
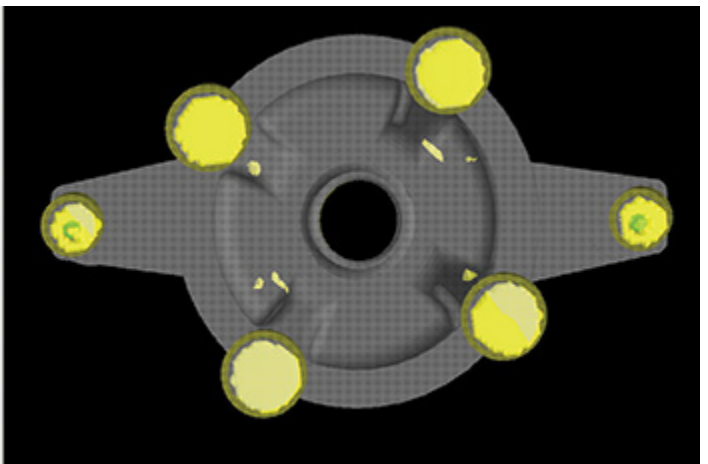
In the volute crossover areas, Hydro noticed a significant amount of flash on both sides. This is created by core lift where two cores are jointed together. While the 3-D printing method will not eliminate the need for separate cores, it allowed Hydro to move the core split to an area that is accessible for grinding. The 3-D printed cores were 0.005-0.20-inch accurate dimensionally in the x, y, and z axis. This gave the engineers precision core filament during the mold building process.

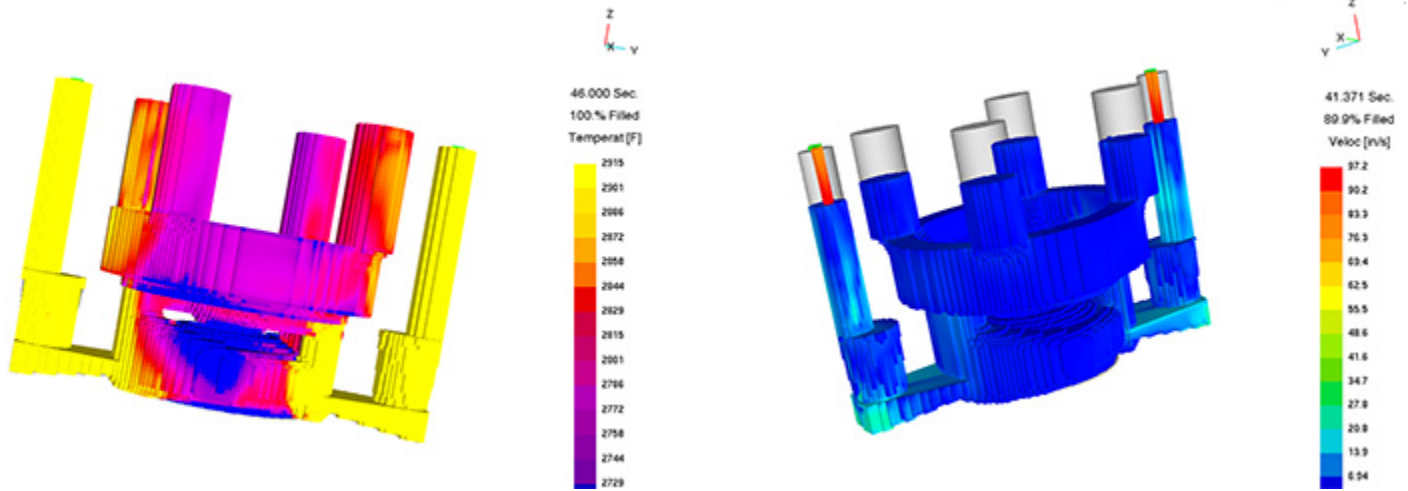
Final CFD Analysis: Optimum Conditions

This is a similar analysis, but in the optimum condition. All the indications are in the riser tubes, and the main casting body is free of defects. Hydro provided the foundry a pour data form for each individual casting and then meets those specs.

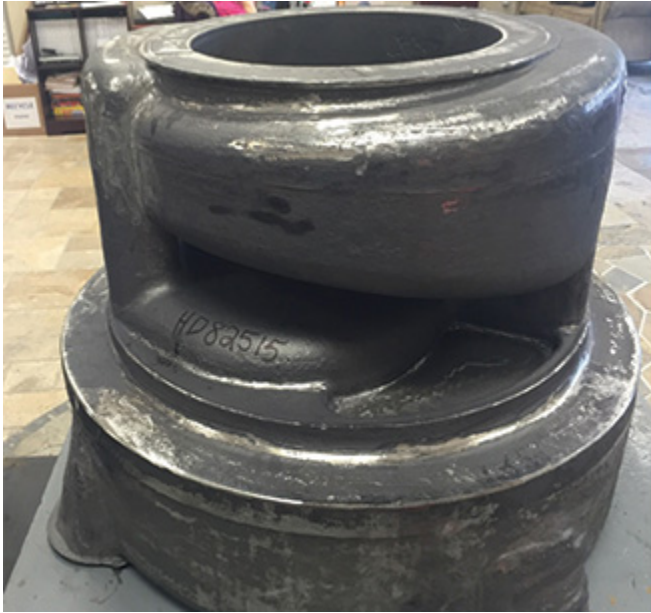
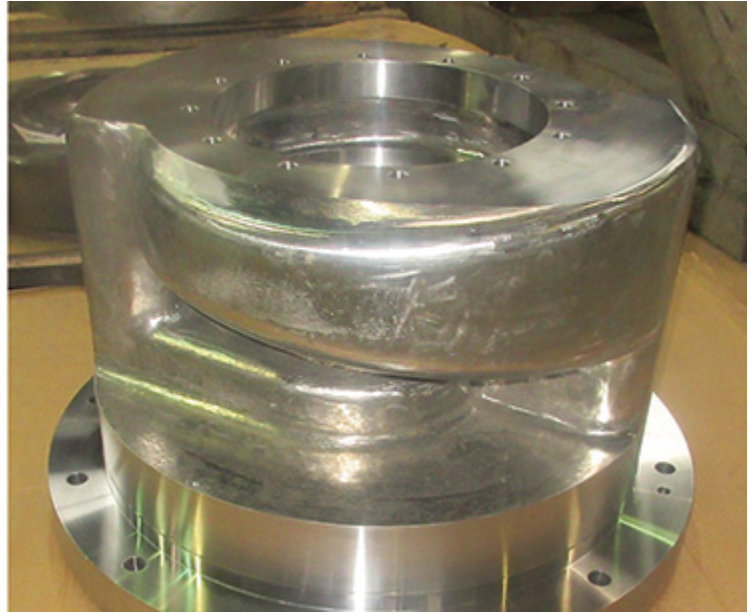
Velocity Analysis

Velocity control is critical in all aspects of pouring. High velocity triggers gas reactions, premature freezing of metal fragments and inconsistent feeding. This is a critical step to ensure that the gating has the proper choke to minimize turbulence during the pouring process. Typically, it is important to keep the velocity below 30 inches per second. Choke points are how foundry workers control the speed of metal. The software package has a program to help design choke points when creating the gating system.

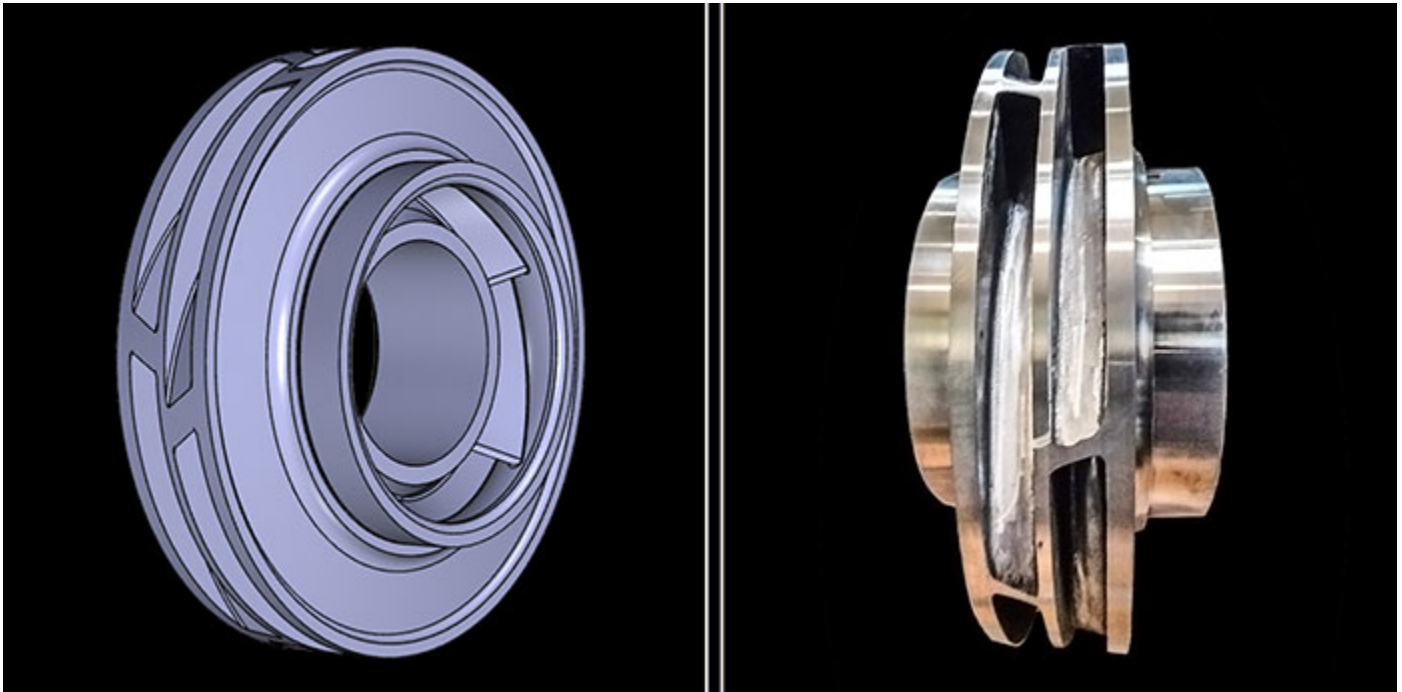
Pressure pulsations at vane frequency are initiated by each of the vanes of the impeller passing close to the volute cutwater lip. These pulsations can affect vibration of the machine. Traditional methods to reduce these pressure pulsations involve increasing the distance between the impeller vanes and lips to allow time, distance and viscosity to smooth out this pressure wave. Unfortunately, this technique does not come without penalty and affects both pump head and efficiency.
