## Engineering a Long-Term Solution

By way of example, this article will discuss a fertilizer plant in the Gulf of Mexico that had a boiler feedwater pump unit that was experiencing performance problems after a significant plant expansion project. Unfortunately, it was not the first time this particular unit had experienced a loss of capacity; the pump had been in operation only 18 months prior to the current issue.

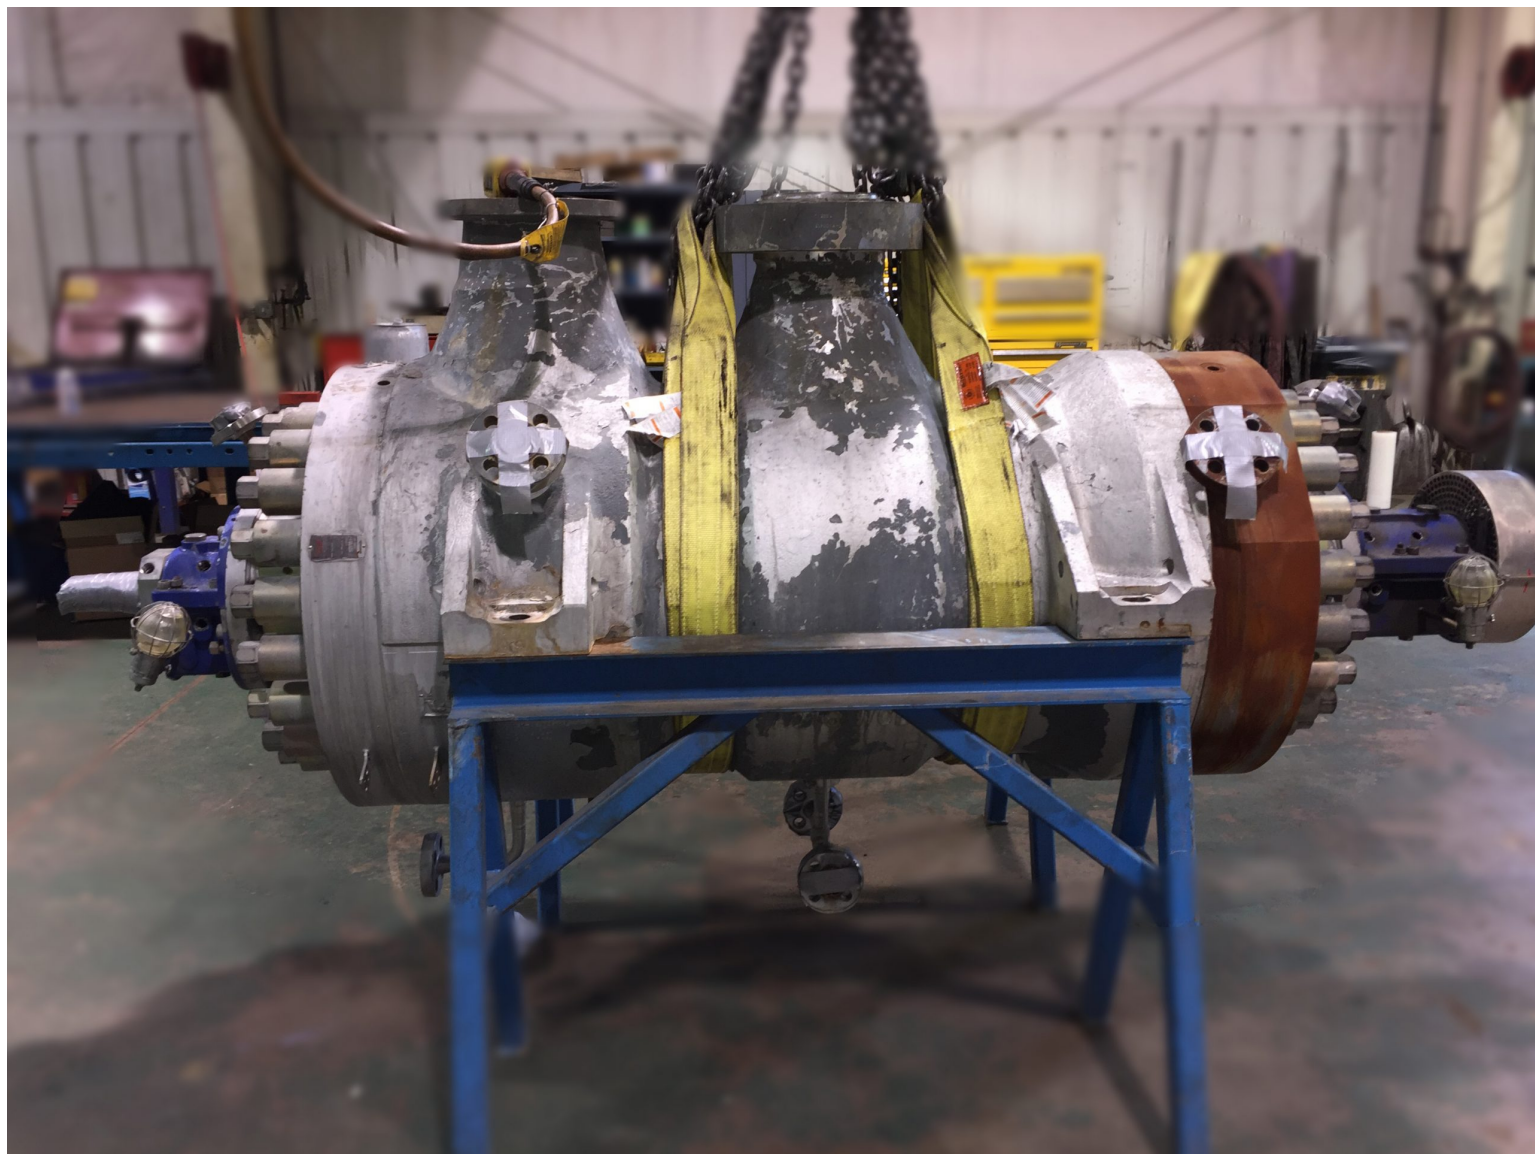
With this new information, the plant manager decided to proceed with the proposed forensic inspection plan. The service provider opted to have the pump sent to a service centre in Houston, Texas, US, for in-depth analysis and repair. The client agreed, and the entire unit, including the casing, was shipped for service (Figure 1).
