Hydro, Inc.'s Centaur IIoT Solution Detects Cracked Coupling at Municipal Wastewater Treatment Plant

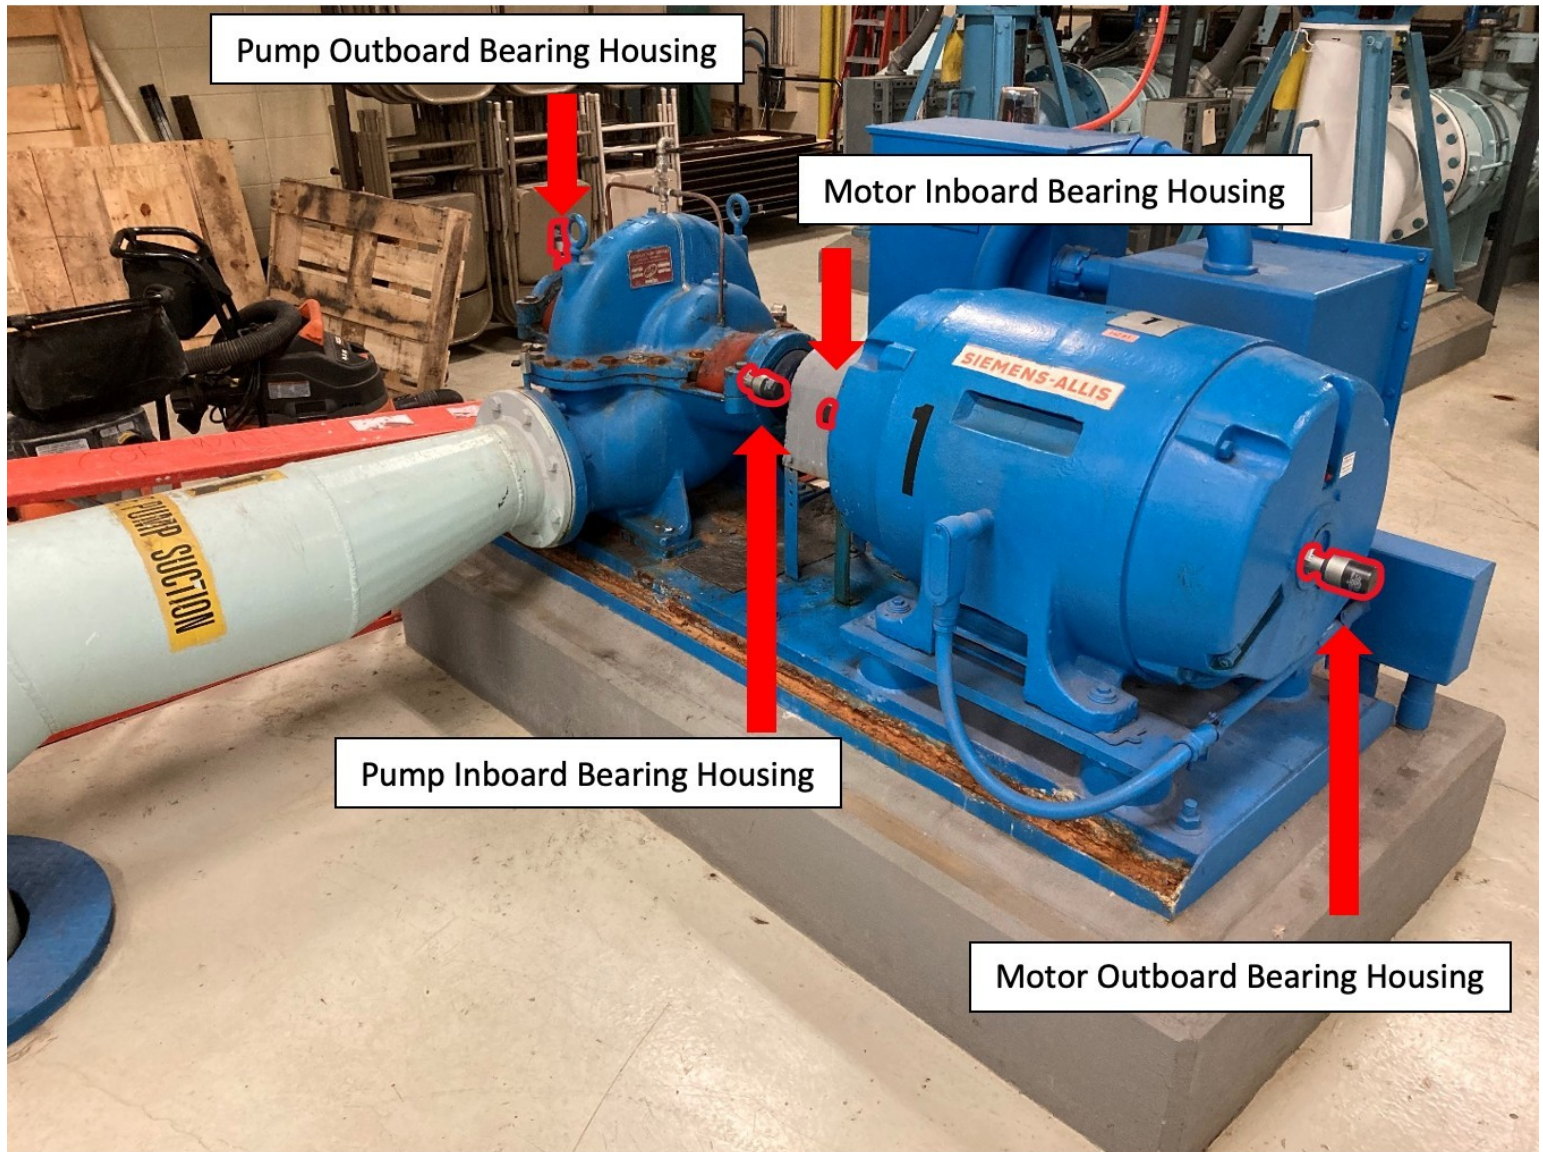
For this installation, the Centaur engineering team outfitted wireless accelerometers at specific points on multiple machine trains. The monitored locations include the motor outboard bearing housing, motor inboard bearing housing, pump inboard bearing housing, and pump outboard bearing housing, as shown below.
