# Service Center Engineering for a Power Plant

## **Circulating Water Pump Fails**

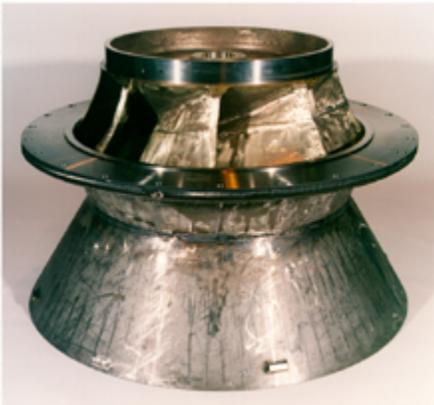
Throughout the job, the service center maintained daily communication with the plant—advising them on any problems, the proposed solutions, and the expected project completion date. Involving the plant was critical to the overall project. The project was successfully completed within 7 weeks, the plant's delivery requirements were met and the pump was in service for the critical summer season.
