Rebuilding Boiler Feed Pumps for the Wastewater Industry

Bob Bluse, Hydro East Inc., and Scott Morisi, Passaic Valley Sewerage Commissioners

Pumps & Systems

October, 2009

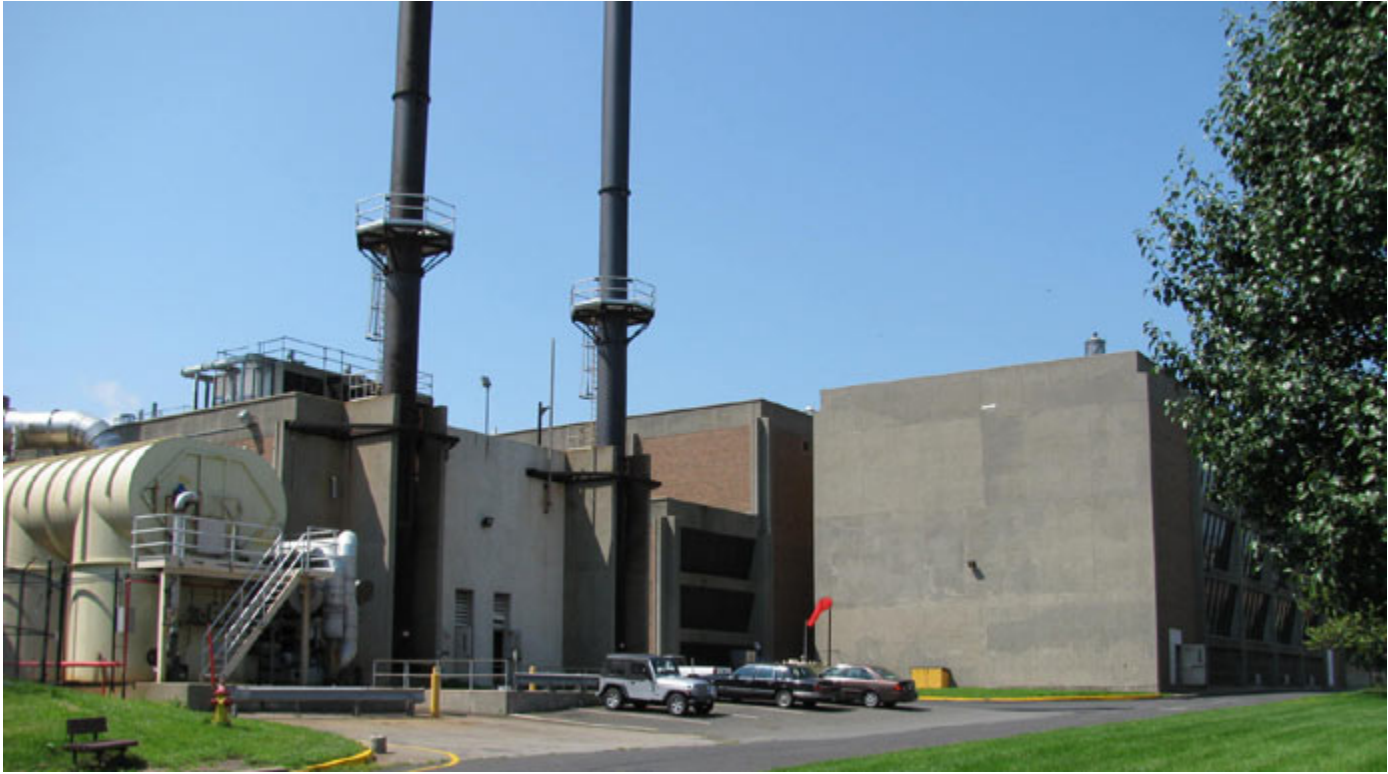
Facility's boiler house

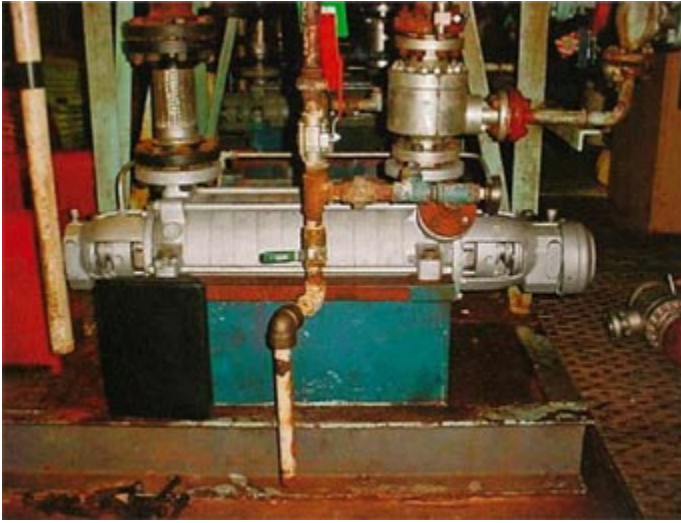
The pump turned freely when it was received. While dismantling the pump's thrust end, the service center found a portion of the bearing cage in the housing. The thrust bearings mounted on the shaft were intact; therefore, this piece of cage was from a previous failure. On one pump, the back to back thrust bearings were installed incorrectly, which resulted in a short run to failure. All bearings were installed correctly with the proper clearances and tolerances as recommended by the bearing manufacturer.

(Left) BFP Installation (Right) Bearing Cage from a previous repair
