Impeller Failure Solution at a Vietnamese Power Plant

Written by: Kwa Soo Teck, Phu My 3 Power Station (Vietnam), & Chandra Verma, Hydro Australia

Publisher: Pumps & Systems / September, 2011

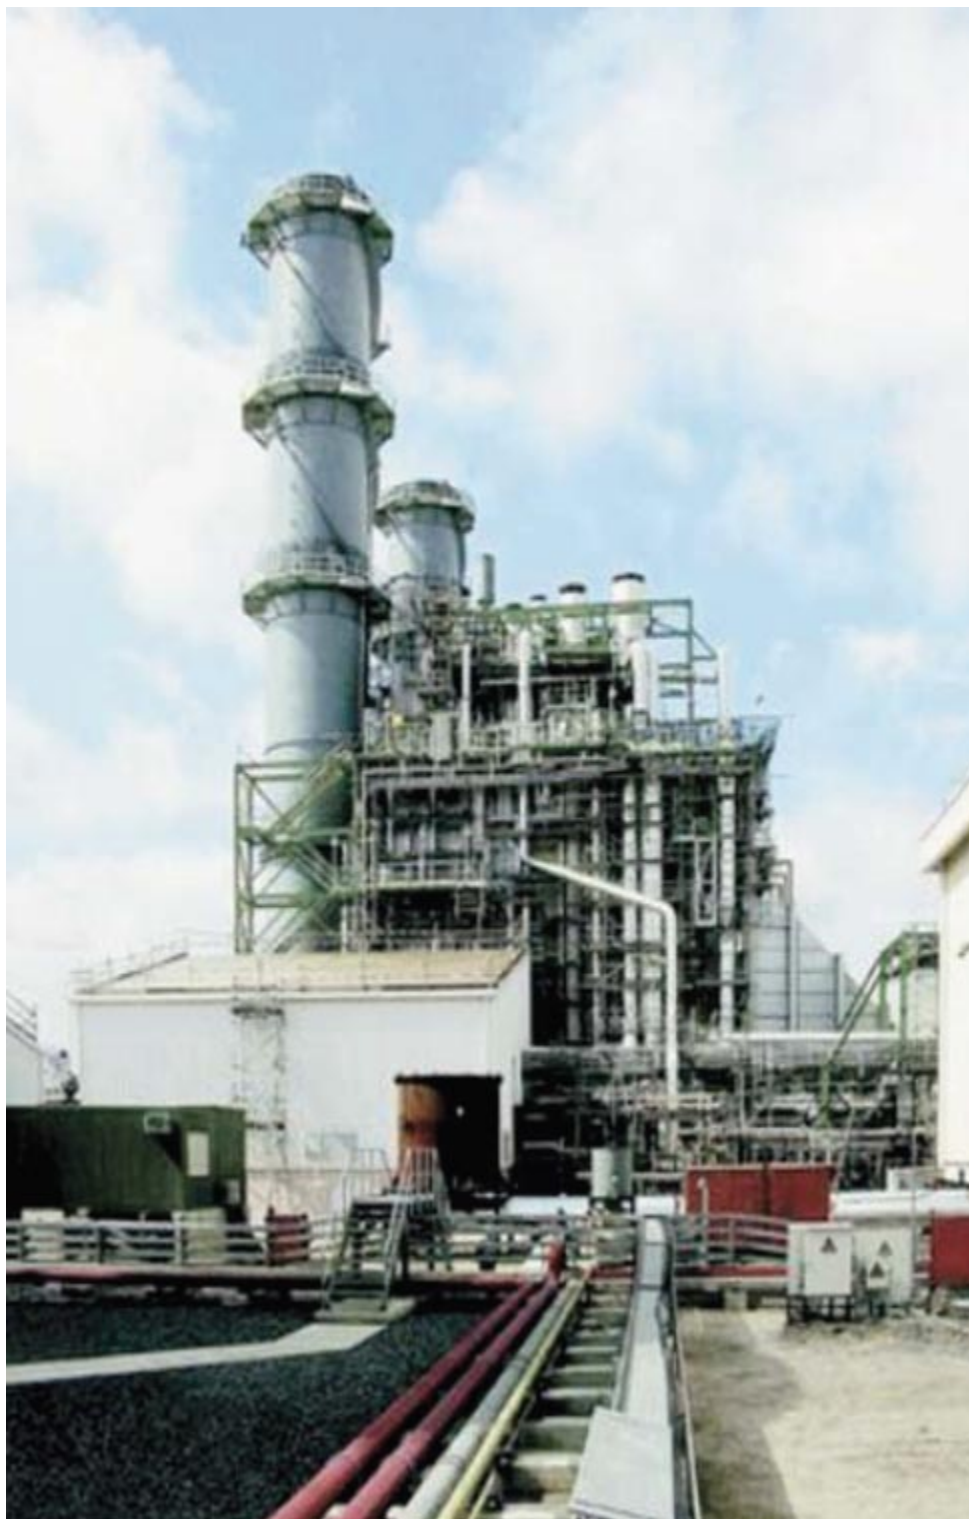
The vertical pumps were used for the circulating water system. The impeller material was a super duplex and the product being pumped was sea water. Over a period of three years, Phu My 3 had experienced catastrophic failures with the impellers and were unsure of the cause. The first pump was

installed in Sept 2003 and the first blade failed in September 2008; the second failure occurred in Sept 2009 and a third failure occurred in June 2010.

On viewing the damaged impellers, which weigh 850 kilograms, it was obvious the quality was poor. The first step in the process was to send over an engineer with a Romer Arm, a 3D coordinate measuring instrument, to reverse engineer the impeller. This data could be used to analyse the existing impeller design.
