Impeller Failure Solution at a Vietnamese Power Plant

Written by: Kwa Soo Teck, Phu My 3 Power Station (Vietnam), & Chandra Verma, Hydro Australia

Publisher: Pumps & Systems / September, 2011

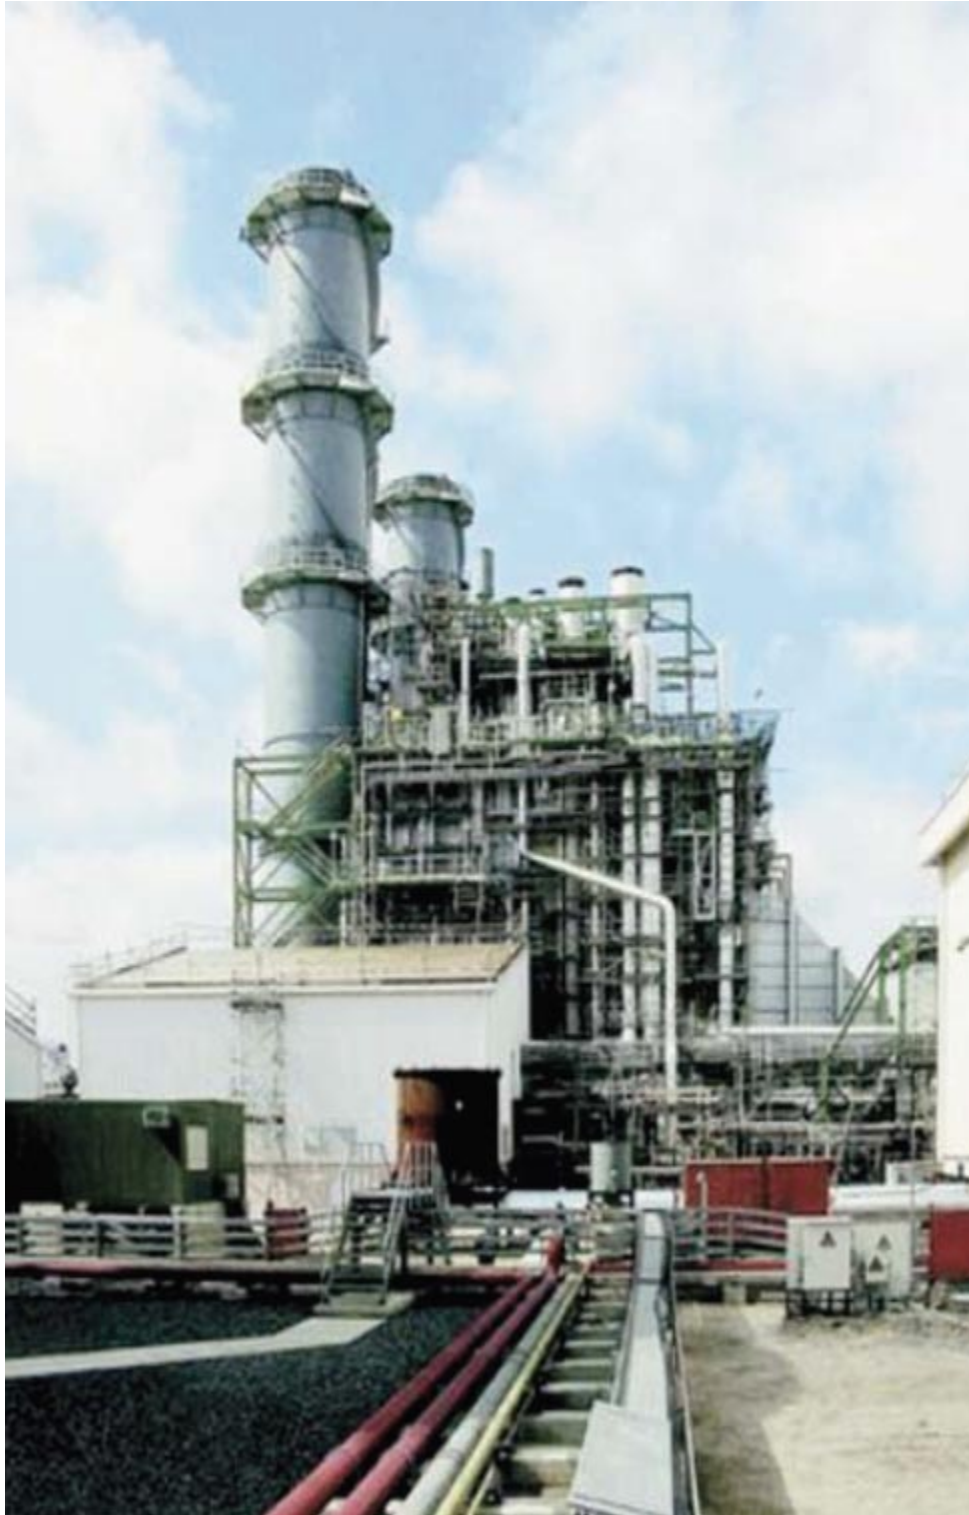
Phu My 3 BOT Power Station, a Vietnamese power station using combined cycle gas turbine technology and operating at 749 megawatt capacity, had been experiencing some problems with their vertical pumps. The station asked Hydro Australia to assess the damage and assist with a solution.

The vertical pumps were used for the circulating water system. The impeller material was a super duplex and the product being pumped was sea water. Over a period of three years, Phu My 3 had experienced catastrophic failures with the impellers and were unsure of the cause. The first pump was

installed in Sept 2003 and the first blade failed in September 2008; the second failure occurred in Sept 2009 and a third failure occurred in June 2010.

On viewing the damaged impellers, which weigh 850 kilograms, it was obvious the quality was poor. The first step in the process was to send over an engineer with a Romer Arm, a 3D coordinate measuring instrument, to reverse engineer the impeller. This data could be used to analyse the existing impeller design.
