Engineering a Long-Term Solution

By way of example, this article will discuss a fertilizer plant in the Gulf of Mexico that had a boiler feedwater pump unit that was experiencing performance problems after a significant plant expansion project. Unfortunately, it was not the first time this particular unit had experienced a loss of capacity; the pump had been in operation only 18 months prior to the current issue.

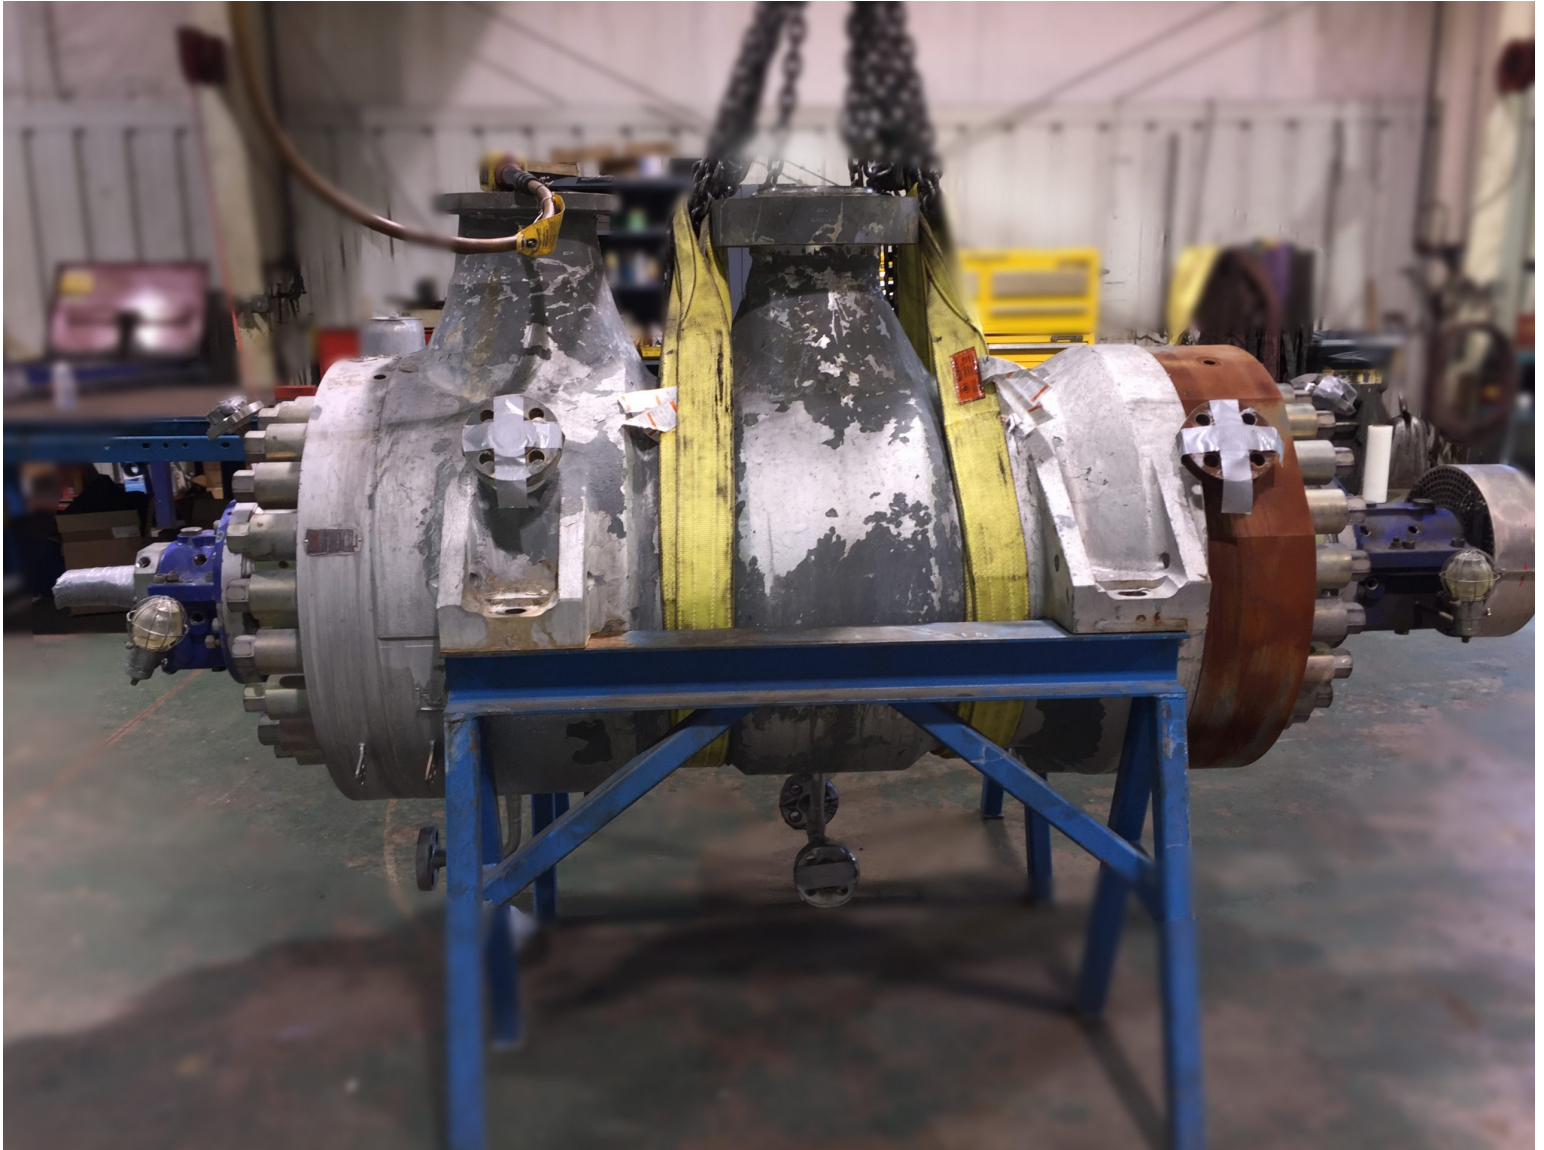
With this new information, the plant manager decided to proceed with the proposed forensic inspection plan. The service provider opted to have the pump sent to a service centre in Houston, Texas, US, for in-depth analysis and repair. The client agreed, and the entire unit, including the casing, was shipped for service (Figure 1).
