# **Engineering a Long-Term Solution**

By way of example, this article will discuss a fertilizer plant in the Gulf of Mexico that had a boiler feedwater pump unit that was experiencing performance problems after a significant plant expansion project. Unfortunately, it was not the first time this particular unit had experienced a loss of capacity; the pump had been in operation only 18 months prior to the current issue.

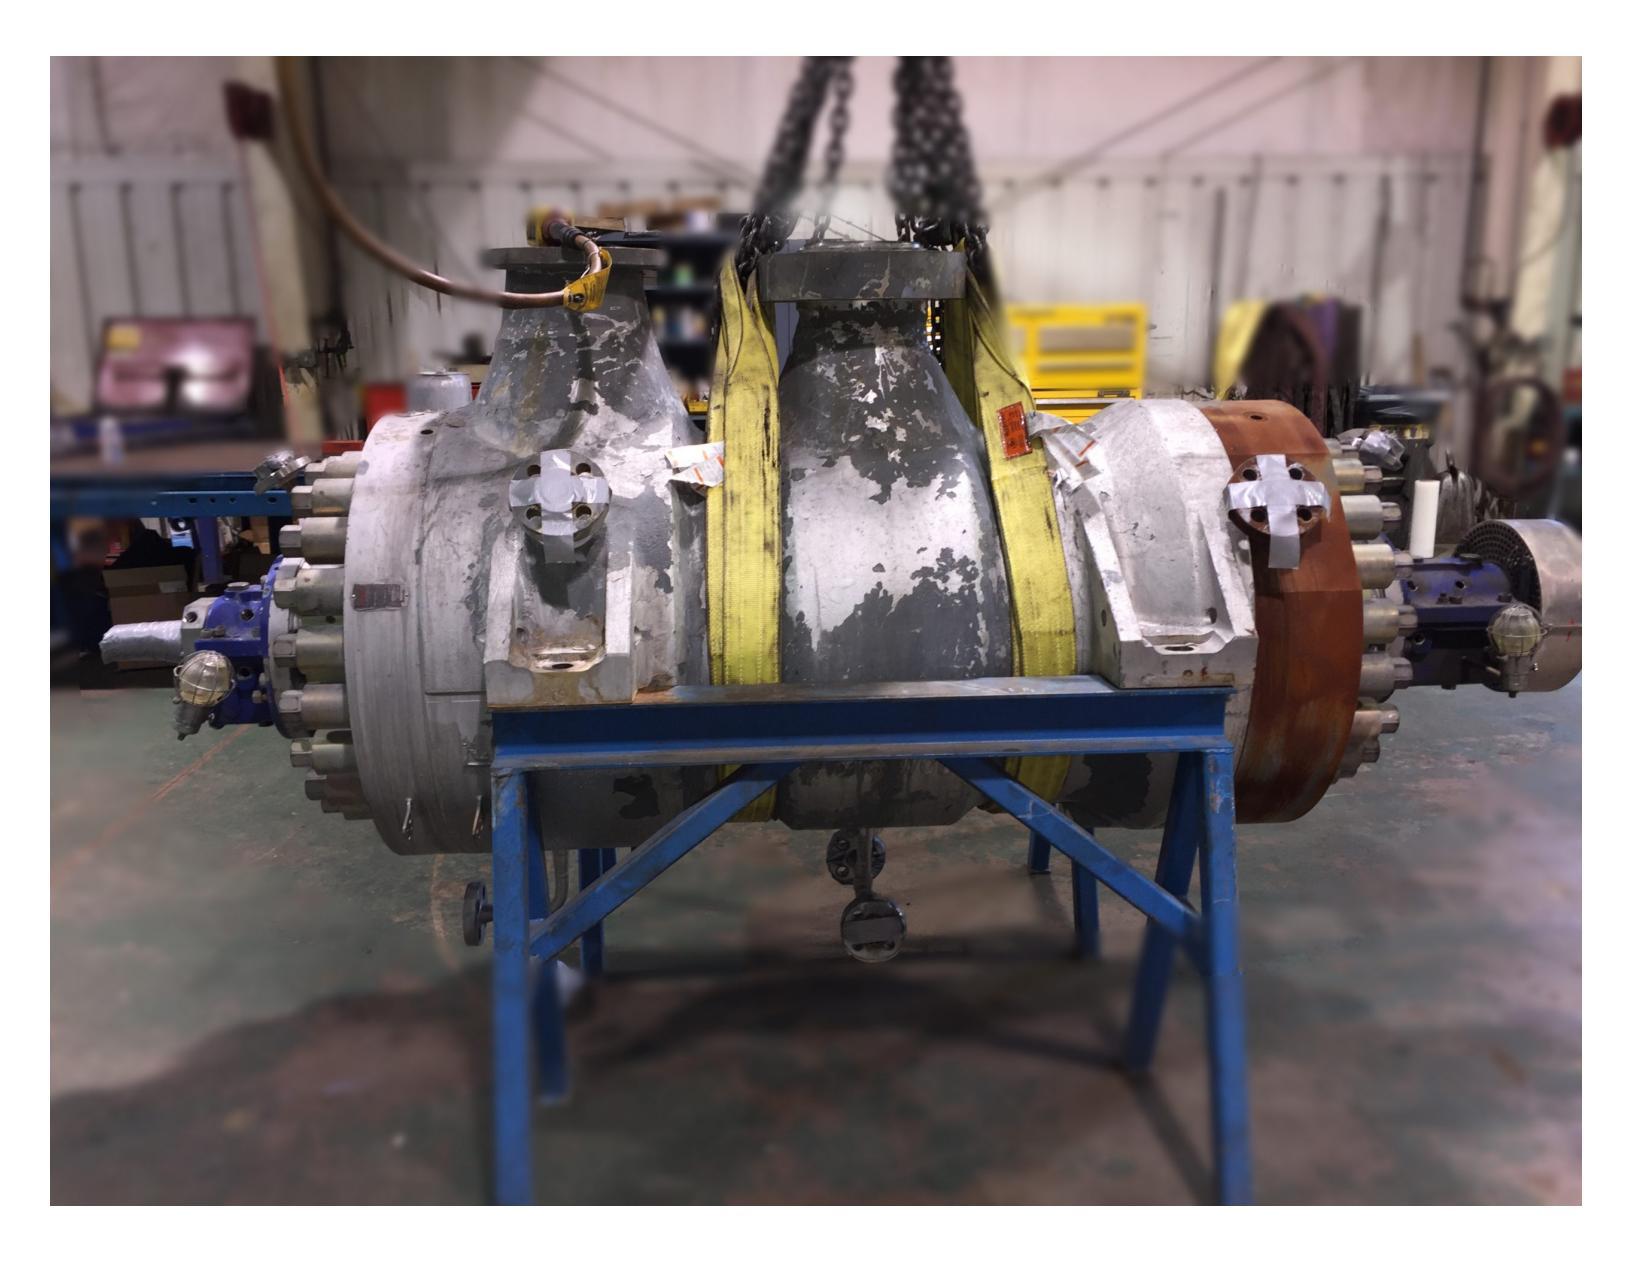
With this new information, the plant manager decided to proceed with the proposed forensic inspection plan. The service provider opted to have the pump sent to a service centre in Houston, Texas, US, for in-depth analysis and repair. The client agreed, and the entire unit, including the casing, was shipped for service (Figure 1).
