Full Refurbishment for Island Refinery

Decoking pump

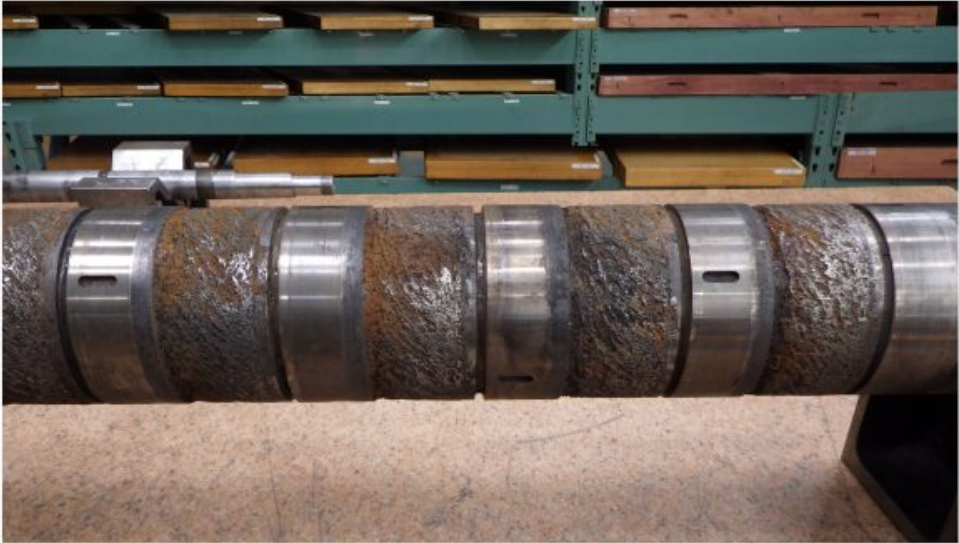
The pump is a high-energy barrel multi-stage pump that is used in a decoking operation. A delayed coker is a type of coker whose process consists of heating the residual oil feed to its thermal cracking temperature in a multi parallel pass furnace. This cracks the long-chain heavy carbon and hydrogen molecules of the residual oil into coker gas oil and pet coke. Cracking begins in the furnace, continues in the transfer line and finishes in the coke drum. The final product at the end of the process is coke.

For the decoker pump, coke fines and water mixed together to create a highly acidic layer on the element. The element itself was also very old and had already suffered significant wear and tear, including:

- The shafts which had major corrosion;
- The impellers had corrosion and cavitation damage;
- The pump cover/casing also had erosion damage;
- The bearing housings needed cleaning;
- The bearing housing discharge head needed modification;

If they had placed the pump into installation, it would have failed immediately upon start-up (Figure 1).

- The shafts were replaced by going forward with a 410 forging instead of a rolled shaft so that the denser structure would avoid sagging;
- Using Direct Laser Deposition (DLD) laser cladding, the impellers were reversed engineered and then welded in order to fix the damage;
- The bearing houses needed to be cleaned and checked for parallel, concentricity and perpendicularity. The bearing housings' discharge also had to be modified from the discharge

head by cutting the carbon steel off the back and inserting some 309 stainless steel to prevent corrosion;

- The barrel itself needed to be set up and machined to remove the corrosion from the high-velocity areas. A weld overlay 309L was also used through laser DLD;
- The areas around the ring have been modified so the pump can now run hard-on-hard through the rings;
- The covers of the pump were also reverse-engineered. The diffusers in the return channels were in very bad shape. Those areas were welded to improve their condition, but should the need arise, the files are available to create an emergency part for installation/repair.
