Engineering Pumps for
Better Performance and Longer Life

Full Refurbishment for Island Refinery

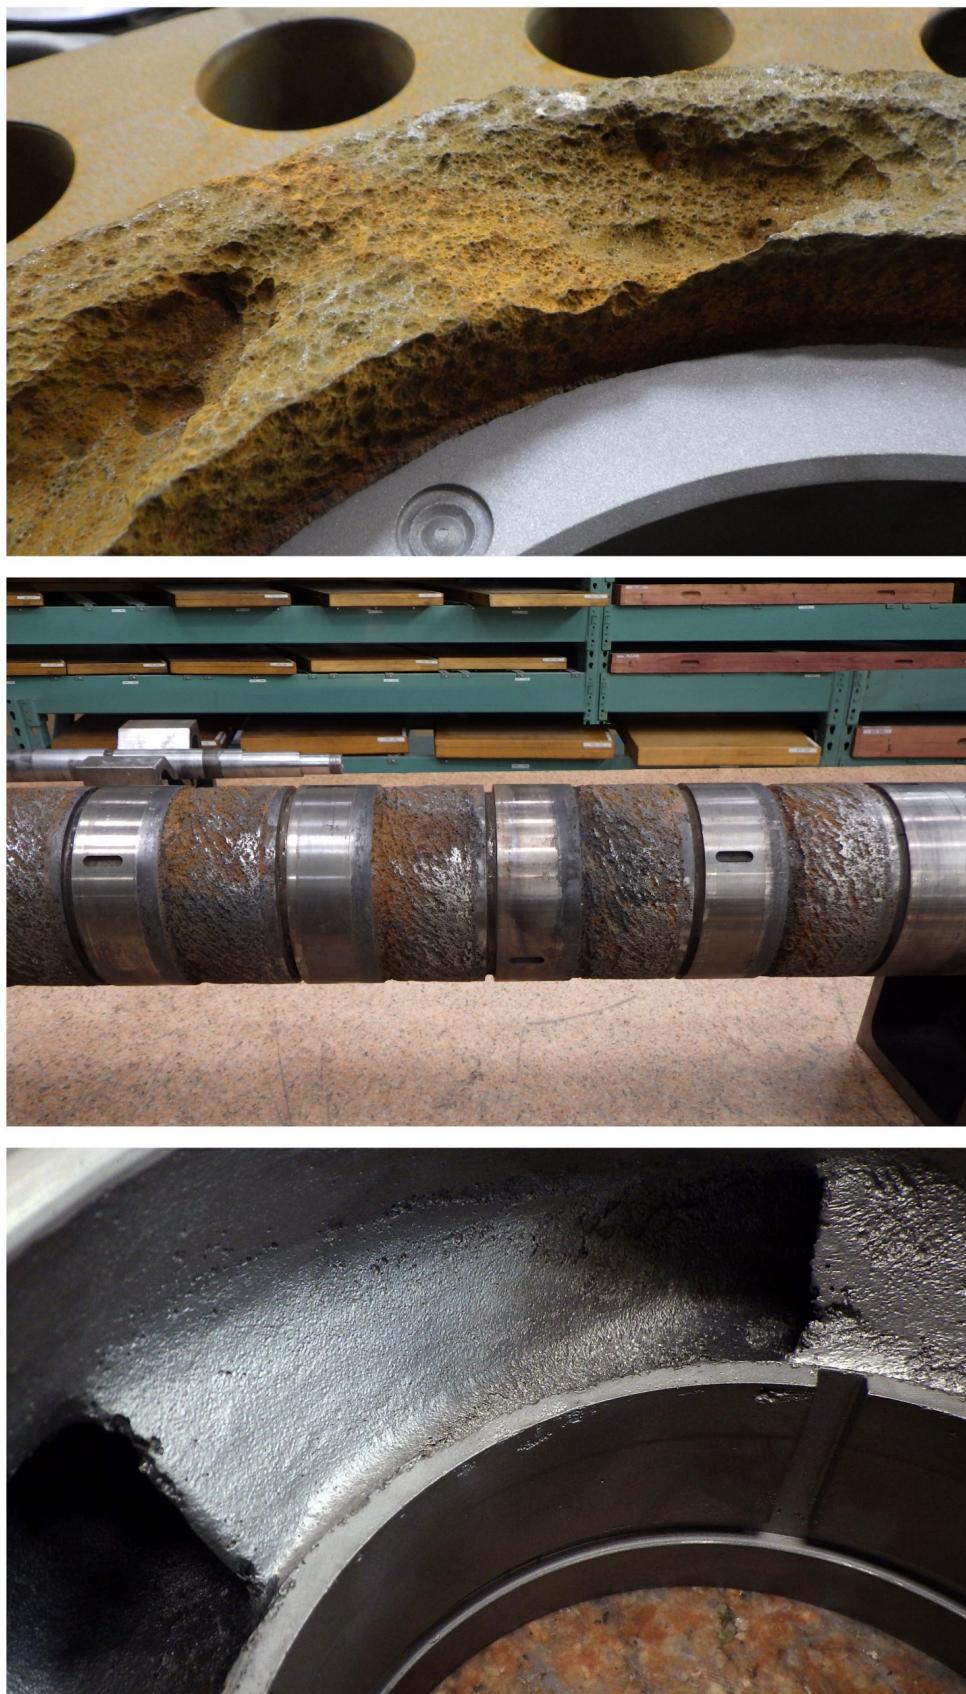
For the decoker pump, coke fines and water mixed together to create a highly acidic layer on the element. The element itself was also very old and had already suffered significant wear and tear, including:

- The shafts which had major corrosion;
- The impellers had corrosion and cavitation damage;
- The pump cover/casing also had erosion damage;
- The bearing housings needed cleaning;
- The bearing housing discharge head needed modification;

If they had placed the pump into installation, it would have failed immediately upon start-up (Figure 1).

- The shafts were replaced by going forward with a 410 forging instead of a rolled shaft so that the denser structure would avoid sagging;
- Using Direct Laser Deposition (DLD) laser cladding, the impellers were reversed engineered and then welded in order to fix the damage;
- The bearing houses needed to be cleaned and checked for parallel, concentricity and perpendicularity. The bearing housings' discharge also had to be modified from the discharge

head by cutting the carbon steel off the back and inserting some 309 stainless steel to prevent corrosion;

- The barrel itself needed to be set up and machined to remove the corrosion from the high-velocity areas. A weld overlay 309L was also used through laser DLD;
- The areas around the ring have been modified so the pump can now run hard-on-hard through the rings;
- The covers of the pump were also reverse-engineered. The diffusers in the return channels were in very bad shape. Those areas were welded to improve their condition, but should the need arise, the files are available to create an emergency part for installation/repair.
