## Re-engineering System Reliability

A US fertilizer plant was experiencing recurring reliability problems with its horizontal multistage boiler feed pumps. The series of repeat failures motivated the owner plant to consult with a widely-known unbiased aftermarket pump service provider. Previous experience with this company's Texas facility gave the plant confidence that they had the capability to troubleshoot the problem and provide a solution. This type of supplier has been classified as a "CPRS"— Competent Pump Repair Shop, because their worldwide affiliates are staffed by specialists who have the fullest support of pump engineers at the company headquarters.

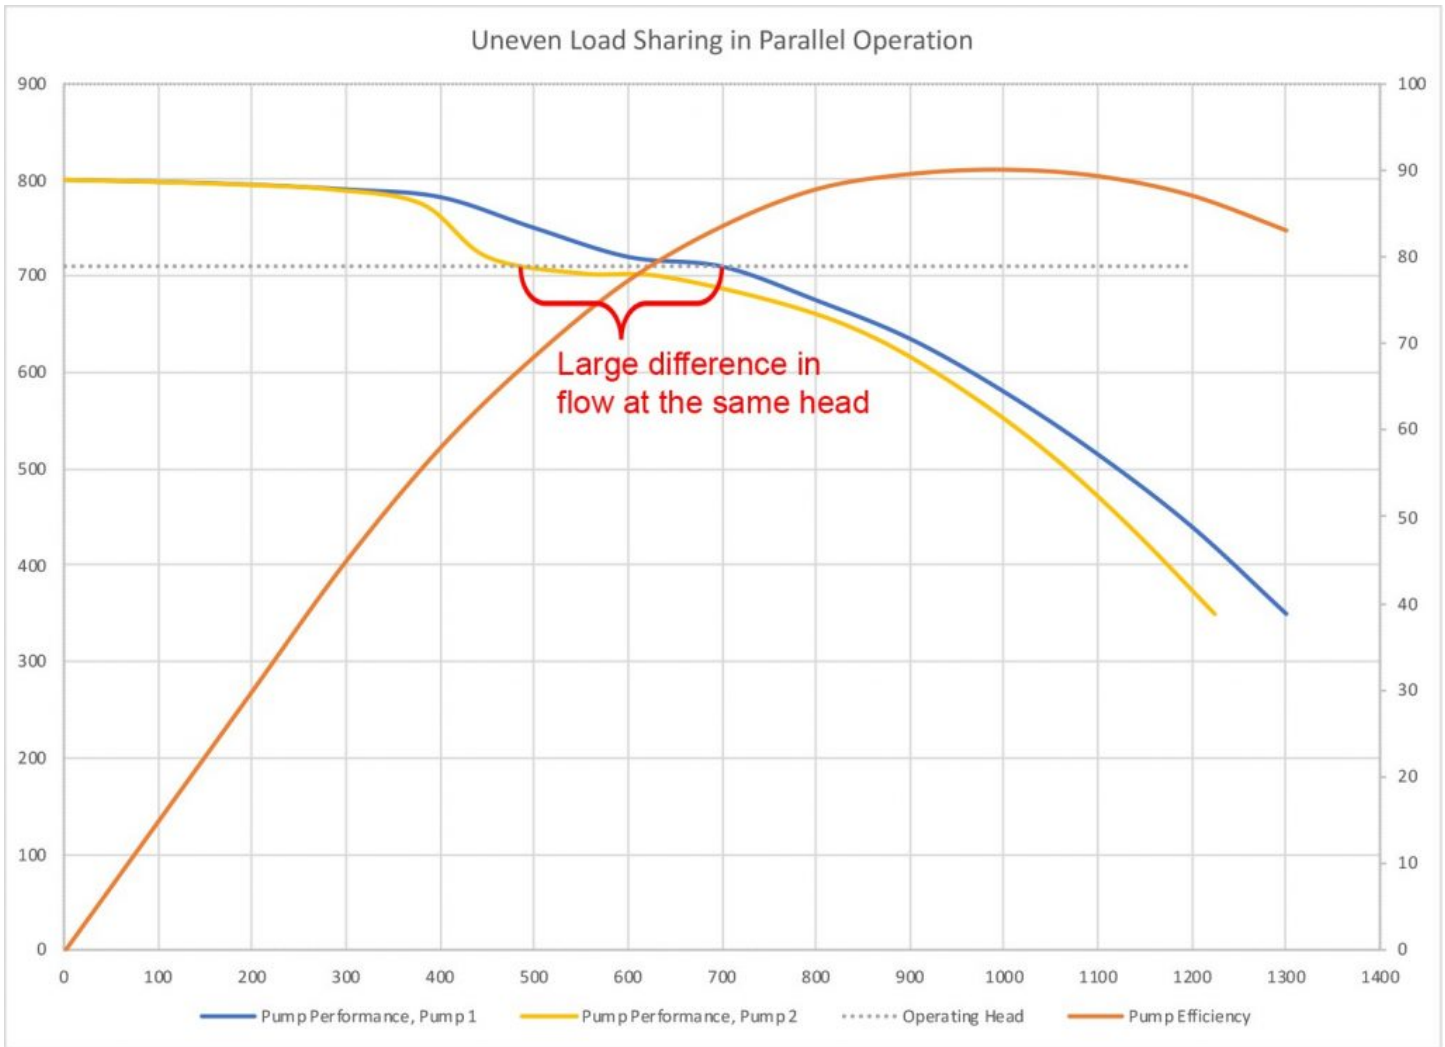
When uneven load sharing occurs between the two pumps, the weaker pump is forced to operate even further back on its performance curve. As shown in Figure 5, the flattening of the performance curve in the 50-80% operating range can worsen this divergence.
