Engineering Pumps for
Better Performance and Longer Life

Unearthing the Root Cause of Vibration Issues

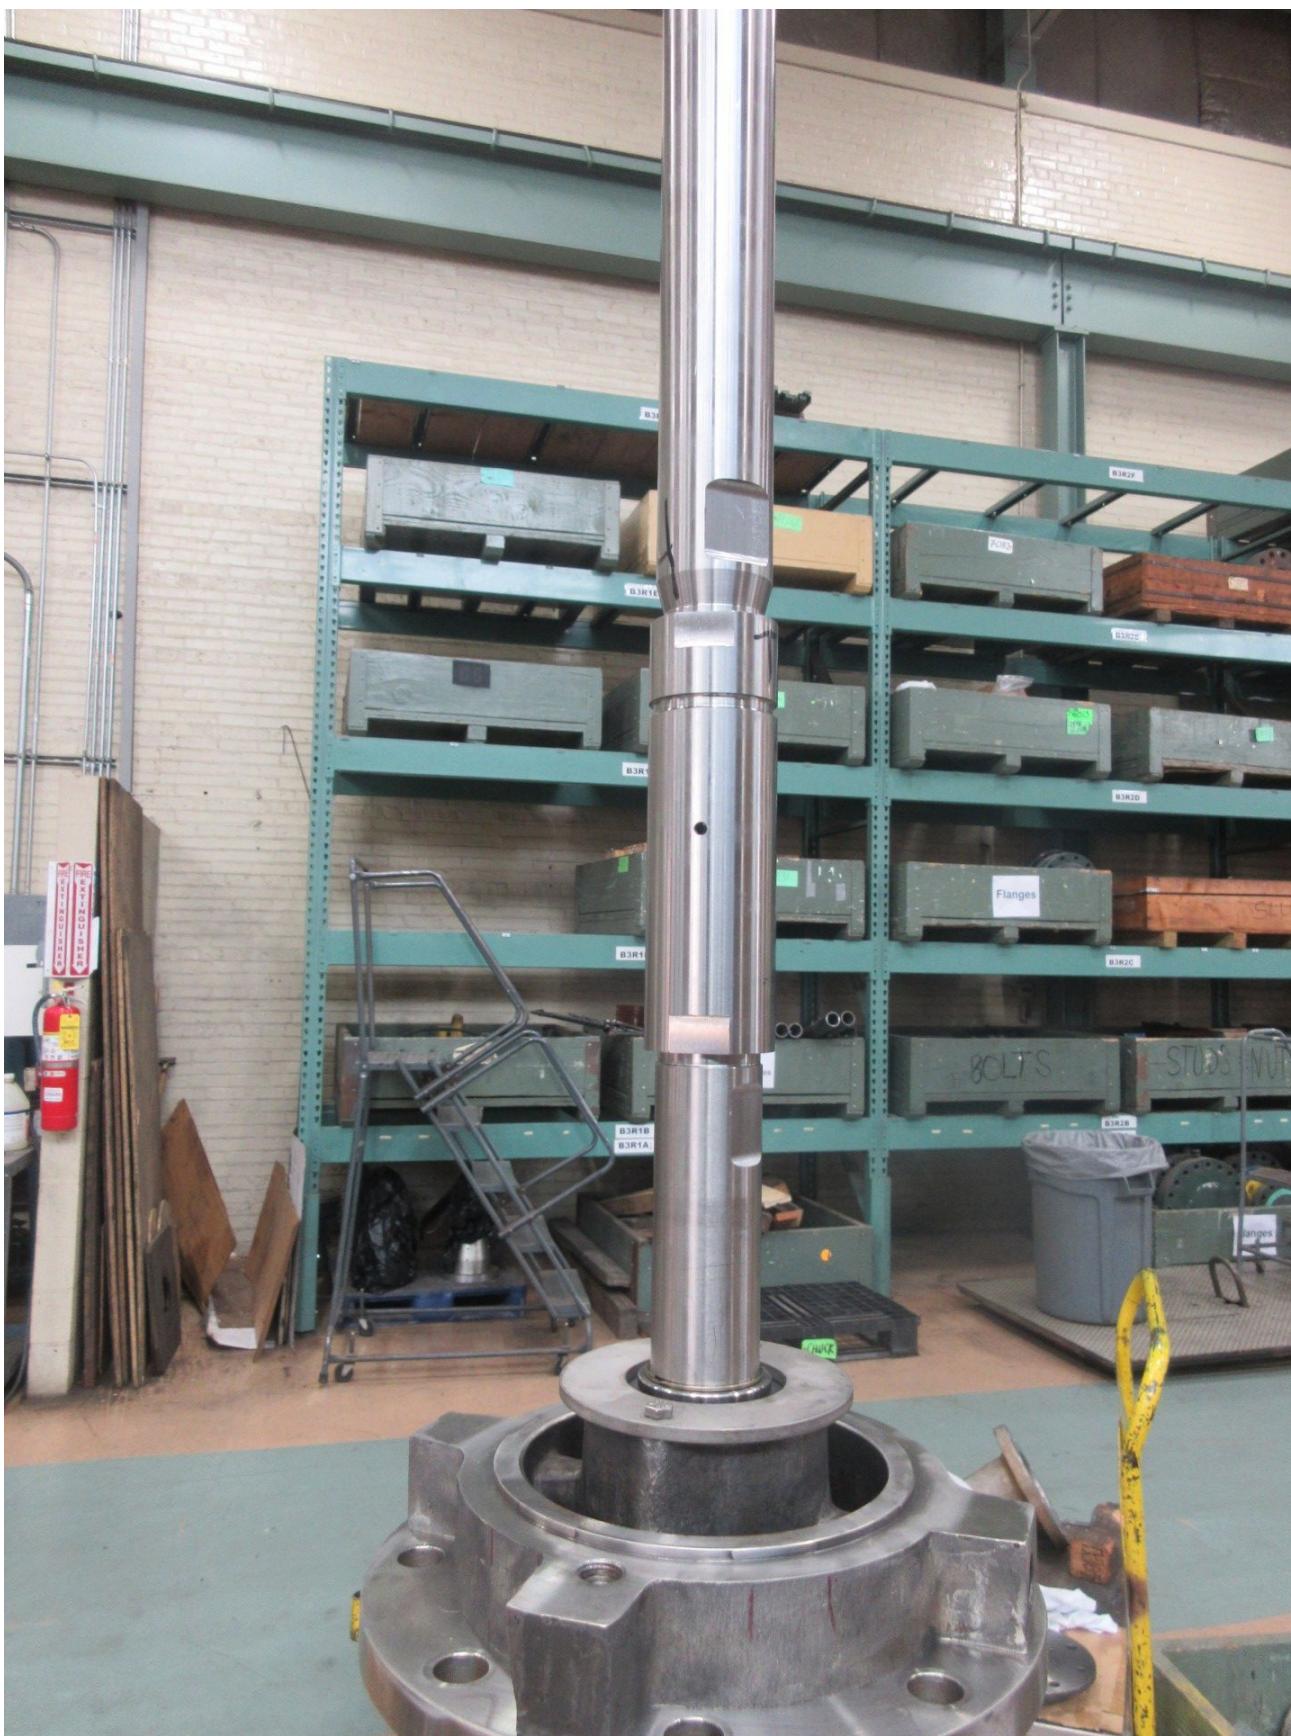
- The UAN Solution pumps are a single stage VS4 vertically suspended pump design and are installed in a process condensate tank. The pump is submerged in the UAN solution and takes suction through an axial suction nozzle equipped with a suction strainer.

The pump has a radial discharge nozzle located at the impeller centerline; this discharge continues through an elbow to a length of vertical pipe that exits the process condensate tank.

Above the impeller, a series of column pipes and lineshafts connect the hydraulic assembly to the motor assembly located on the tank top flange. The lineshafts are supported by three guide bushings located in column spiders.

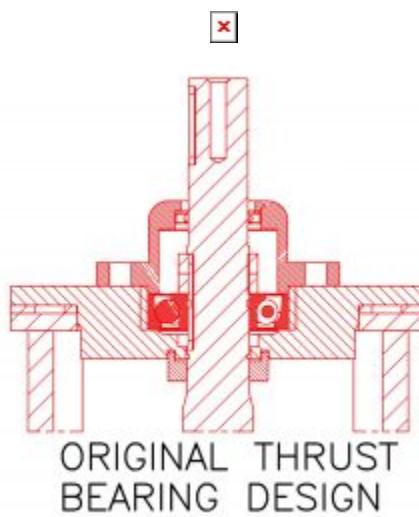
The aftermarket pump service provider used its engineering team to redesign the pump and remove the design flaws that caused high vibration, accelerated wear, and poor reliability.

In addition to refurbishing or replacing the damaged parts and providing a new mechanical seal, five major changes were implemented:

- The single row angular contact motor thrust bearing was replaced by a double-row deep groove ball bearing
- The lineshaft coupling location was moved to above the guide bushing area. Shaft sleeves were manufactured and installed to run against the bushing bore
- All bushings were designed to have a spiral groove that would help flush any particulate still present in the lubricating flush out of the bushing bore
- Component tolerances were significantly tightened to ensure better centerline compatibility of stationary parts and to reduce the probability of misalignment

replace the angular contact bearing is able to handle axial loads in either direction and will not be at risk of unseating due to axial upthrust. This bearing design will also protect the mechanical seal by restricting rotor axial movement in both directions. In order to accommodate the new bearing, the bearing housing was modified.
