## An Engineered Battle Against Cavitation

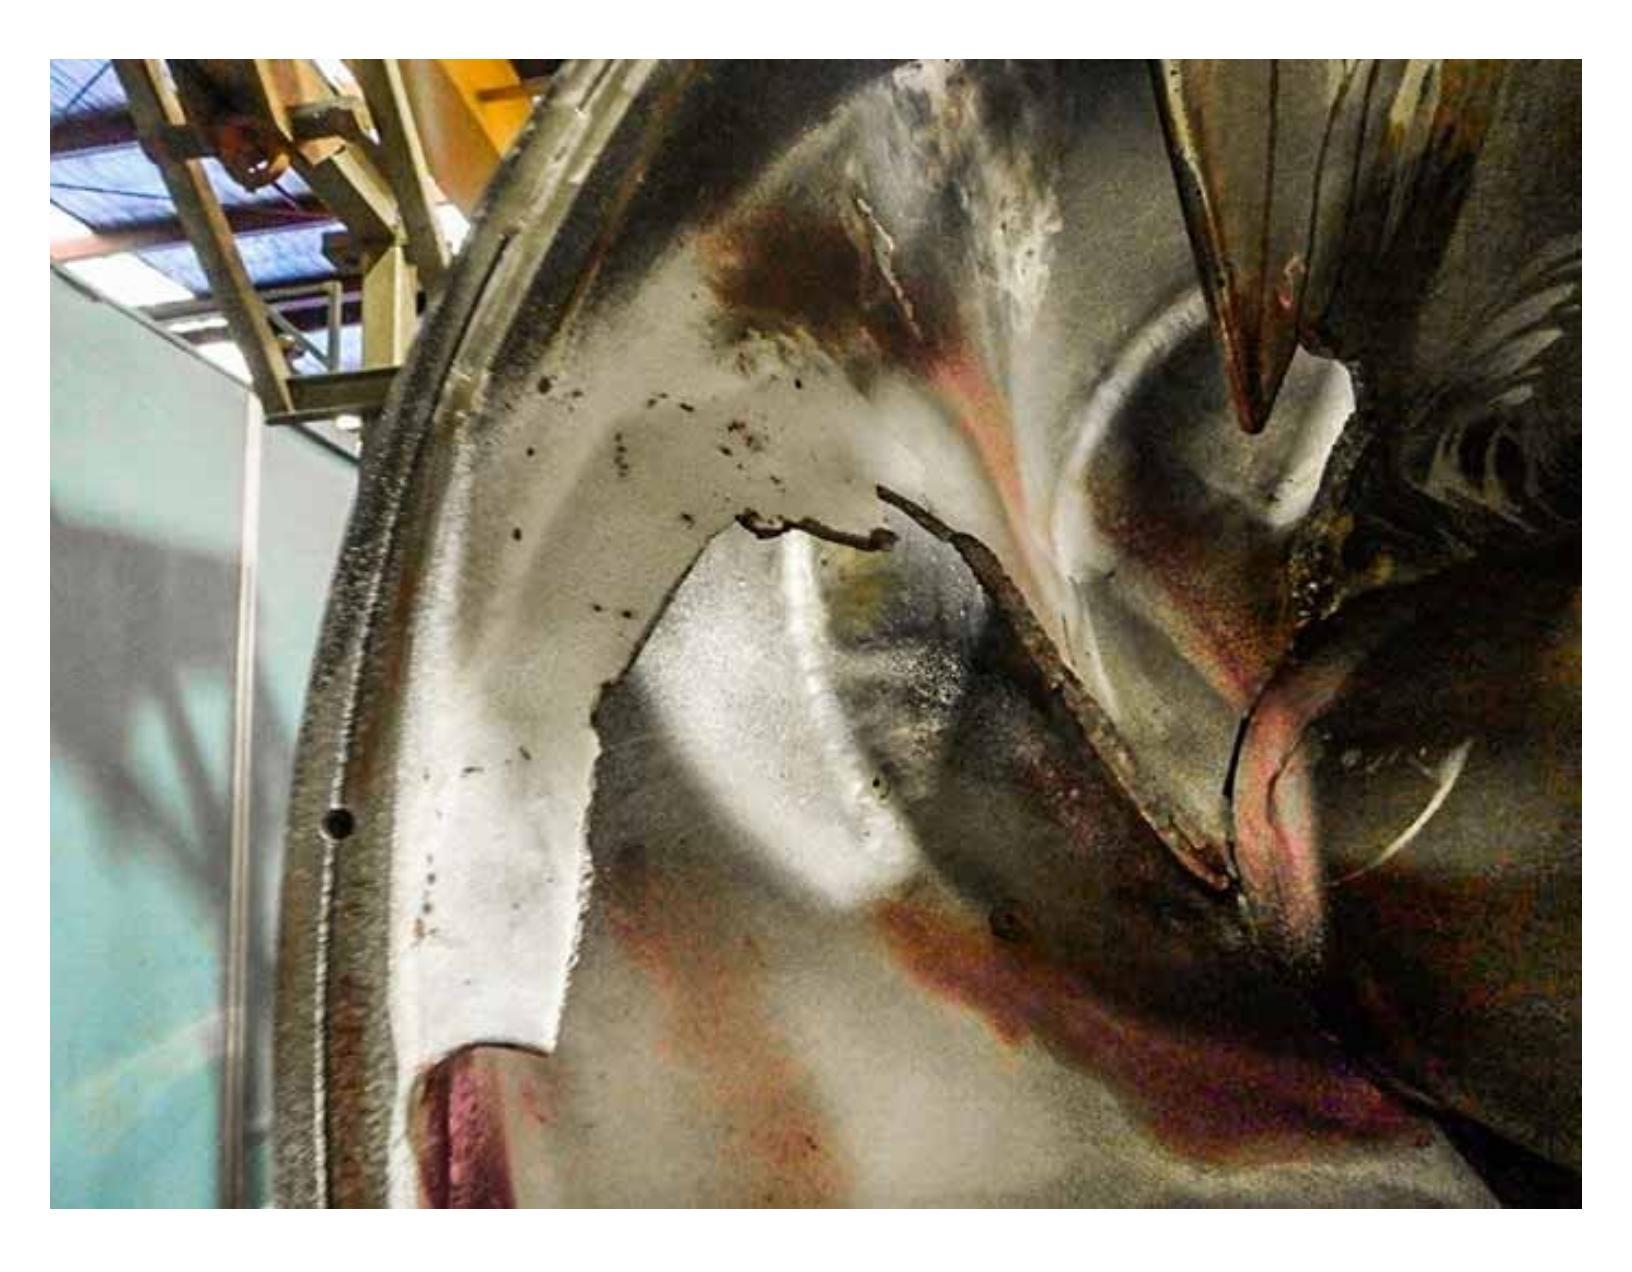
The results of the forensic analysis showed that the impeller blades were suffering cavitation to the low-pressure side of the vanes. Additionally, the cavitation and cracked vanes toward the eye also indicated that the sizing of the inlet and its associated blade angles may be active factors in the repeated failures.
