Root Cause Analysis Uncovers Casting Defects

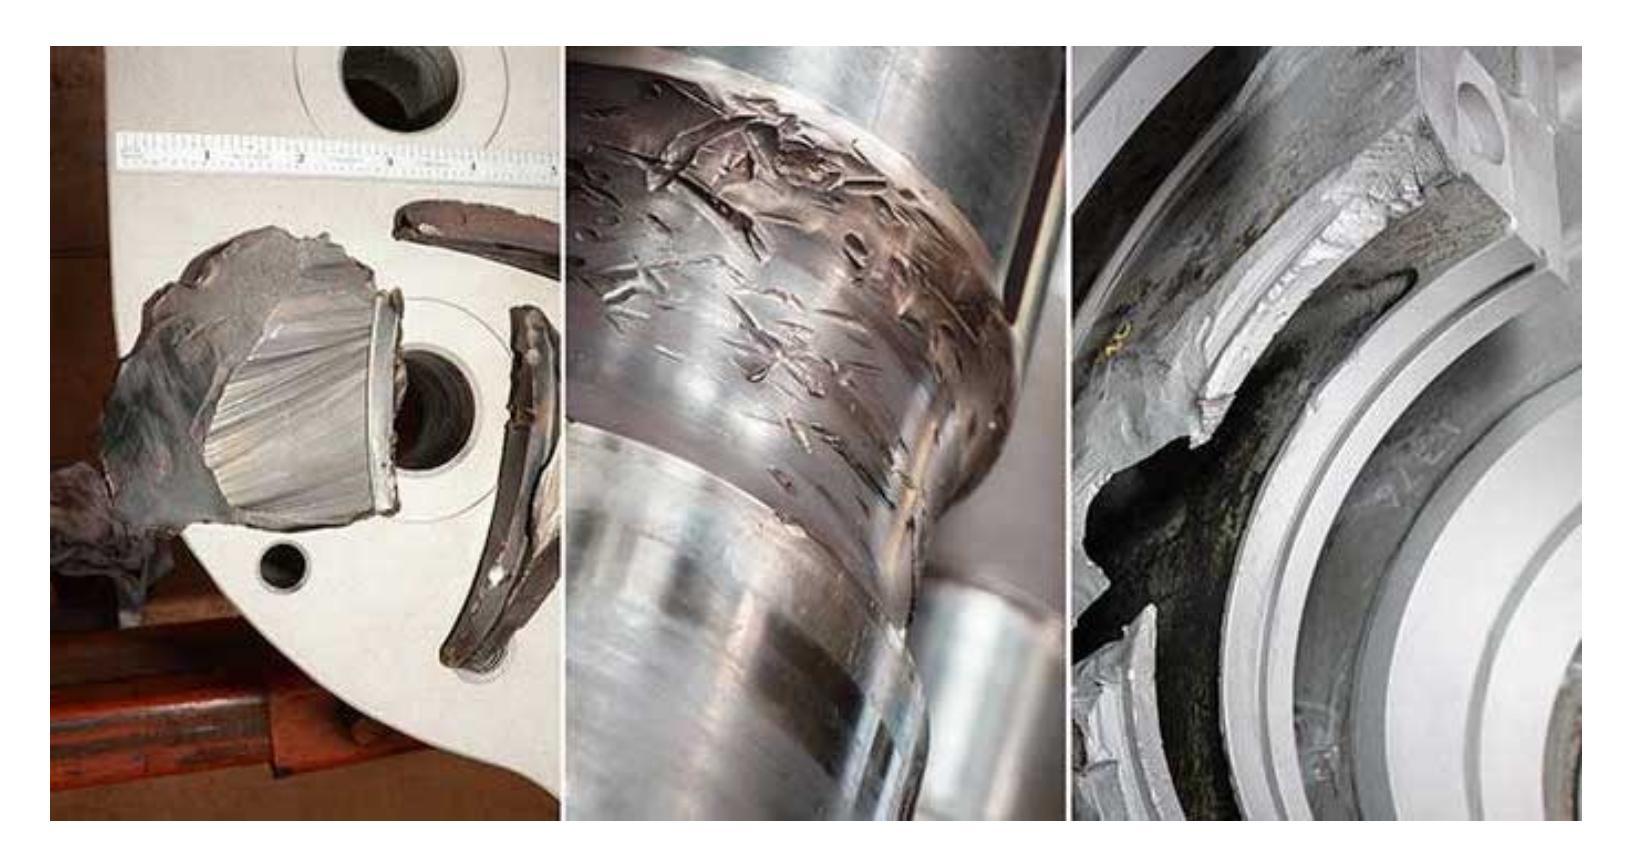
Efficiency and reliability are at the forefront of a successful pumping system. As such, unplanned outages can be a detrimental disturbance to the overall operation. In this case, the end user's high pressure multistage BB5 barrel pump was experiencing severe vibration, unstable performance, and failure in the field leading to unit shutdown.

Previously, the pump had been running for six months before experiencing catastrophic failure, requiring a shutdown and removal for further analysis. Initially, the unit's damaged components were repaired by welding, and the volute was reassembled and installed for use. Upon its installation, the power plant placed the unit back into service but encountered a second emergency shutdown after two months in operation.
