## Fertilizer Focus: Volute Reprofiling Resolves Vane Pass Vibration

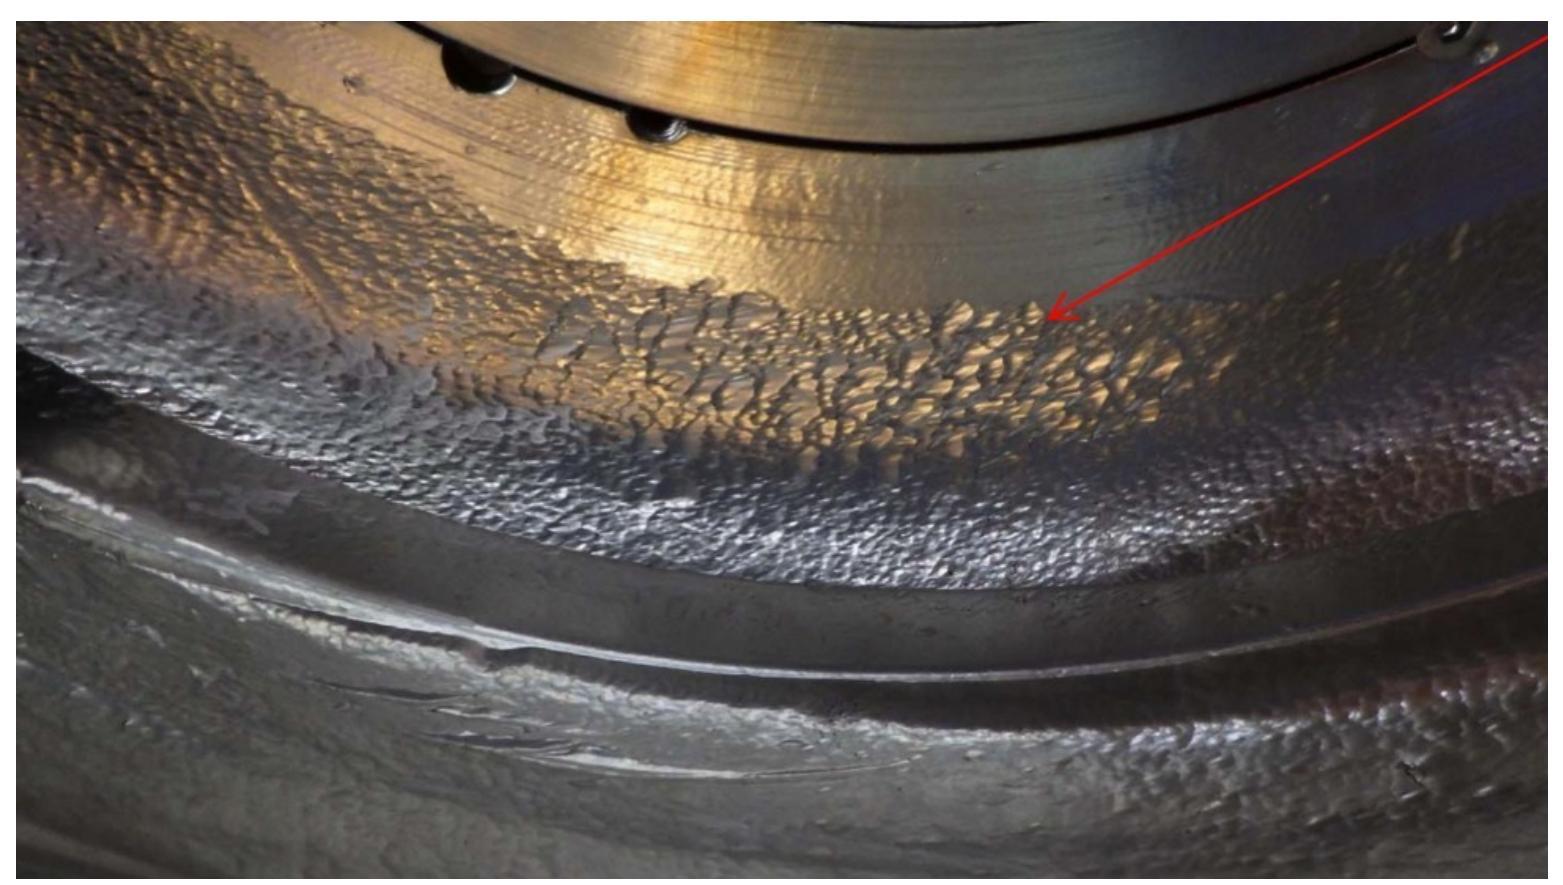
When the vibration and performance indicated that it was time to take the pump out of service for refurbishment, it was sent to <u>Hydro's Chicago service center</u> for inspection and analysis. The inspection showed significant damage caused by component contact and erosion.

After reviewing the inspection data, an engineering analysis was completed on the design to determine what could be done to eliminate the vibration. The engineering team determined that the vane pass vibration was related to shock waves caused by the high energy fluid impacting the volute lip. This was intensified in the first stage, where the 4-vane impeller was discharging into a dual volute. The volute lip was reprofiled to reduce this impact and provide a smoother transition from the impeller exit into the volute passage.

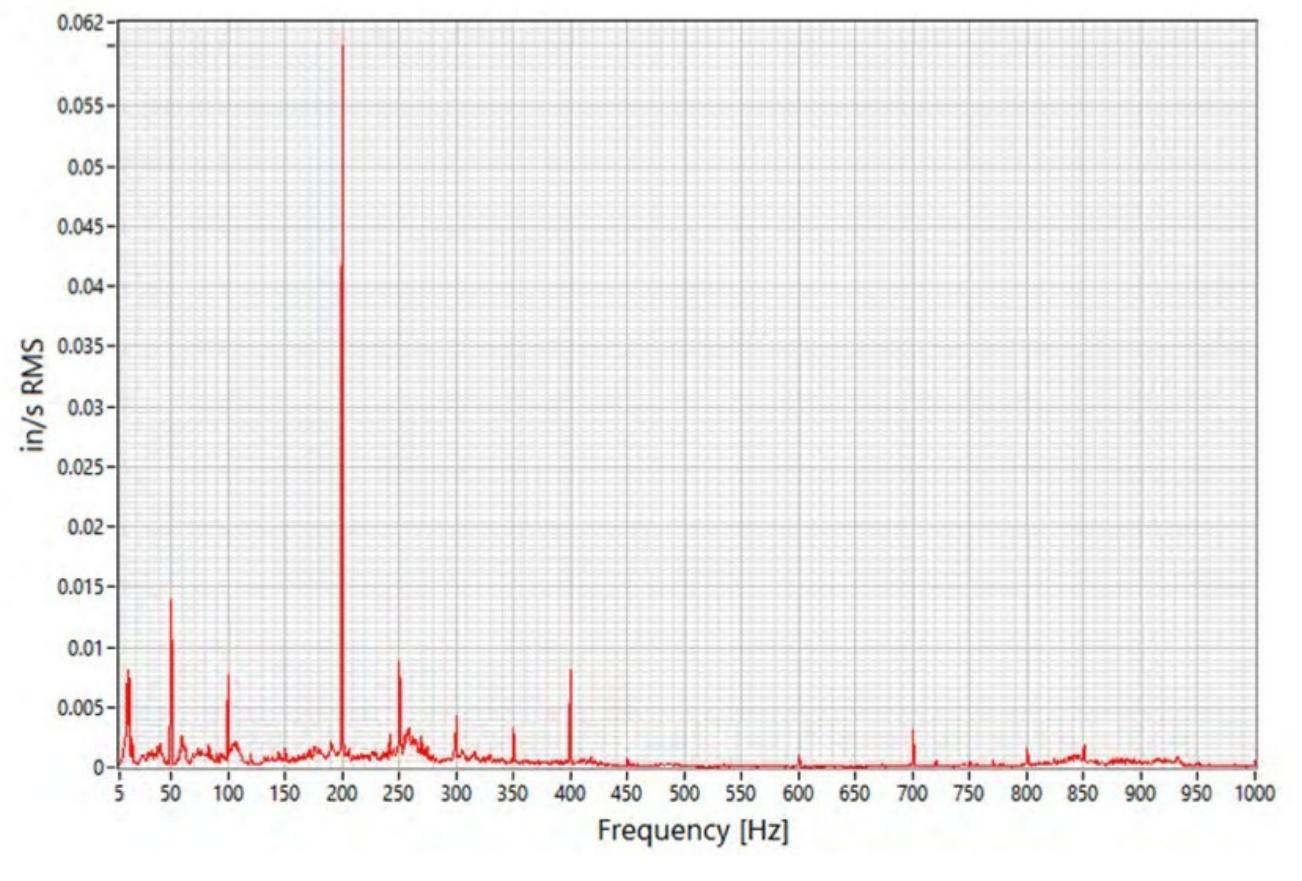
1. Reduced Vane Pass Vibration Observed During Testing

The upgraded design was tested in <u>Hydro's performance test lab</u>. This gave the end user confidence that the hydraulic performance of the pump had not been negatively affected by the volute lip geometry modification. It also verified that the vibration amplitudes had been reduced. After successful testing, the modified pump was returned to the field, where it continues to run smoothly.
