Upgrades Maximize Efficiency of 82-Year-Old Pump

Publisher: Pumps & Systems / August, 2012

Engineered Modifications and Upgrades for an IR 24 HV Cooling Water Pump

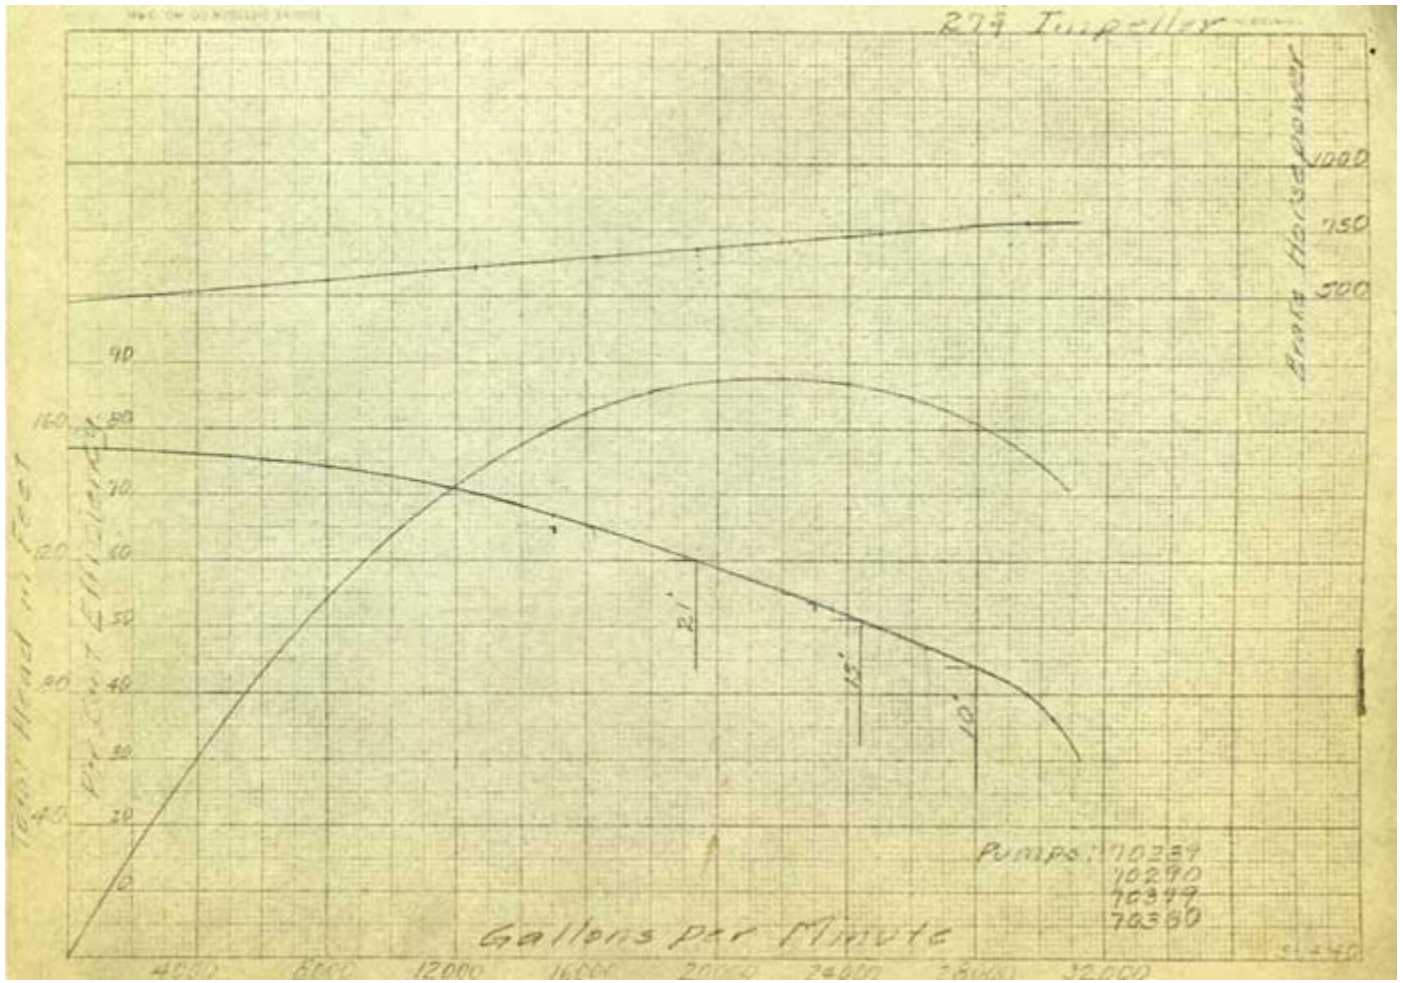
Positioned on the shores of Lake Michigan are two stations that contain cooling water pumps which feed cooling water to BP's Whiting Refinery. The #1 water station contains four IR 24 HV pumps, which are large, single-stage, double-suction, horizontal split case pumps. Four pumps in station #1 (P-11, P-12, P-13, and P-14 in the photo below) are unique in that they were designed with a bottom-suction configuration.

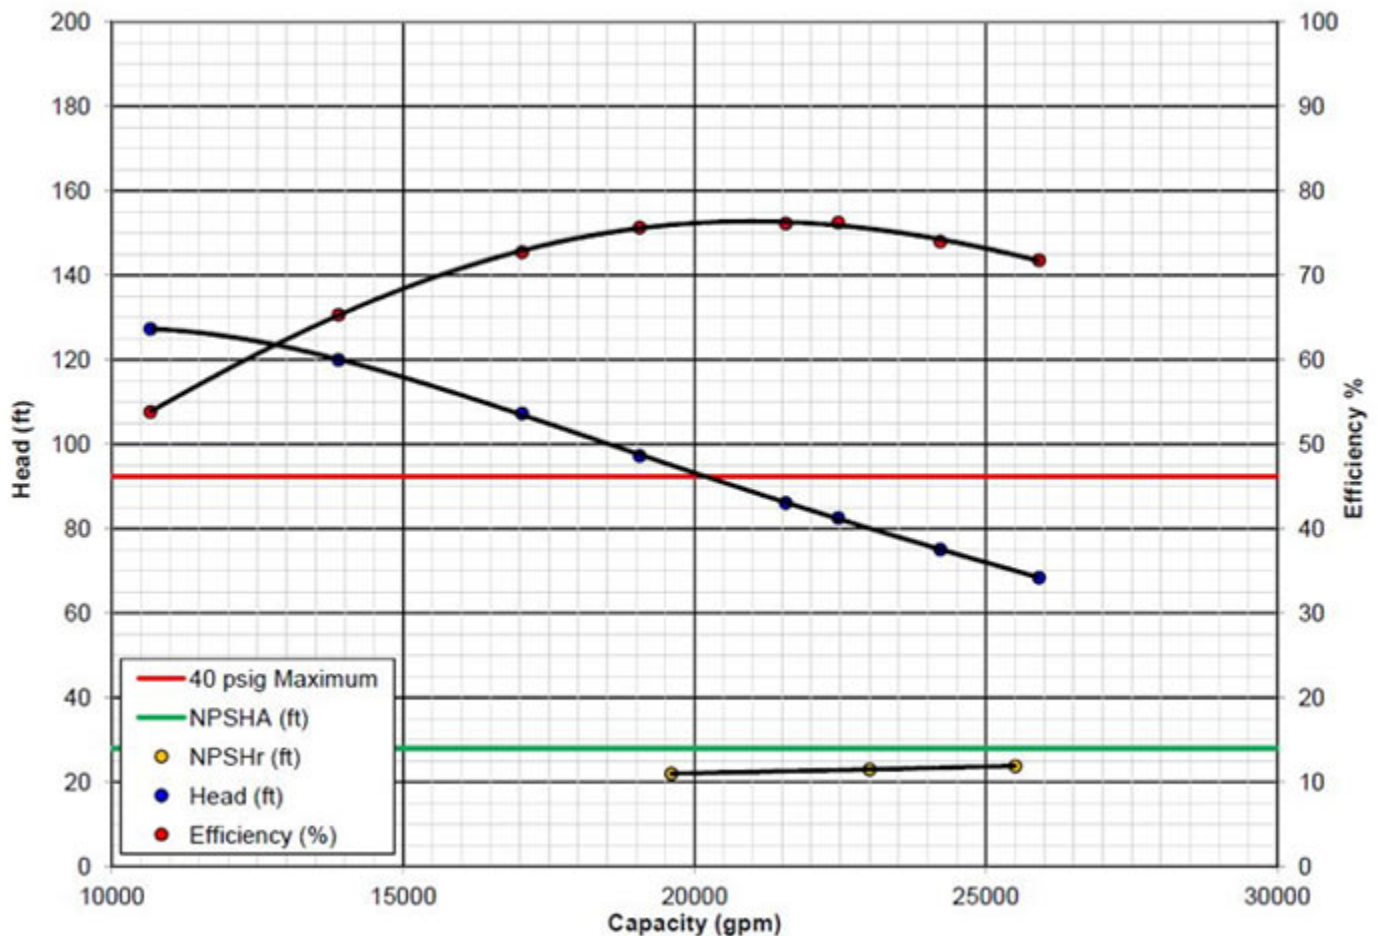
The tests showed that the pump can be operated to the right of BEP and still stay within net positive suction head available (NPSHa). The data indicates that one pump operating at a higher capacity can eliminate the need for three pumps operating at reduced capacity. These findings suggest significant potential energy savings for the refinery and may enable BP Whiting to run just one of these pumps in each water station during the winter months and two pumps in each water station during the summer months. "The performance testing we did went a long way toward allowing us to shut down unnecessary water pumps, and the modifications we made to this pump will allow us to run it more reliably," confirms Bill Rademacher, one of the Rotating Equipment Engineers who helped lead the
