## Hydro South Tests Nuclear Power Vertical Condensate Pump at Test Lab

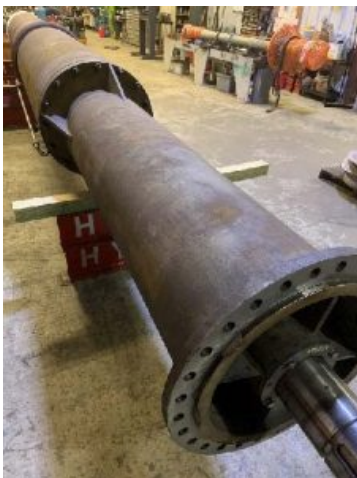
Hydro's Performance Test Lab is equipped with state-of-the-art instruments for testing and has an extensive quality assurance program to support the nuclear industry. The Test Lab provided testing services for the Condensate bowl assembly with its in-house discharge head and motor. This method results in less set-up time and piping fabrication but still assures the integrity of the test.

The Test Lab's Siemens Variable Frequency Drive allows testing to be performed at different speeds. A torque meter is used to ensure that the mechanical power and efficiency results are not compromised by the reduced speed test. In the case of the Condensate pump, motor limitations required testing at a lower speed; the results were corrected using the Affinity Laws.

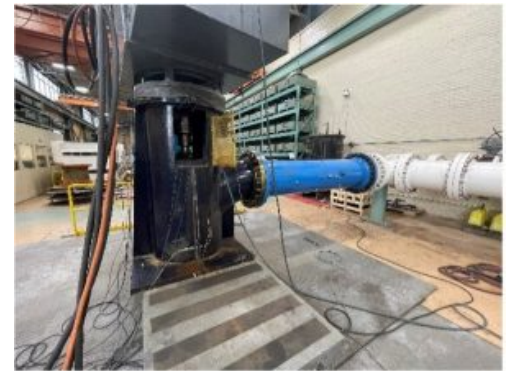
The performance test confirmed that the rated condition passed the 1B acceptance grade defined by the Hydraulic Institute. The efficiency results showed that the pump will operate close to the best efficiency point, which can reduce the energy cost and increase the time between overhauls.

Furthermore, the pump is driven by a 4000 HP motor, so it's critical that the mechanical HP doesn't exceed this value over the full operating range from shut off to runout. The performance curve confirmed that the power required for the operating range remains below 4000 HP. With extensive knowledge of repairing pumps and in-house testing capability, Hydro was able to provide a quick turnaround for the overhaul of a complicated vertical pump and verify that it meets the requirements for operating in the field.
