Headbox Feed Casing Refurbishment

Application: Headbox Feed

Pump Details: Single-stage Sulzer ZPP 800

Pump Type: Double-suction Horizontal Split Case

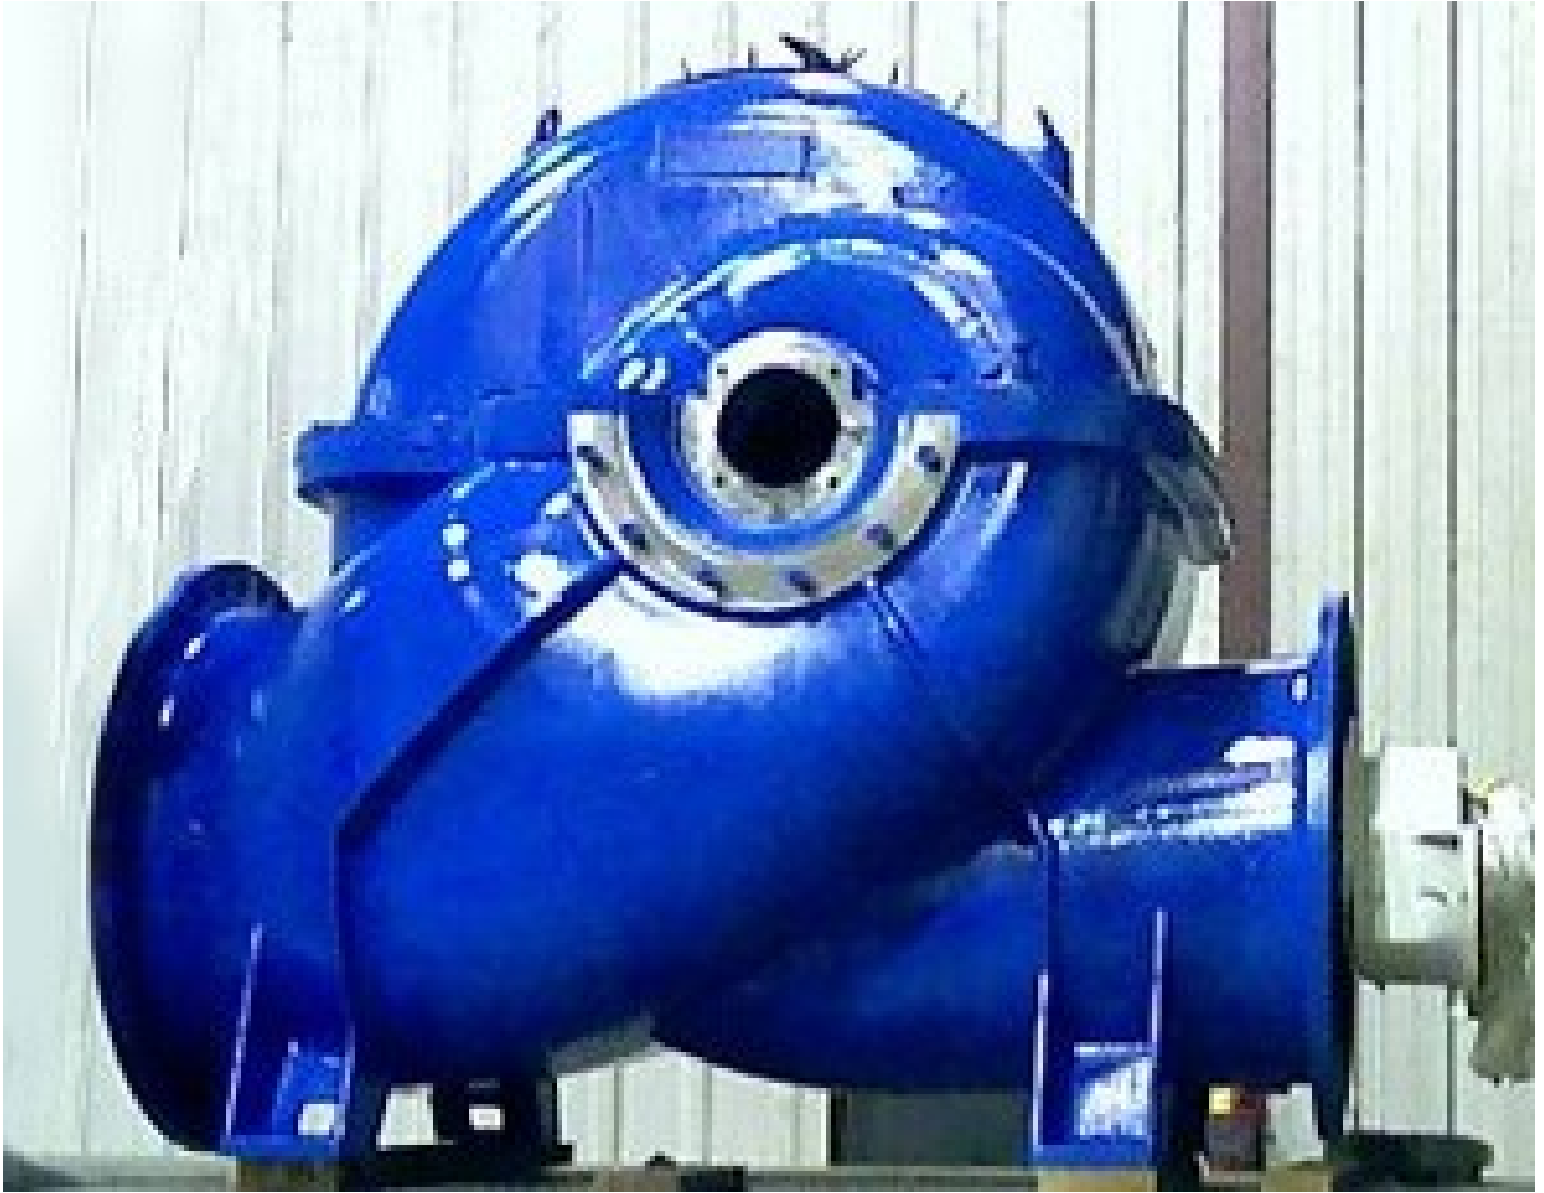
To avoid a temporary shut down of the mill, Hydro was able to perform a line bore and insert upgrade within a period of three days. Utilizing around-the-clock shifts, Hydro completed the case inspection and developed machining fits and tolerances to restore the casing to its original specifications. Hydro then manufactured and mounted inserts to the casing.

Not only were the casing and wear components restored to their original fits, the upgraded materials will significantly improve mean-time-between-repair.
