## Hydro South Tests Nuclear Power Vertical Condensate Pump at Test Lab

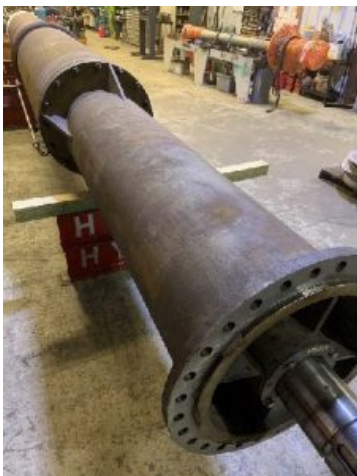
Hydro's Performance Test Lab is equipped with state-of-the-art instruments for testing and has an extensive quality assurance program to support the nuclear industry. The Test Lab provided testing services for the Condensate bowl assembly with its in-house discharge head and motor. This method results in less set-up time and piping fabrication but still assures the integrity of the test.

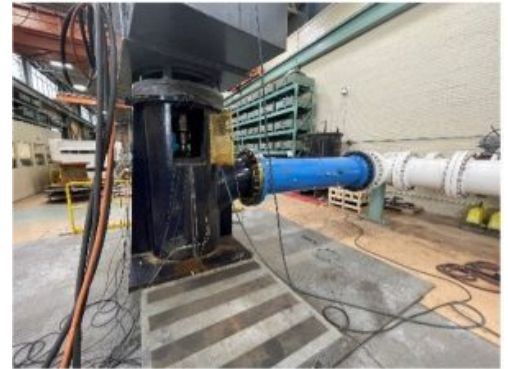
The performance test confirmed that the rated condition passed the 1B acceptance grade defined by the Hydraulic Institute. The efficiency results showed that the pump will operate close to the best efficiency point, which can reduce the energy cost and increase the time between overhauls.

Furthermore, the pump is driven by a 4000 HP motor, so it's critical that the mechanical HP doesn't exceed this value over the full operating range from shut off to runout. The performance curve confirmed that the power required for the operating range remains below 4000 HP. With extensive knowledge of repairing pumps and in-house testing capability, Hydro was able to provide a quick turnaround for the overhaul of a complicated vertical pump and verify that it meets the requirements for operating in the field.
