Improving Pump Efficiency to Save Energy and Increase Generating Capacity

Ross Bertoli, Hydro Australia, and Mark Moerke, International Power Hazelwood

Pumps & Systems

August, 2009

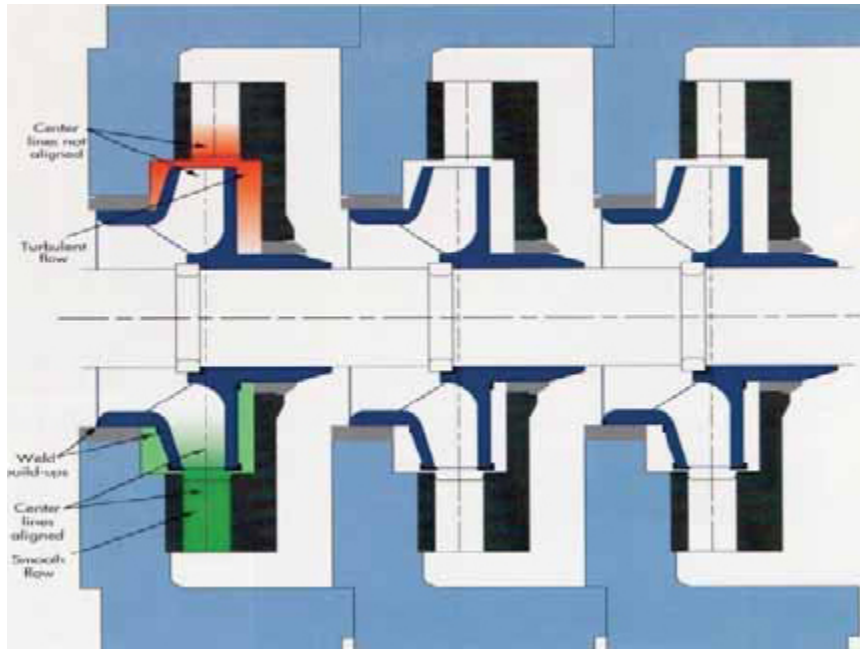
Rotor Centralization was performed to improve pump efficiency

The center performed rotor centralization, which involves the centering of the rotating hydraulic components (impellers) within the stationary hydraulic components (in this case, the diffusers) to optimize pump efficiency. Pump efficiency is improved because a rotor with aligned hydraulic components is less likely to experience turbulence and heat rise in the fluid as it exits the impeller and enters the diffuser. This also helps in reducing the overall vibration signature. The service center performed a detailed dimensional analysis, using a computerized coordinate measuring machine, to take numerous dimensions of each hydraulic component at every stage to ensure centerline compatibility.

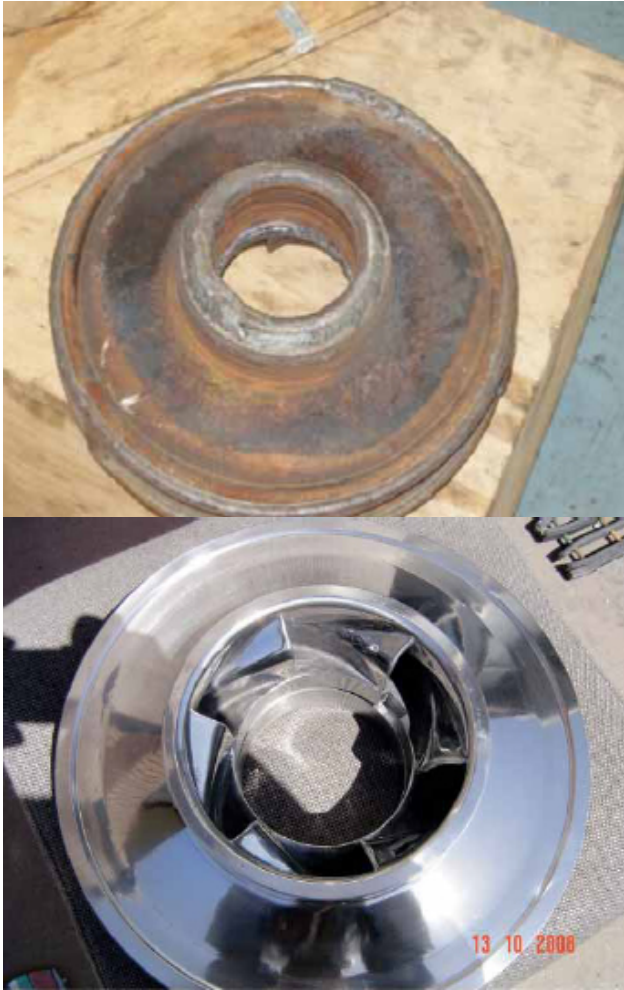
The impellers were completely re-welded and polished (before, top, and after, bottom)

The service center reduced the A-Gap and corrected the overlap to improve flow through the pump and reduce recirculation. However, to perform the A-Gap modification, the impellers needed to be completely re-welded, stress relieved and re-machined. After the welding and machining was completed, all the waterways on the diffusers and impellers were highly polished to reduce friction and gain as many efficiency points as possible.
