# Collaboration and Innovation Result in Efficient Outage

**Publisher:** Nuclear News / September, 2013

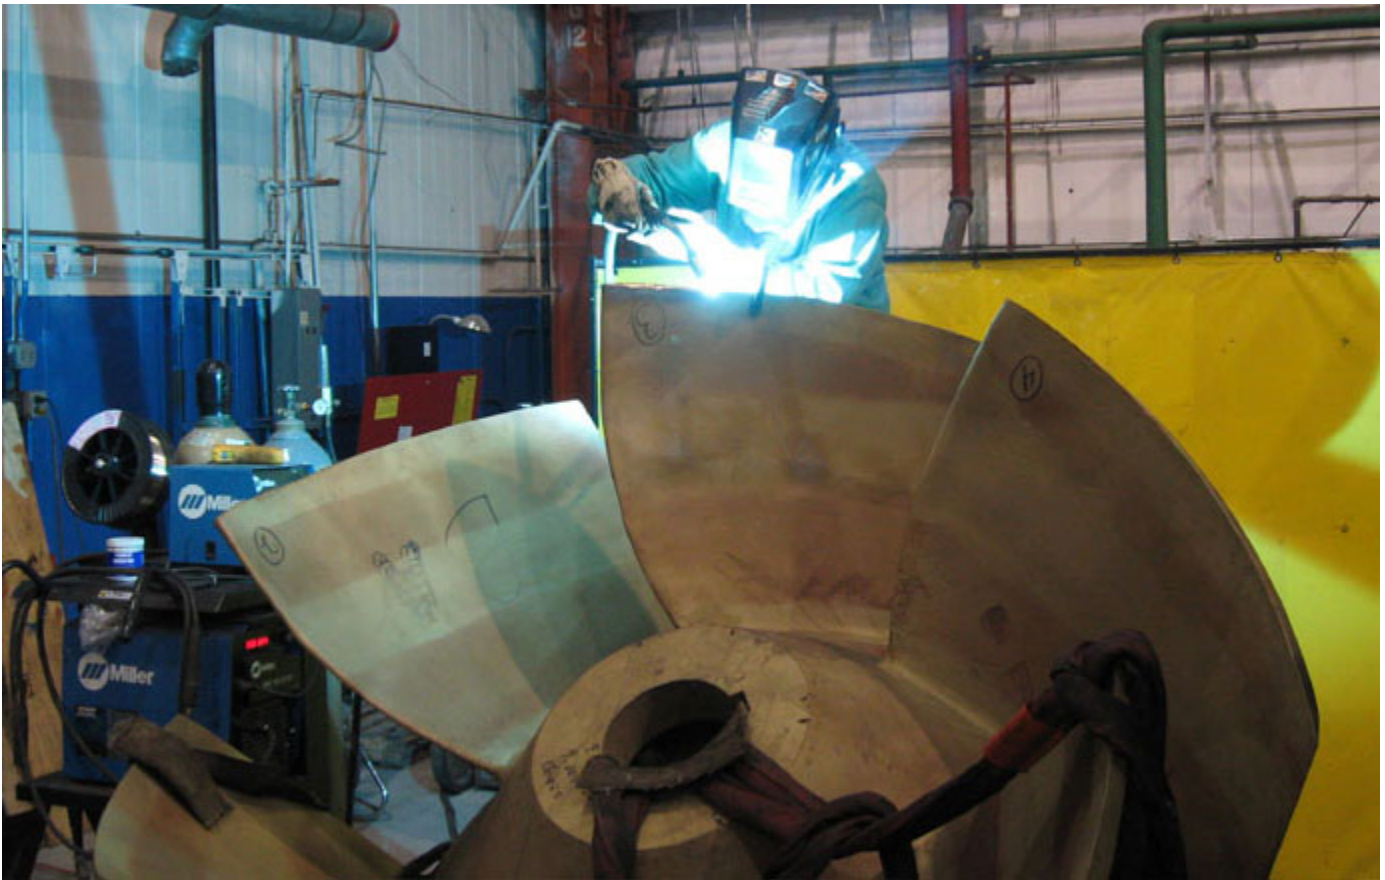
**A Hydro East welder repairs the impeller of a Foster Wheeler circulating water pump.**

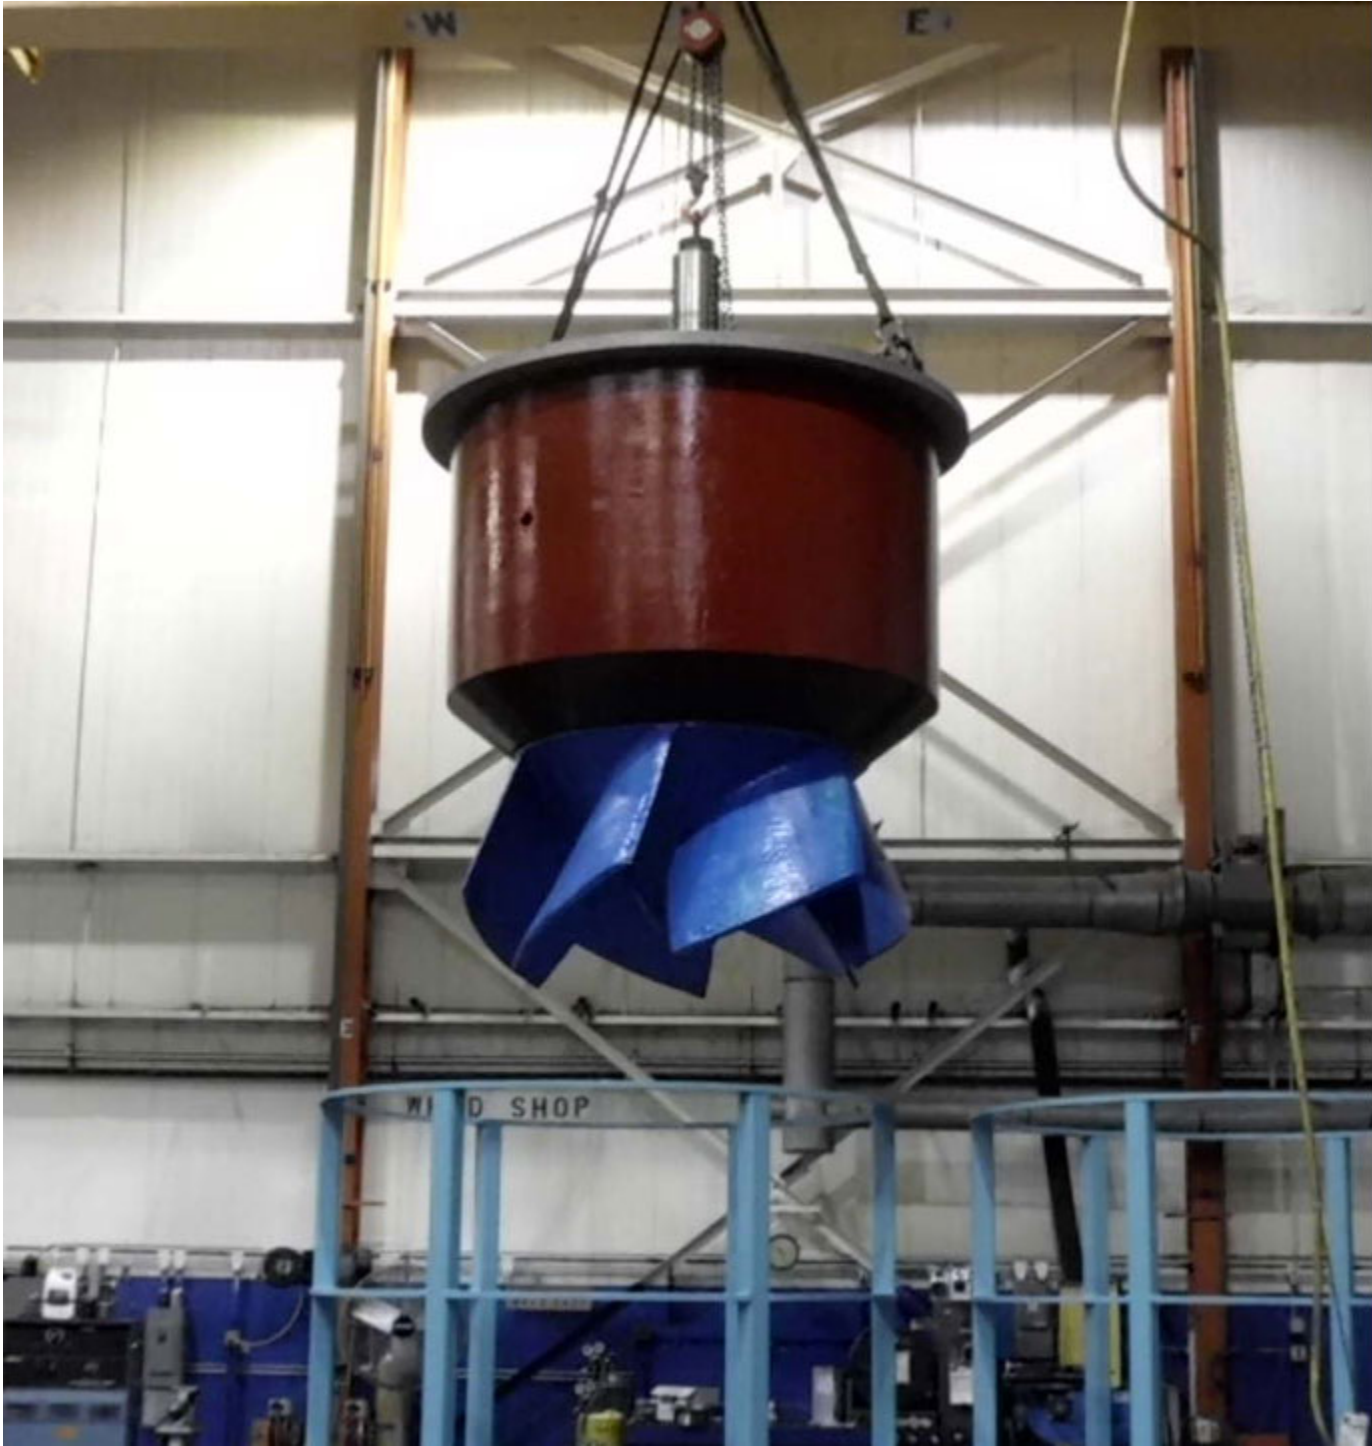
Because the revised plan specified that the rotors would be removed and installed as complete assemblies rather than individual components, the engineers at Hydro East designed special shipping fixtures to support the assemblies during transport. After the conceptual design for the fixtures was submitted to Calvert Cliffs and was approved, three were fabricated at the Hydro East service center. These fixtures proved to be essential for keeping the pumps stable during transport.

It is critical to have the proper in-transit supports when delivering a rebuilt vertical pump back into service. The goal is to maintain the alignment of the vertical pump during transport. Typically, the pumps are transported to a job site on flatbed trailers, secured with heavy chains that can bend or otherwise negatively affect the newly rebuilt pump. With the specially fabricated fixtures, Hydro East's field service team was able to achieve precision alignment when it came time to install the vertical pumps back into service at Calvert Cliffs.
