Circulating Water Pump Repair & Refurbishment

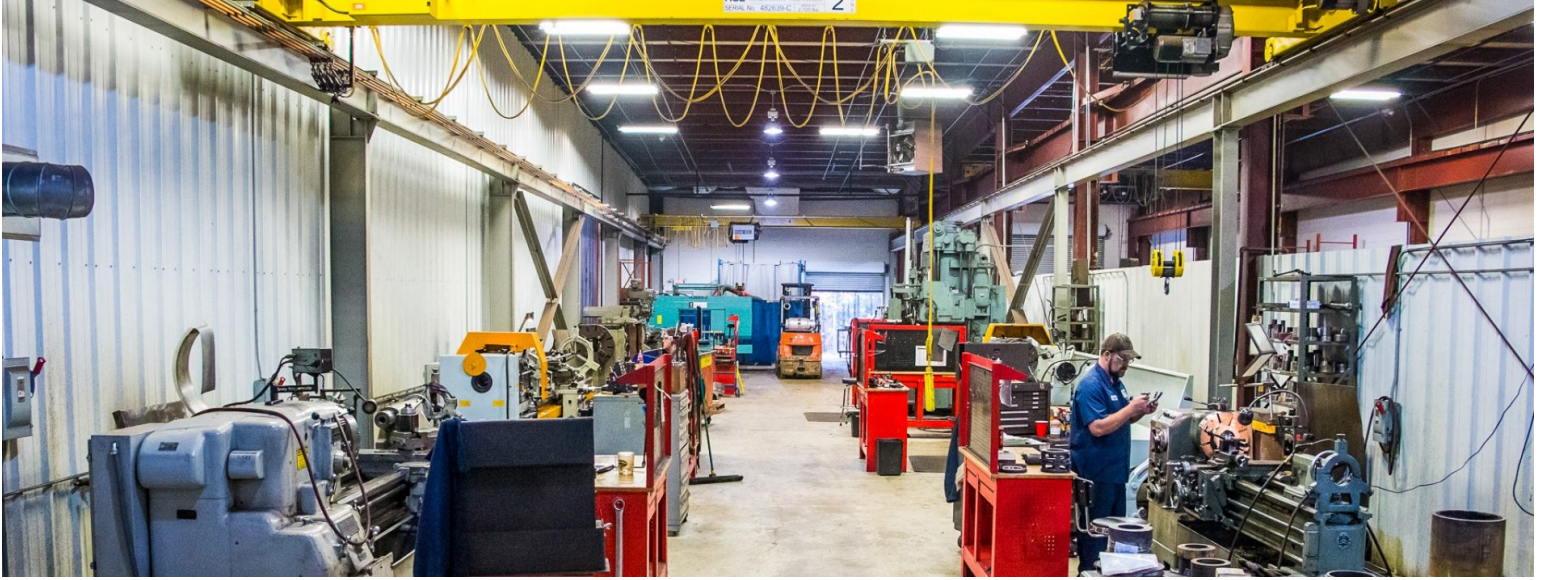
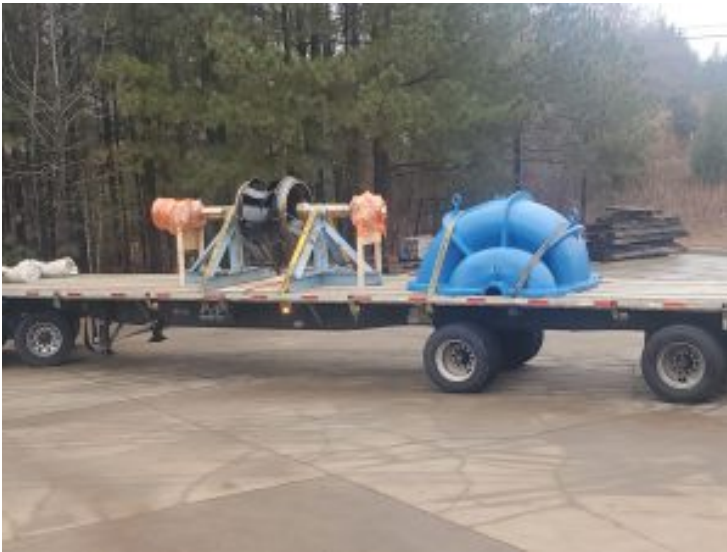
Before the pump was pulled for the outage, the spare parts were sent to the Hydro South facility for inspection. This is where the first problem was discovered- the threaded shaft and shaft sleeves were designed for the incorrect rotation. If they had been installed as-is, the rotation of the pump would have resulted in displacement of the sleeves. The plant elected to modify the parts to prevent the sleeves from backing off during operation. Hydro South accomplished this by drilling and tapping the sleeves for set screws and dimpling the shaft.

The second problem was discovered when the rotating element arrived at the Hydro South shop. During the dimensional inspection, it became clear that the spare impeller was much larger than the original impeller. Not only would performance be affected, but the larger suction eye of the spare impeller could not be accommodated in the existing casing. The only option available was to reuse the old impeller, which required extensive repair to the vanes.

By leveraging their experience with complex pump repair and keeping an open line of communication with the plant, the Hydro South shop developed a work scope that addressed the problem. They completed the refurbishment within 8 days, which allowed the plant to maintain their 14-day outage schedule. Because the problem was identified and addressed quickly and efficiently, the plant can expect reliable operation of their pump for the rest of the plant operating life.
