# Byron Jackson Process Water Pump Improvements

**Application: Pond Process Water**  
**Pump Details: Byron Jackson 32KXL**  
**Pump Type: Multi-Stage Vertical**

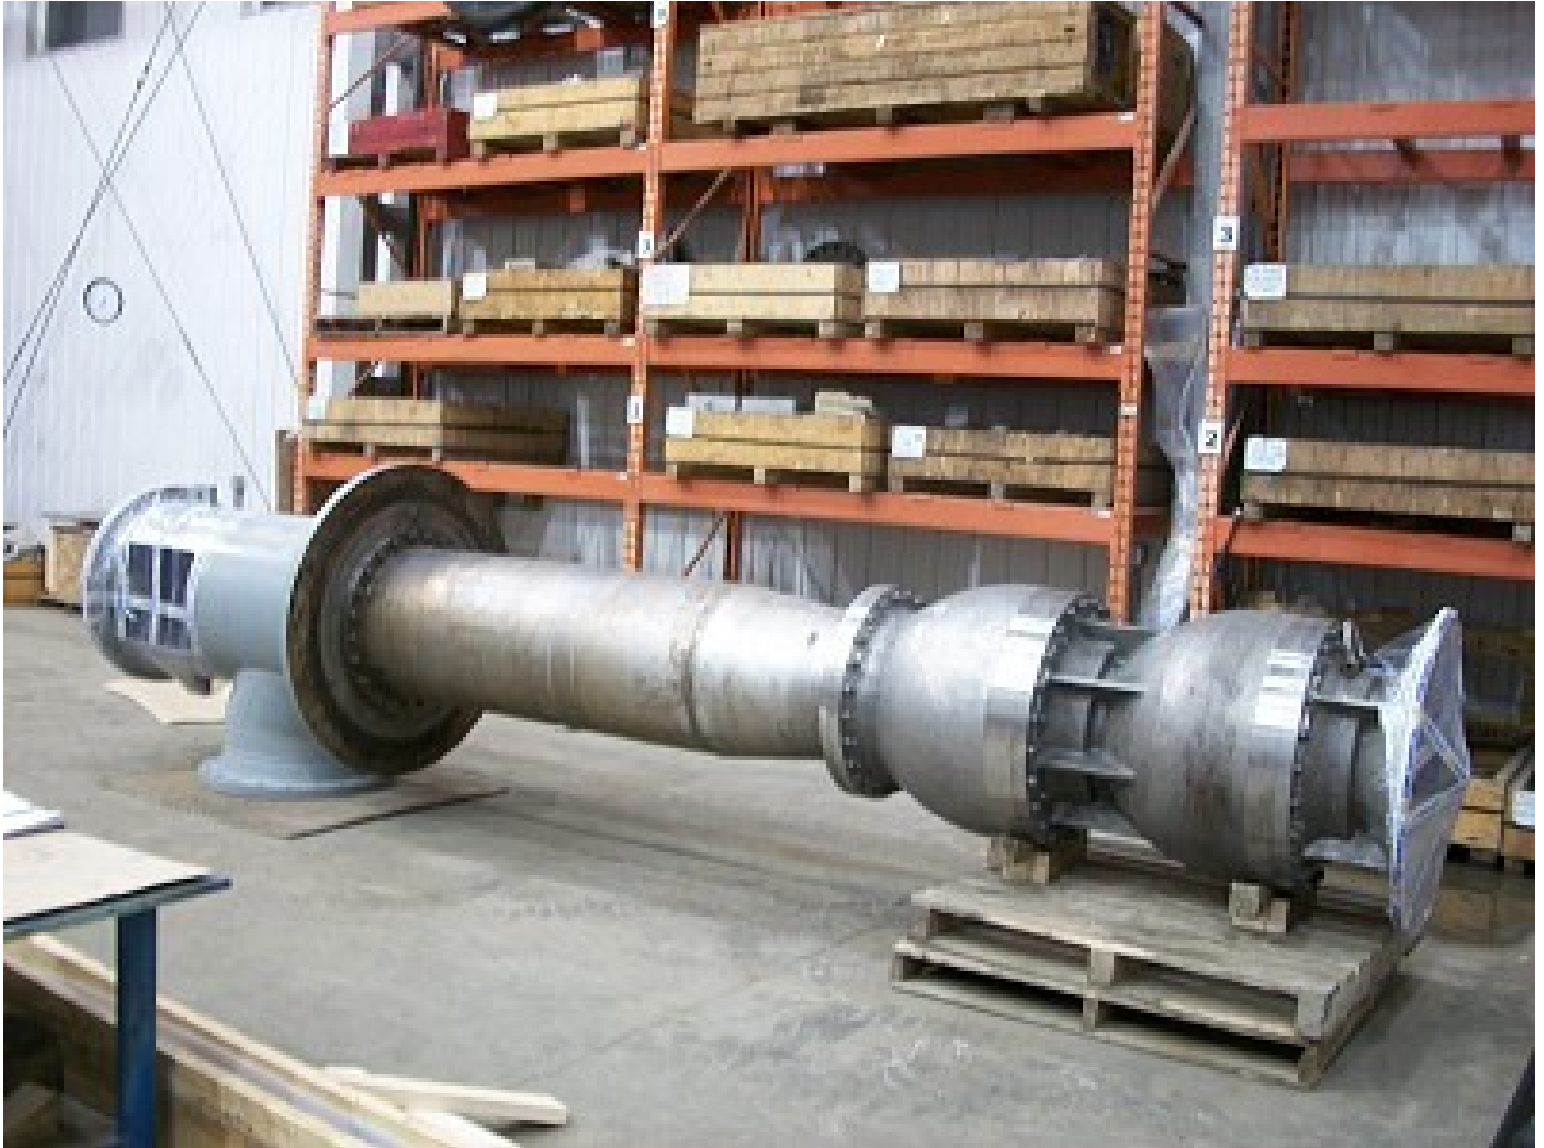
This pump had been “upgraded” by replacing the upper bearing with an enclosure tube, which was not part of the original design. The lack of that bearing contributed to the instability of the top shaft and may have lead to the pump's failure.

After fully reverse engineering the pump, Hydro redesigned the existing enclosure tube to incorporate the missing upper bearing. The modification involved machining the enclosure tube into two pieces and joining them together with a coupling and adding a bushing to stabilize the shaft.

Because the spare parts provided were of an older design and no longer fit the pump, Hydro manufactured several parts. These included a new transition piece, diffusers, a new bearing, and suction bell. Moreover, the impeller vane tips were weld-repaired and re-machined, and the impellers were then balanced to 4 W/N. The pump, which was rebuilt to standard specifications and reconstructed using a durable stainless steel, was returned to service successfully.
