Byron Jackson Process Water Pump Improvements

Application: Pond Process Water Pump Details: Byron Jackson 32KXL Pump Type: Multi-Stage Vertical

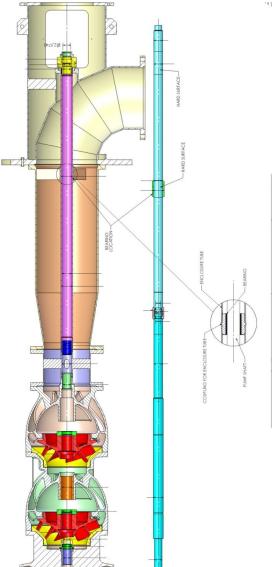
Industrial pumps are sometimes repaired or modified by smaller local repair shops that do not have the engineering oversight to ensure that the repairs and modifications meet the original design's intent. When Hydro received this pump, it was clear that prior modifications that had been performed without engineering review were causing problems.

This pump had been "upgraded" by replacing the upper bearing with an enclosure tube, which was not part of the original design. The lack of that bearing contributed to the instability of the top shaft and may have lead to the pump's failure.

After fully reverse engineering the pump, Hydro redesigned the existing enclosure tube to incorporate the missing upper bearing. The modification involved machining the enclosure tube into two pieces and joining them together with a coupling and adding a bushing to stabilize the shaft.

Because the spare parts provided were of an older design and no longer fit the pump, Hydro manufactured several parts. These included a new transition piece, diffusers, a new bearing, and suction bell. Moreover, the impeller vane tips were weld-repaired and re-machined, and the impellers were then balanced to 4 W/N. The pump, which was rebuilt to standard specifications and reconstructed using a durable stainless steel, was returned to service successfully.
