# Upgrades Maximize Efficiency of 82-Year-Old Pump

**Written by:** Bill Rademacher and Jarrod Streets, BP, Jeff Johnson and William Gottschalk, Hydro Inc.

**Publisher:** Pumps & Systems / August, 2012

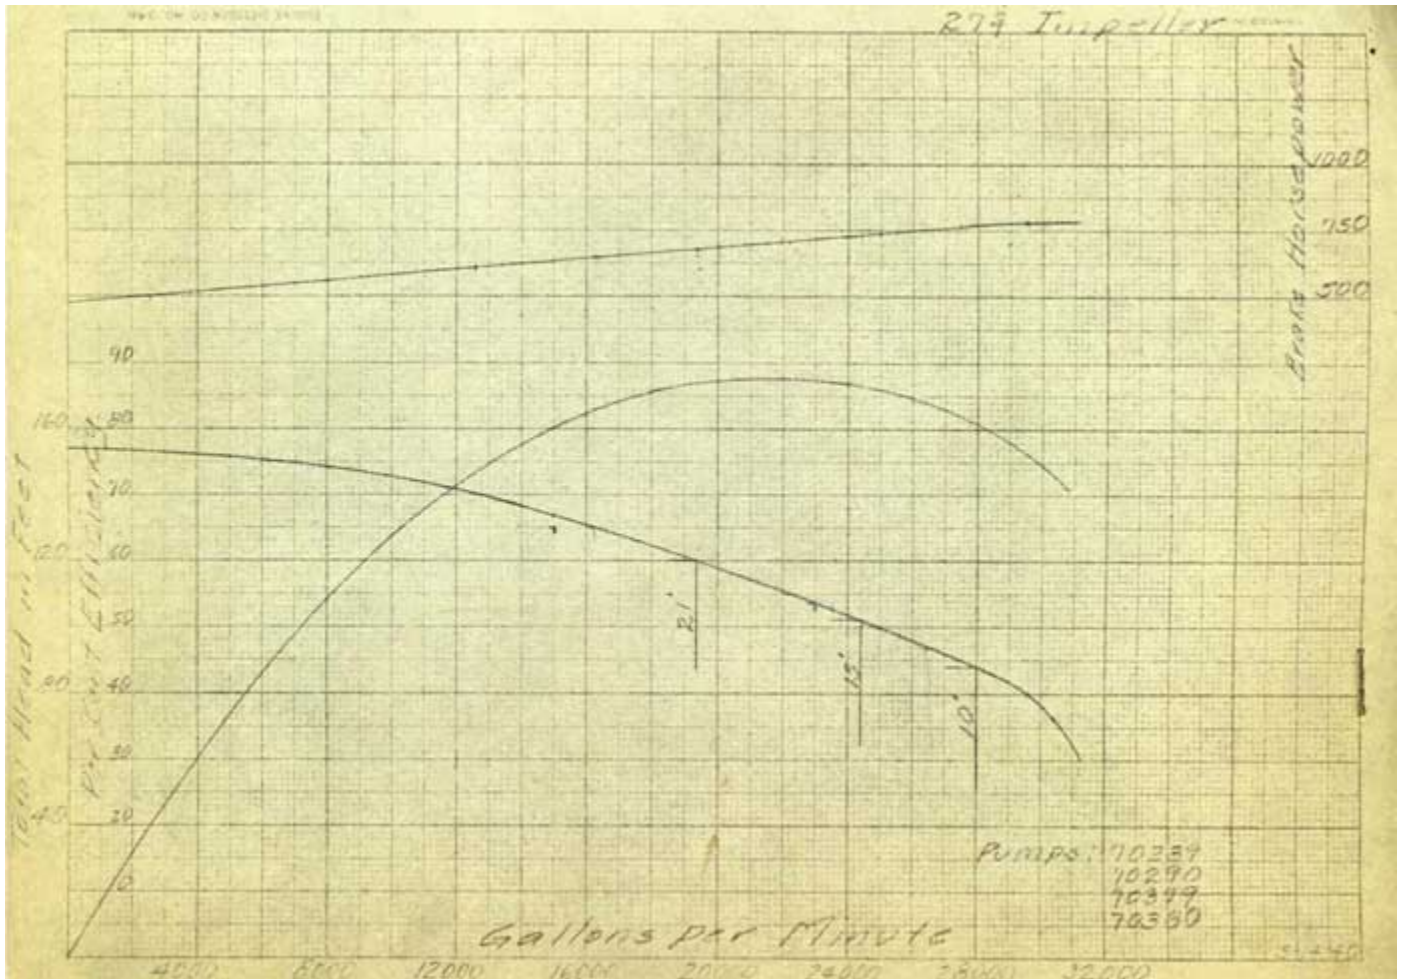
Positioned on the shores of Lake Michigan are two stations that contain cooling water pumps which feed cooling water to BP's Whiting Refinery. The #1 water station contains four IR 24 HV pumps, which are large, single-stage, double-suction, horizontal split case pumps. Four pumps in station #1 (P-11, P-12, P-13, and P-14 in the photo below) are unique in that they were designed with a bottom-suction configuration.

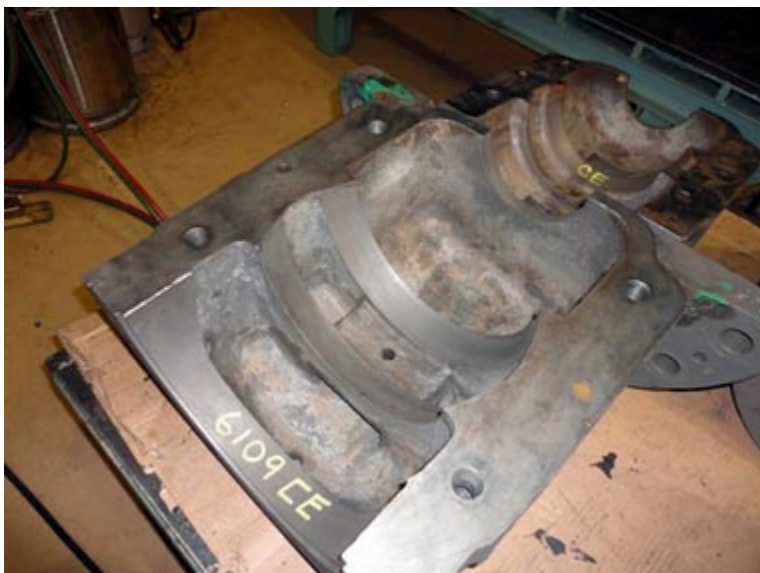
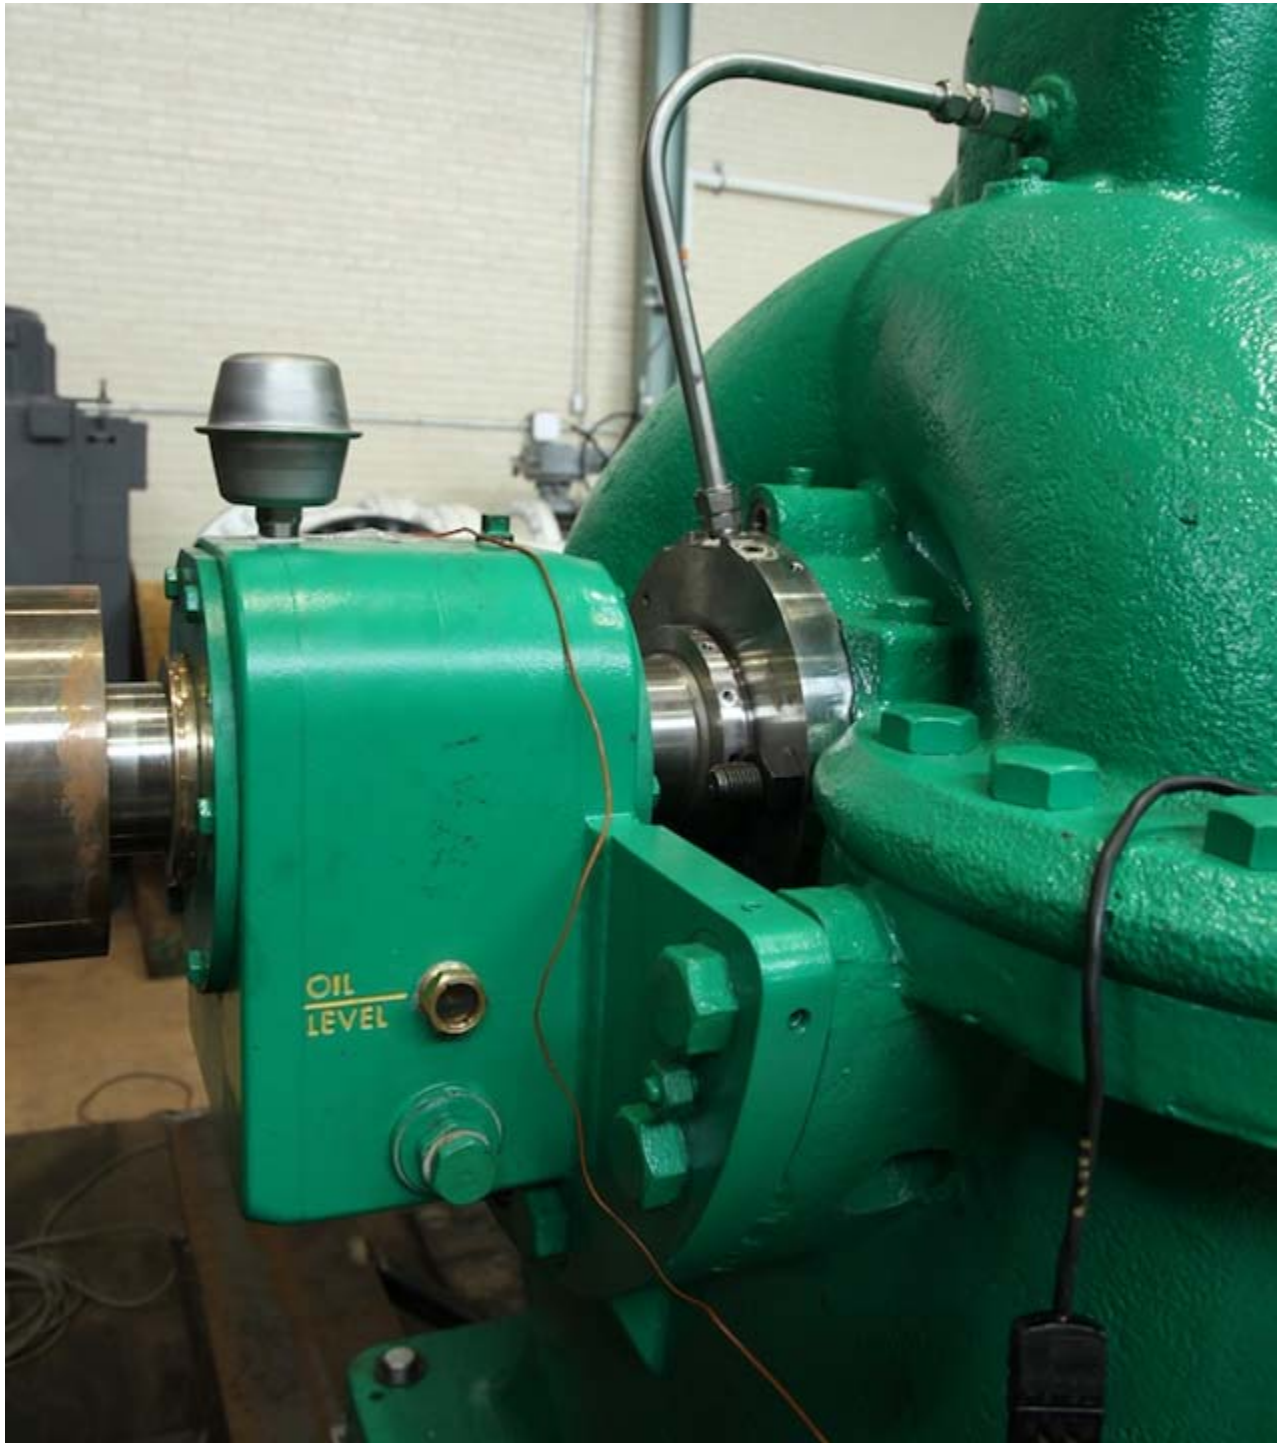
The refinery's rotating equipment engineers first asked Hydro's engineers about redesigning the bearing housings. The original bearing housings were 2.5 foot long with spherical shell journal bearings that were hard to machine and made proper alignment difficult. More importantly, redesigning the bearing housings would help to reduce the weight on the external bearings. Because the bearings were identified to be an obsolete design, Hydro's engineers evaluated new bearing configurations at the request of the refinery. Axial thrust and bearing loads were reviewed to determine the best bearing design. Modifying the bearing design gave the refinery another option to upgrade from packing to mechanical seals, which would provide an added benefit of reducing leakage and decreasing energy consumption. The evaluation of upgrading to mechanical seals prompted a review of shaft deflection, or bend in the shaft. Mechanical seals can accommodate a limited amount of shaft deflection, so the shaft would need to be redesigned to work with the mechanical seals.

Once the engineering review was complete and all the modifications were agreed upon, Hydro went to work. The shaft was modified to a stepped design and the distance between the bearings was shortened to reduce deflection at the seal faces. The sleeve bearings were removed and ball bearings were put in to greatly handle the axial thrust of the rotor, thus stabilizing the shaft and lowering vibration. New mechanical seals were installed along with newly manufactured bearing housings,

which were fabricated at Hydro's service center. Hydro manufactured the new bearing housings from steel plate using their 5-axis CNC machine.

Design changes were made to the impeller wear rings after a mechanical and metallurgical review was performed on the original cast iron wear rings. Hydro manufactured new impeller wear rings from a more durable stainless steel. The size of one impeller wear ring was made larger to reduce axial shuttling by prescribing the direction of axial thrust away from the thrust bearing. Specialized processes were used to machine, grind and metalize the impeller wear rings. The applied metal is harder than the parent metal, increasing the erosion resistance and extending the life span of the wear rings.

The pump casing was line-bored. Damage to the inside of the casing, which had been caused by axial shuttling and erosion, was repaired. The casing was also machined to create a larger bore for the new mechanical seal glands. After the pump rebuild was complete, the pump was shipped to the Hydro's pump performance test lab in Chicago.

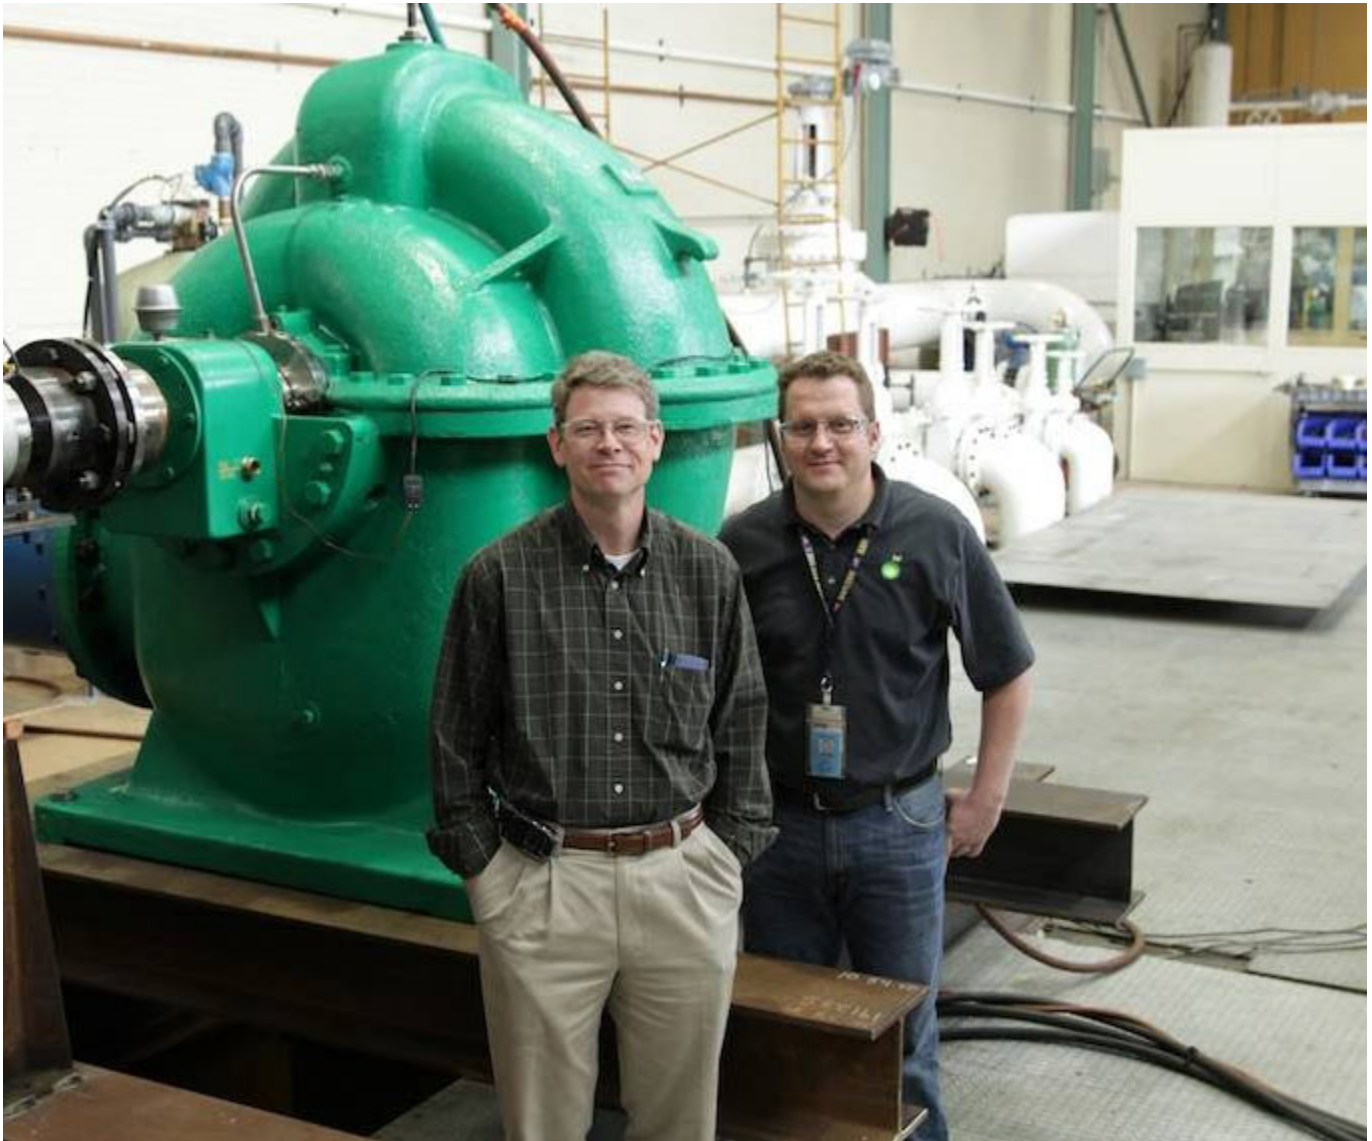
To test the pump, Hydro's Test Lab engineers designed and constructed a customized test configuration. Instead of placing this pump on the horizontal test stand, it was set up over the test lab's vertical pit to accommodate the 30" bottom suction inlet. A sturdy baseplate was erected to support the 800-horsepower motor and the pump, which sat above the vertical pool that contained approximately 65,000 gallons of water. Attached to the pump's suction inlet was a 17-foot column pipe that extended down into the pit and would be used to draw water up into the pump.

When a horizontal pump is tested, it is critical to flood the system before the pump is started. In actual operation in the field, the elevation of the water in the sump below the pumps is controlled by a sluice gate that holds back the water in Lake Michigan from flooding the water station. In this unique set up, all the water was well below the pump level; so Hydro's test lab engineers had to back fill the pump using water from the 38,000 gallon tank on the horizontal test loop. A butterfly valve had been strategically affixed to the bottom of the column pipe and remained closed while Hydro's test lab

engineers opened the tank valve and flooded the pump. Once the pump was completely flooded, Hydro's test lab engineers closed the valve to the tank and opened the butterfly valve to the pit. Using an eductor, a vacuum was created to keep the water from draining into the pit. This allowed for optimal pump start up conditions.

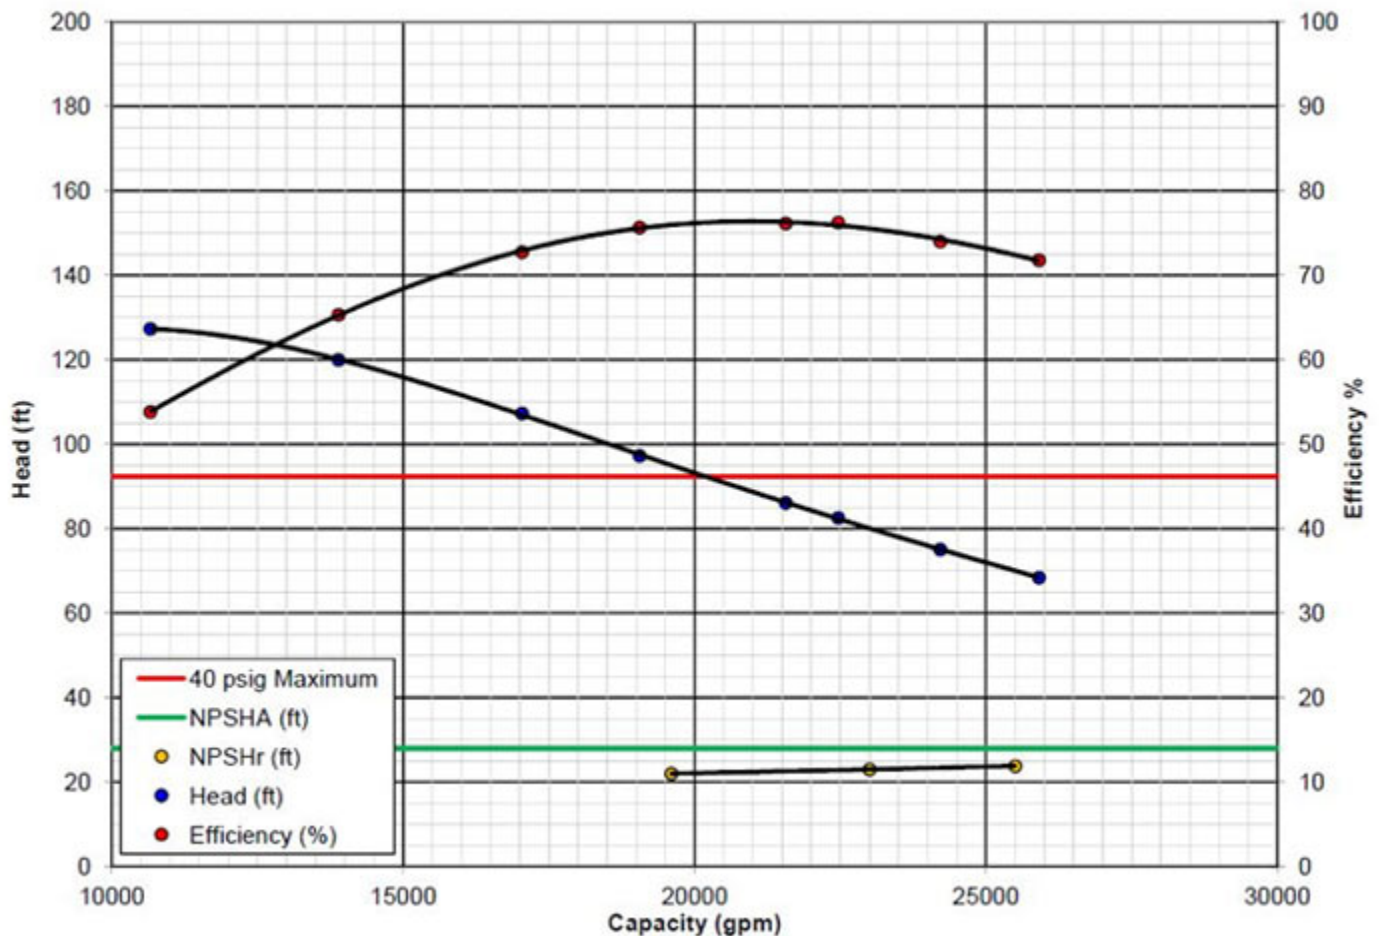
The tests showed that the pump can be operated to the right of BEP and still stay within net positive suction head available (NPSHa). The data indicates that one pump operating at a higher capacity can eliminate the need for three pumps operating at reduced capacity. These findings suggest significant potential energy savings for the refinery and may enable BP Whiting to run just one of these pumps in each water station during the winter months and two pumps in each water station during the summer months. "The performance testing we did went a long way toward allowing us to shut down unnecessary water pumps, and the modifications we made to this pump will allow us to run it more reliably," confirms Bill Rademacher, one of the Rotating Equipment Engineers who helped lead the
