A Trusted Partner for Lasting Solutions

Material Upgrades Lead to Lower Maintenance Costs

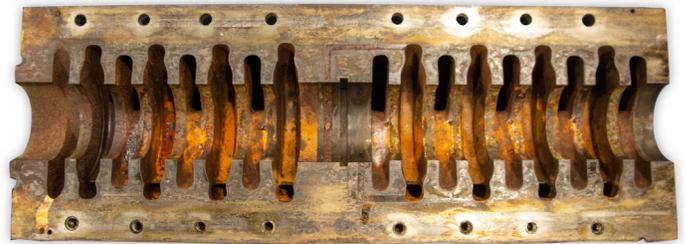
The application for this pump requires repeated cycling, on and off, which can be hard on the design, and over its life cycle, Hydro Rocky Mountain had performed numerous repairs on this unit as well as its sister pumps. This line of pumps was originally built in the 1950s, with four-part cases forged out of cast-iron. Because of the metallurgic properties of cast-iron, any build-ups or welding to the case required the addition of brass inlays, in addition to excessive machining.

As the price of brass increased, so did the cost of repairs, and upon the pump's most recent return to Hydro Rocky Mountain, the price of brass coupled with the amount of brass required to complete the job meant that the cost of the repair would be almost as much as casting a whole new case. In this instance, Hydro Rocky Mountain recommended the latter, to ensure a long-term solution for the customer.

Solution: Hydro Rocky Mountain's Denver facility is part of the Hydro, Inc. worldwide network of service centers, and because of that, the facility was able to work with Hydro Parts Solutions in Houston to develop a comprehensive casting scope. This plan would not only provide the customer with a newly machined case with tolerances brought back up to original specs, but it would also provide a case cast out of carbon steel.

The customer opted to proceed with Hydro Rocky Mountain's plan to replace the case with upgraded materials. Hydro Rocky Mountain sent the case to Hydro Parts Solutions to be reverse engineered and cast with a quick turnaround. After the case was cast and machined, it was returned to Hydro Rocky Mountain to be mated with its rotor, which was simultaneously being repaired and re-machined in the shop. Once the pump was reassembled and inspected, it was returned to the customer ready to return to service as soon as production resumed.
